Inspection Procedure:

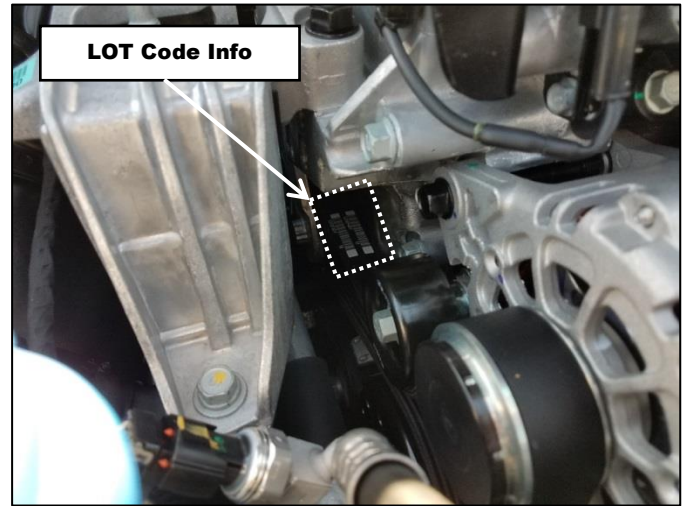
1. Open the hood and check the lot code information on the V-ribbed belt.

If the lot information is not visible, then quickly **START** and **STOP** the engine until the lot information portion becomes visible.

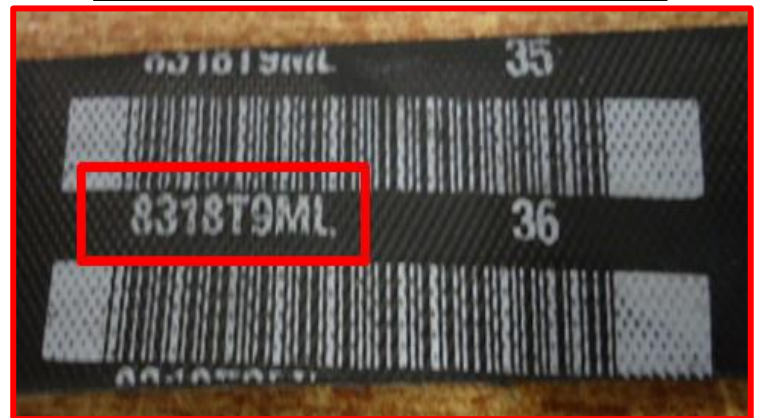
- Lot Code is 8318T9ML is **NO GOOD**.
- All other Lot Codes are **GOOD**.

NO GOOD (Lot Code "8318T9ML")

3.
 - If the lot code **is not** "8318T9ML" (GOOD), then no further work is needed.
 - If the lot code **is** "8318T9ML" (NO GOOD), then replace the V-ribbed belt following the service procedure in the Shop Manual.
 - **Refer to the Shop Manual section for Elantra (Ada) > 2018 > G 2.0 MPI > Engine Mechanical System > Drive Belt > Repair Procedures**
