Reference	SSM73065
Models	Discovery Sport / L550 Range Rover Evoque / L538
Title	9HP Transmission Internal Differential Seal Plug Missing
Category	Driveline
Last modified	16-May-2018 00:00:00
Symptom	501000 Automatic Transmission Concerns
Attachments	11SSM73065 Differential Sealing Plug.pdf

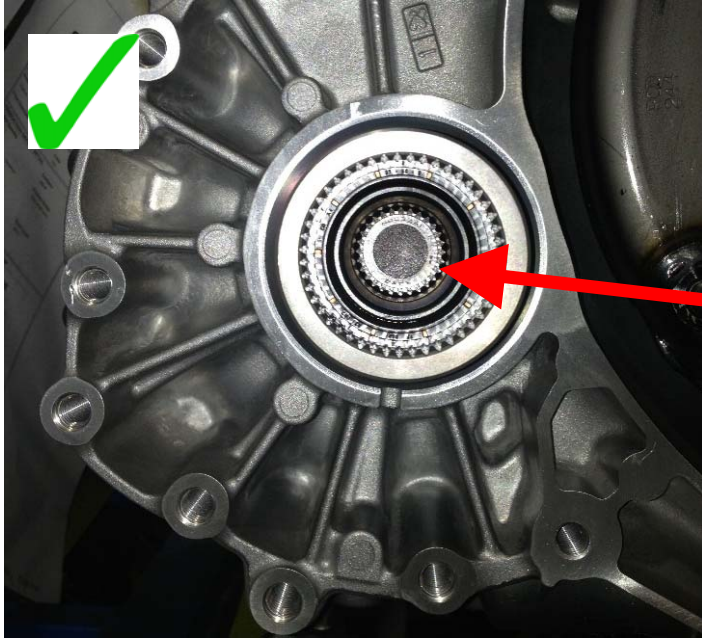
Images A1 and A2 show the differential sealing plug intact (Differential cross pin not visible)

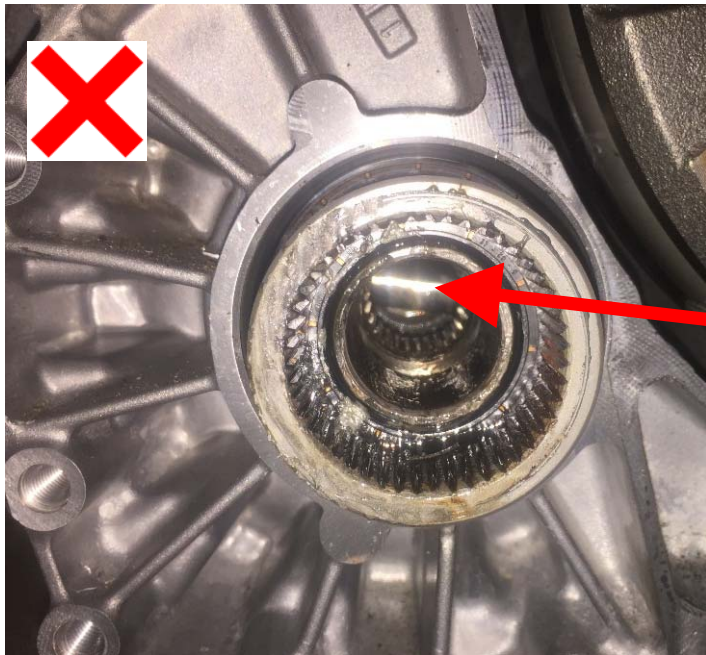
Oil leakage from the joint of 9 HP transmission and front differential following a repair in and around the Transmission internal differential right output half shaft.

Transmission internal differential right output half shaft sealing plug missing.

Images B1 and B2 show the differential sealing plug missing (Differential cross pin visible)

Under no circumstances must any tooling be used to remove the halfshafts by attempting to push the halfshafts out through the transmission as this will dislodge the sealing plug.

- If the sealing plug is in place please carry on with the repair.
- If the sealing plug is missing and cannot be located there is a chance the plug may be within the automatic transmission unit. In this case please escalate to the recommended department and also please raise an EPQR.
