LTB01178NAS1

# TECHNICAL BULLETIN

501-03: Body Closures

Tailgate/Quarter Panel Trim Worn

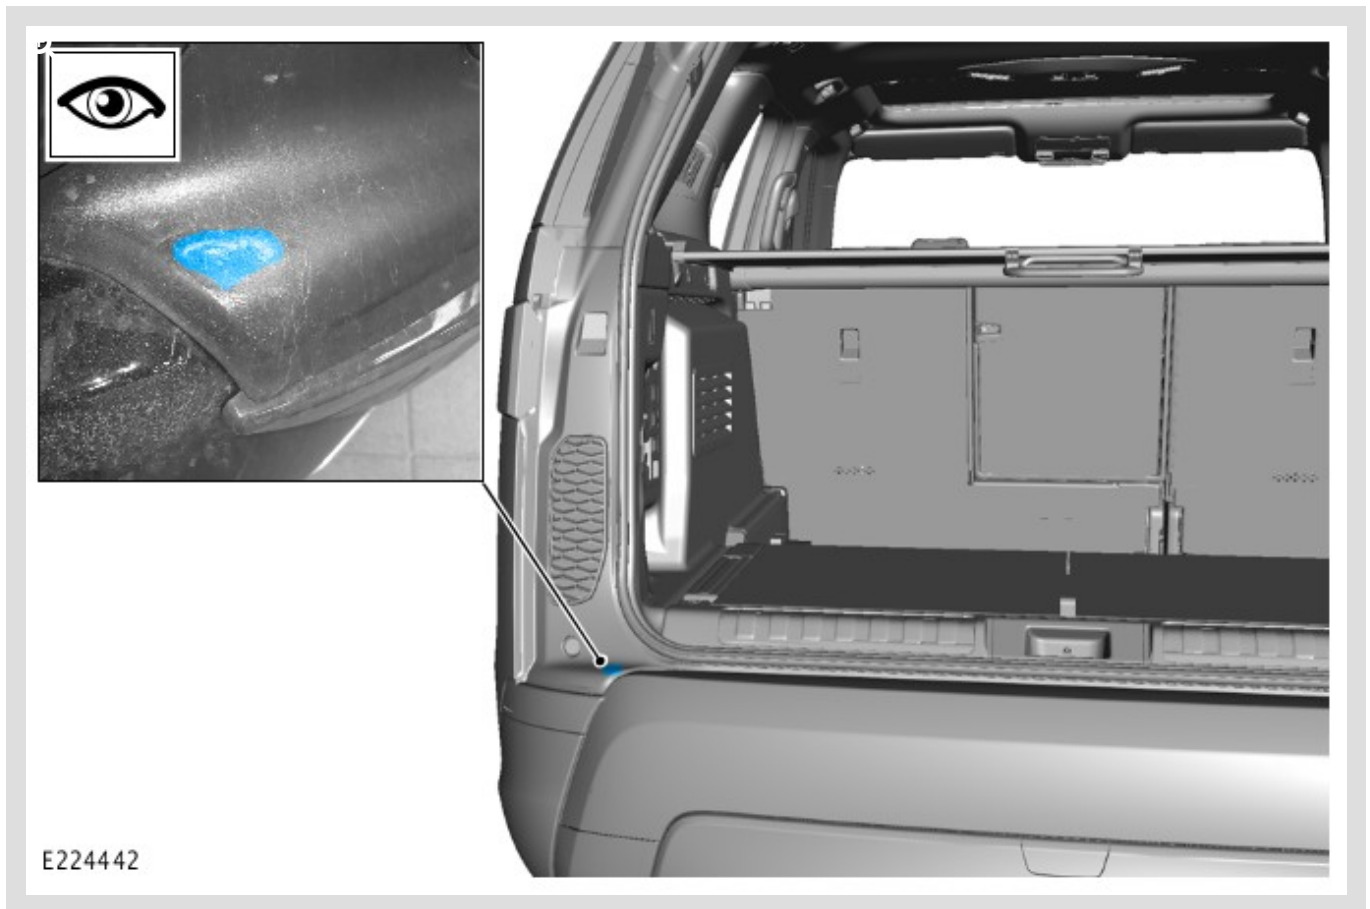
Inspect the Quarter Panel Tailgate Trim for signs of wear.

- If the Quarter Panel Tailgate Trim does not show signs of wear, go to step 4.
- If the Quarter Panel Tailgate Trim does show signs of wear, go to step 3.

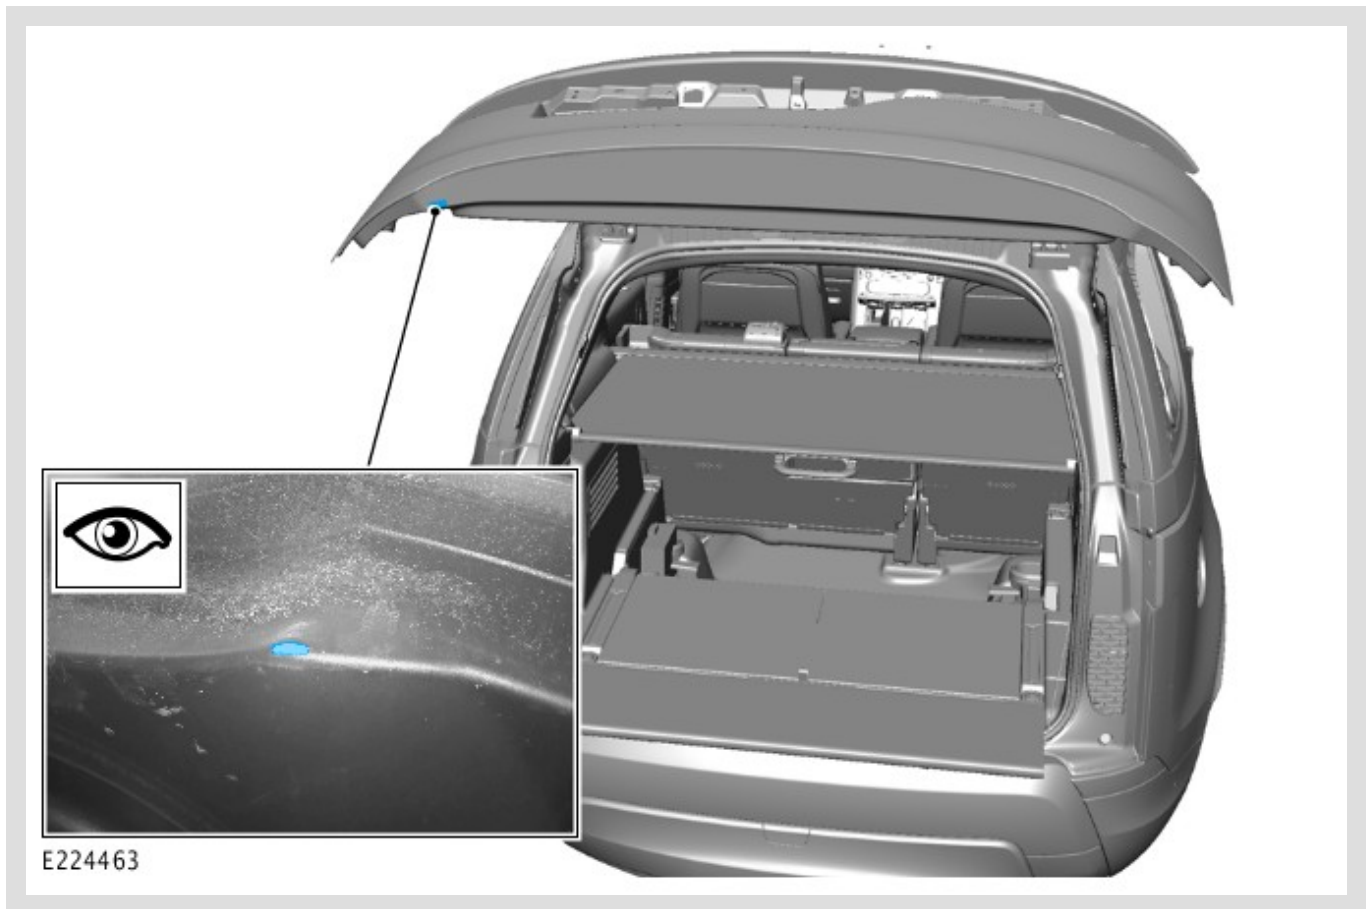
Visually inspect the tailgate for signs of wear.

- If the tailgate does not show signs of wear, go to step 6.
- If the tailgate does show signs of wear, go to step 5.

**5** **ONLY if required:** have the tailgate repaired by an approved body shop.
