## SERVICE BULLETIN

**APPLICABILITY:** 2014-2018MY Forester

**NUMBER:** 05-63-18

**SUBJECT:** Steering Rattle Sound / Steering Wheel Vibration

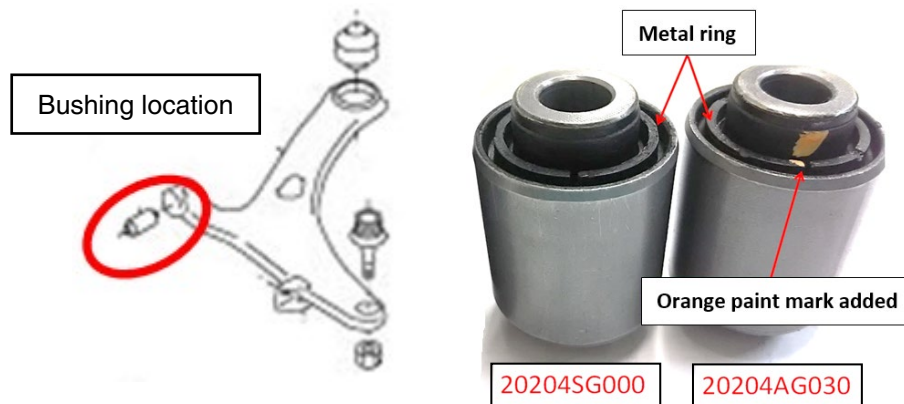
This bulletin announces a design change made to the forward bushing used in the front lower control arm to address customer concerns of a rattle-type sound and / or a possible vibration felt in the steering wheel. The material for the cushion portion of the front bushing has been changed.

The images below show the location of the front bushing and the new part as identified by the orange paint mark. **NOTE:** Control (Lower) Arm Assembly part numbers are supplied as reference only as nearly all repairs will only require bushing replacement. Always refer to the Service Manual for inspection requirements prior to making any repairs.

Description	Part Number	Note
BUSHING-TRANSVERSE LINK FRONT	20204AG030	Front bushing will have both the metal ring <u>and</u> an orange paint mark
LOWER ARM ASSEMBLY- FRONT LEFT	20202SG011	
LOWER ARM ASSEMBLY- FRONT RIGHT	20202SG001
