SERVICE BULLETIN

APPLICABILITY: All 2015-17MY Vehicles with Fujitsu TEN (F10) 7in. Multimedia Navigation (AVN) & Display Audio Units
NUMBER: 15-177-14R
DATE: 10/16/14
SUBJECT: “Gen 2” & “Gen 2.1” Operating Tips
REVISED: 06/11/18

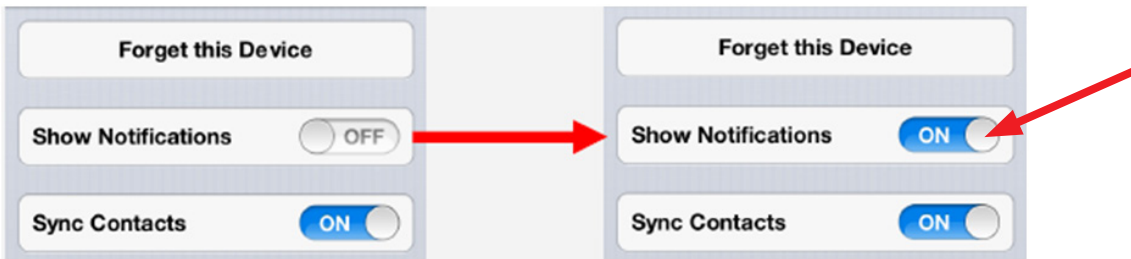
CONDITION #1: Cannot receive incoming text messages on the head unit when using an iPhone.

“Show Notifications” is not activated in the iPhone’s Bluetooth Settings menu.

4. Slide “Show Notifications“ button to “ON”.

New incoming text messages will now be displayed on the head unit as they are received.

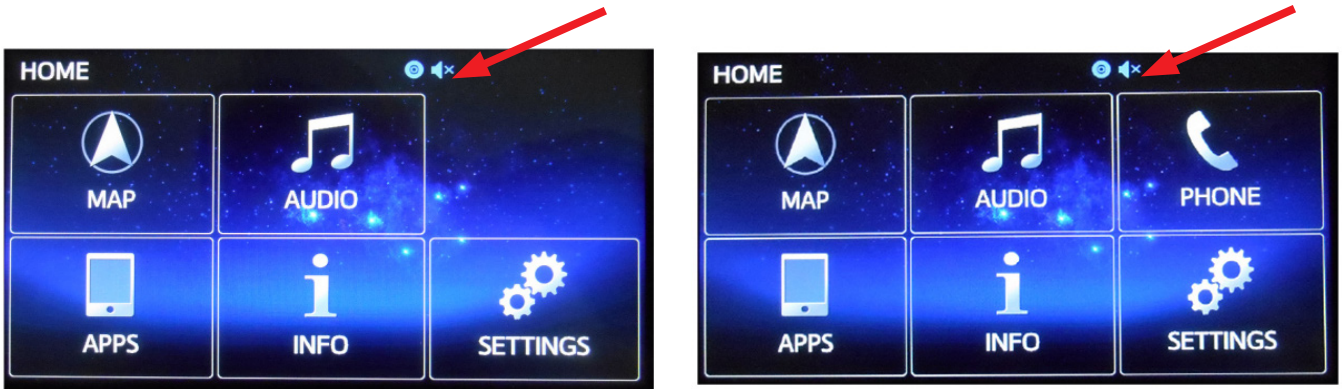
CONDITION: #5: A “Phone” button is not displayed on the HOME screen.

- Microphone is not properly connected to the head unit
- Microphone detection wiring (MIC DET) is open
- Microphone unit is defective

- Confirm the microphone wiring is securely connected to the head unit.
- Confirm there is not an open circuit or short in the Microphone detection (MIC DET) wiring.
- After the wiring has been confirmed to be OK, replace the microphone if necessary.

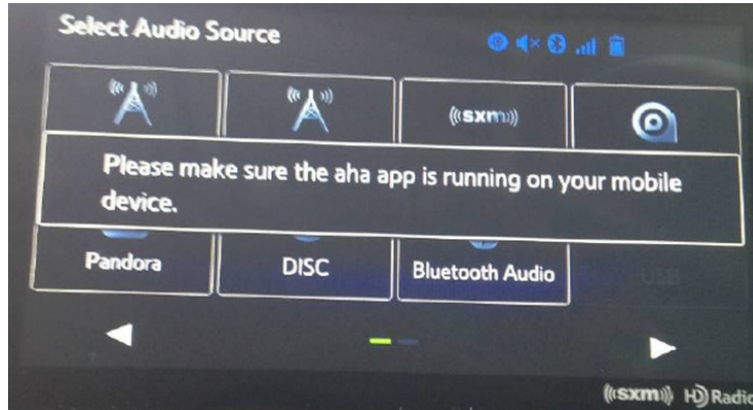
aha Message

CONDITION #10: When selecting aha or Pandora on the head unit with a Smartphone (iPhone or Android) connected, the head unit displays a message informing the user to check the app on their Smartphone (see below).

- Pandora or aha App is not installed on the Smartphone.
- Pandora or aha App is not launched on the Smartphone.
- The iPhone is not connected to the system to the head unit with a USB Cable or in the case of an Android Smartphone, the Smartphone is not paired to the head unit using Bluetooth or launched.

- Download the Pandora or aha app to the Smartphone.
- Launch the Pandora or aha app on the Smartphone.
- Connect the iPhone to the head unit using a USB cable.
- Pair the Android phone to head unit using Bluetooth.
- Select Pandora or aha on the head unit from Audio Source

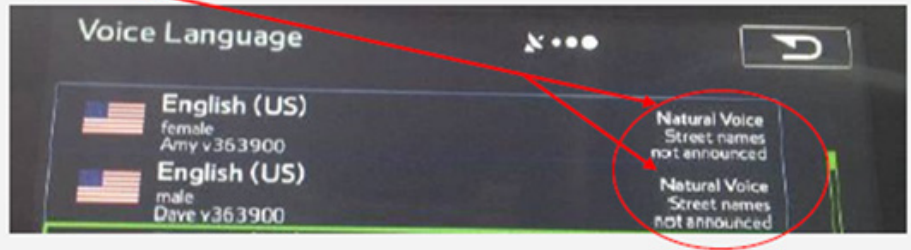
Figure 1

CONDITION #12: When using the voice command to operate navigation system functions, the following message is displayed: “This feature cannot be used with the selected guidance voice profile”.

“Natural Voice” (Figure 1) is selected from the Voice Language menu when “Text To Speech” (TTS) is required (Figure 2) for proper voice command operation.

- Follow the steps below to change from Natural Voice to TTS:
 1. Select “Home”.
 2. Select “Settings”.
 3. Select “General”.
 4. Select “Language”.
 5. Select “English (US) TTS Voice”.

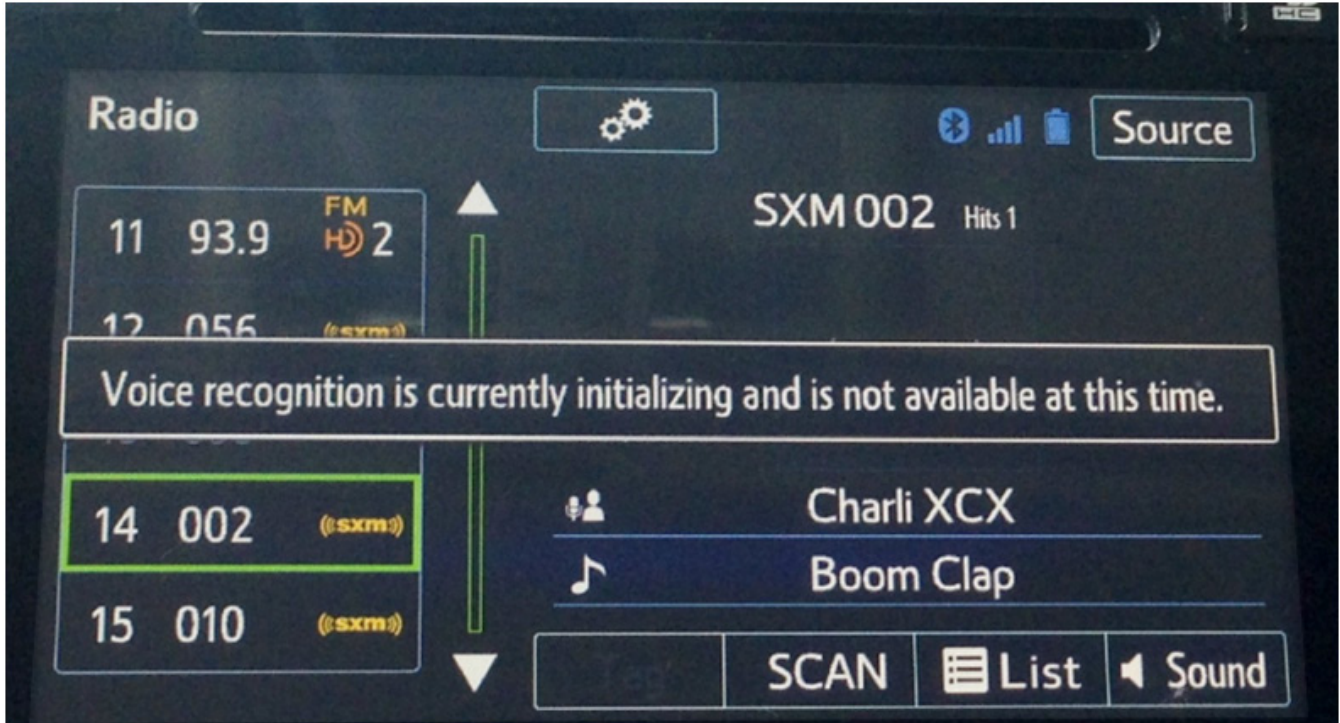
CONDITION #15: The message “Voice recognition is currently initializing and is not available at this time” appears on the screen.

When the head unit is turned on, the system scans XM stations along with every song (digital file) on the currently loaded CD, connected USB device and / or Bluetooth Audio player. It also scans the phone contacts stored on all Bluetooth-connected Smartphones. The system then creates voice tags for all the XM station names, artists, songs, albums, playlists, podcasts, genres, and contacts. During this process, the head unit will also display “Voice Recognition is currently initializing and is not available at this time” (see picture below).

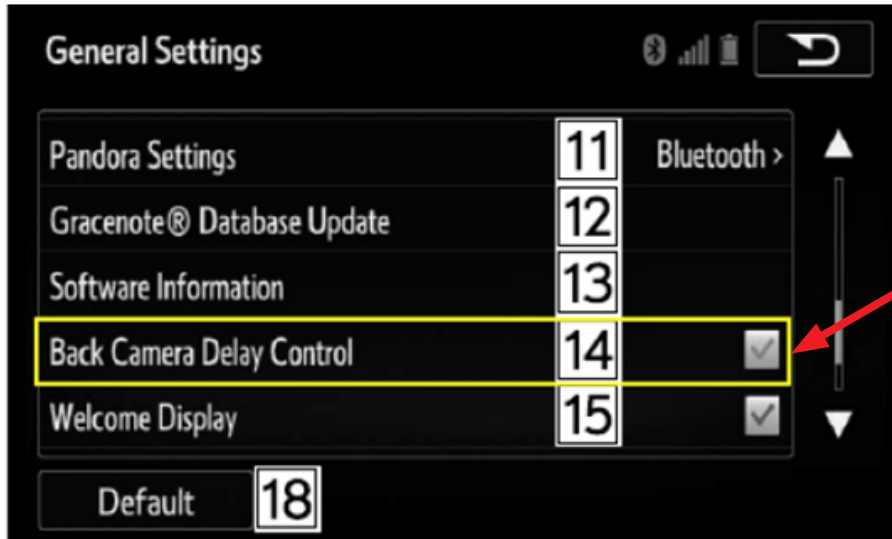
CONDITION #17: Back-up camera image remains displayed after shifting out of Reverse

“Back Camera Delay Control” setting is set to “ON”

When set to “ON”, the back-up camera image will remain displayed for about 7 seconds after moving the shifter out of Reverse. The image will turn off when shifting into Park or when vehicle speed exceeds 5 mph.

1. Touch “HOME” button.
2. Touch “SETTINGS” button.
3. Touch “General”.
4. Unselect the “Back Camera Delay Control”.

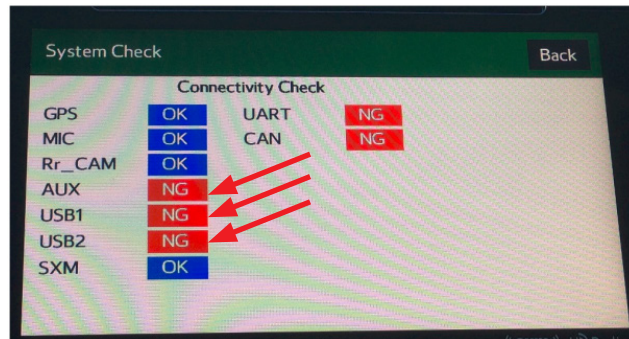
CONDITION #18: When in Diagnostic Mode, AUX, USB1 and USB2 all show as being NG

- Turn the ignition switch to ACC (or press the Engine Start Stop button).
- While pressing and holding the “a” button, press the button “b” twice.

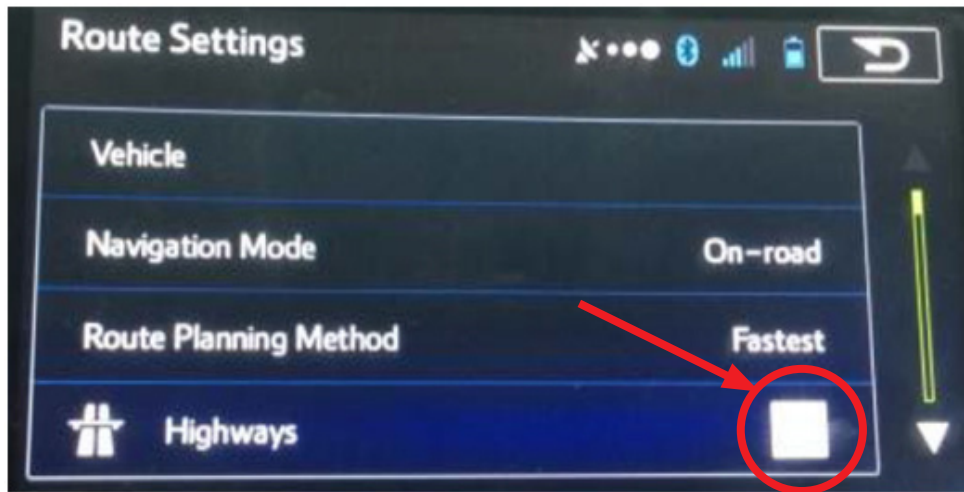
CONDITION #20: The Navigation system often routes the user off the highway, and onto rough surface (dirt / gravel) roads.

In the Route Settings menu, the “Highways” selection box is unchecked.

- Select “**Menu**” on the Map Screen
- Select “**More**”
- Select “**Settings**”
- Select “**Route Settings**”
- When “**Highways**” is checked the navigation system will always consider using highways first when planning routes.

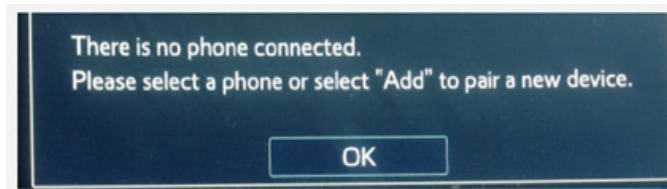
Pic 1

CONDITION #24: Messages are displayed on the screen after pressing / holding the Talk switch on the steering wheel to activate Siri (2016 MY vehicles equipped with Gen 2.1 Navigation / Display Audio system).

1. The message shown in (Pic 1) will display when there is no phone paired with the unit.

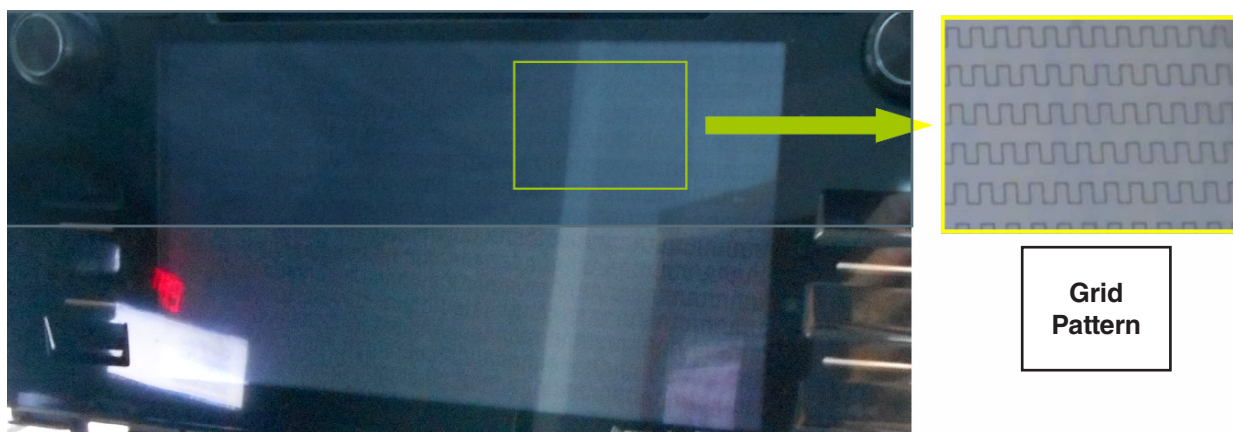
CONDITION #37: Grid pattern visible on the entire display area, all the time.

Defective Display unit.

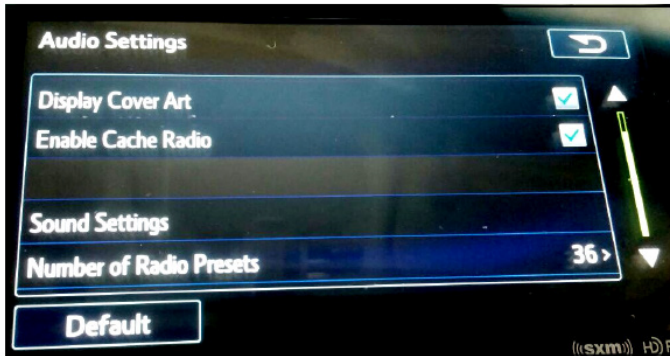
CONDITION #38: ASL (Automatic Sound Levelizer) function does not appear in Audio Settings as indicated in the Owner's Manual.

ASL function not displayed in vehicle.
