SERVICE BULLETIN

APPLICABILITY: 2015-2017MY Legacy and Outback
 2015-2017MY Impreza and XV Crosstrek
 2015-2018MY Forester
 2016-2018MY WRX
 2015-2016MY BRZ

NUMBER: 15-199-16R
DATE: 05/05/16
REVISED: 06/11/18

SUBJECT: Reprogramming File Availability to Address Operational Concerns with 6.2” Clarion Display Audio Unit

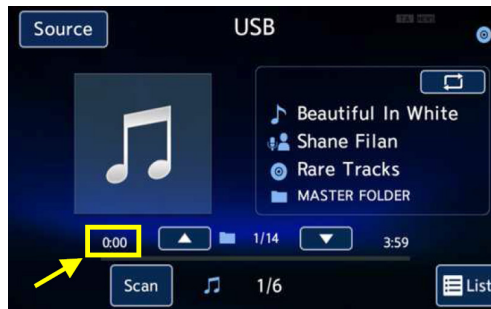
- When listening to music from a USB drive, the elapsed play time counter stays at 0:00.

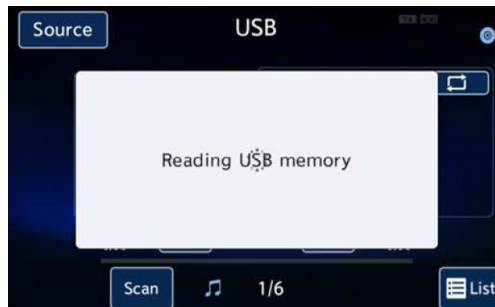
- When listening to music from a USB drive, the music plays normally but the screen display shows “Reading USB Memory”.

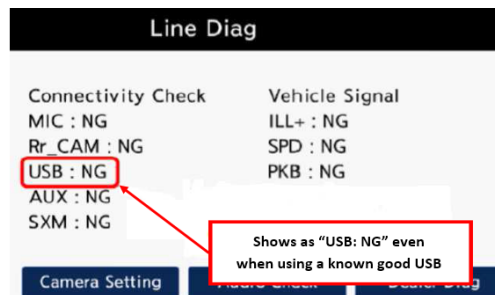
- In diagnostic mode, “USB: NG” is displayed even though a known good USB drive is plugged in.

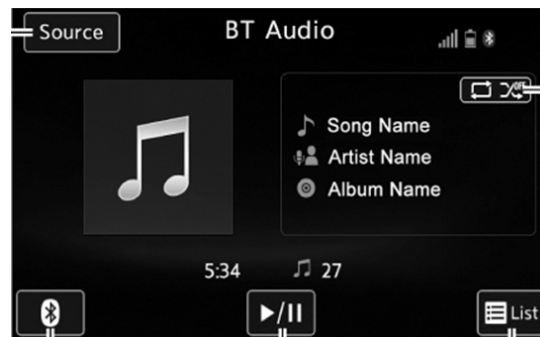
- All the function keys such as the steering switch, hard keys on the head unit and touch panel (display) become inoperative after playing music for 3-4 hours using a Bluetooth-connected device and no input from any of the keys on that connected device. When this occurs, music continues to play normally but the display screen freezes.

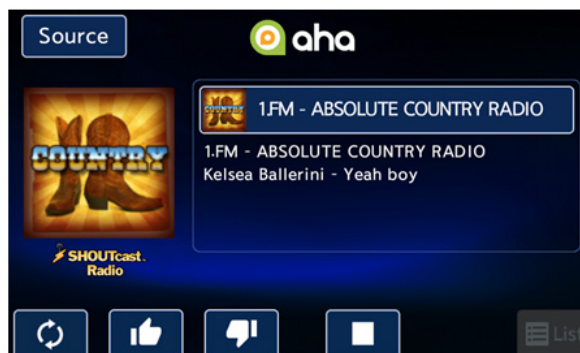
- ✓ When making a hands-free call using the voice command function, the ring-back tone is not heard from the speakers.
- ✓ When making a hands-free call using the voice command function, the user enters the number using the phone's buttons but, a dial tone is not heard from the speakers.
- ✓ When receiving a call using the hands-free and voice command functions, the ringtone is not heard from the speakers.
- When using the ahaRadio feature, song title and artist information does not update after the previous song ends.
