SI B32 01 18
Steering and Wheel Alignment

TURN SIGNAL SWITCH AND WIPER SWITCH APPEARS UNEVEN/TWISTED

F15 (X5)	F16 (X6)	Produced from 5/1/17 to 5/31/17	SA245 Power adjustable steering column
----------	----------	---------------------------------	--

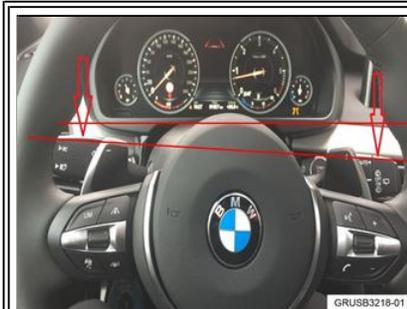
The turn signal switch and wiper switch appear uneven when the steering wheel is used as a reference point

The fixture for the steering column stalk and the washer fluid switch is assembled on a slant

Replace the steering column

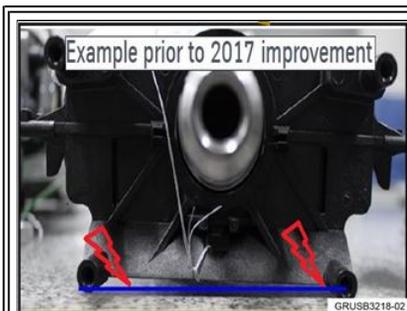
The attachment points at the bottom left and right must be the same distance on the level surface.

If the distances are different, the riveting is slanted. Replace the steering column.
