**R 1200 RT Special Vehicles, (K52, OA13)**

**Service Information No. SI 61 001 18**

## Additional multifunction switch for special vehicle

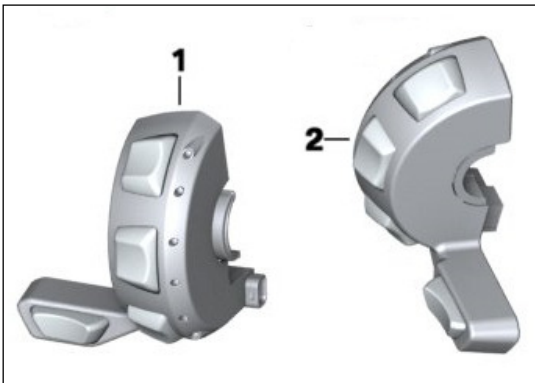
In the course of quality observations, BMW Motorrad has established that the additional multifunction switches for special vehicles may allow moisture in and can lead to a failure of the LIN bus. In the case of a failure the additional functions will no longer work.

Figure: 1 Left additional multifunction switch  
Figure: 2 Right additional multifunction switch

For this reason the additional multifunction switches must be replaced on all affected vehicles.

Both the left and right additional multifunction switches must be replaced according to repair procedures.

61 31 017 (Replacing the left additional multifunction switch).

61 31 020 (Replacing the right additional multifunction switch).

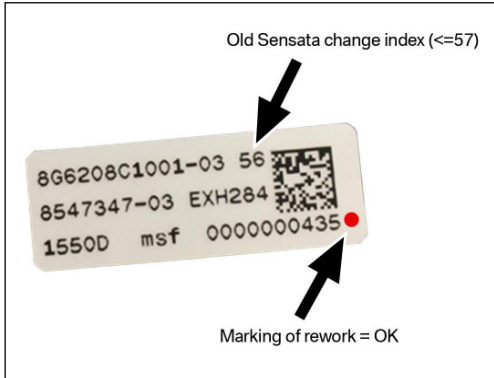
Switches with a revision index  $\leq 57$  and with a RED or BLUE dot on the label  
(rework carried out by the supplier)

The additional multifunction switches with the following identifications are OK. Only these may be installed in the course of the Technical Campaign:

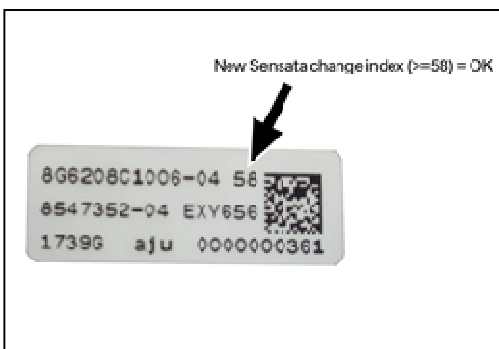
Switches with a revision index  $\geq 58$  on the label
