H057NAS1

TECHNICAL BULLETIN

Service Action: Ingenium I4 2.0L Diesel Rear Cover Oil Leak

MODEL:	MODEL YEAR:	VIN:	ASSEMBLY PLANT:	APPLICABILITY:
F-PACE (X761)	2018	256900	Solihull	INGENIUM I4 2.0L Diesel

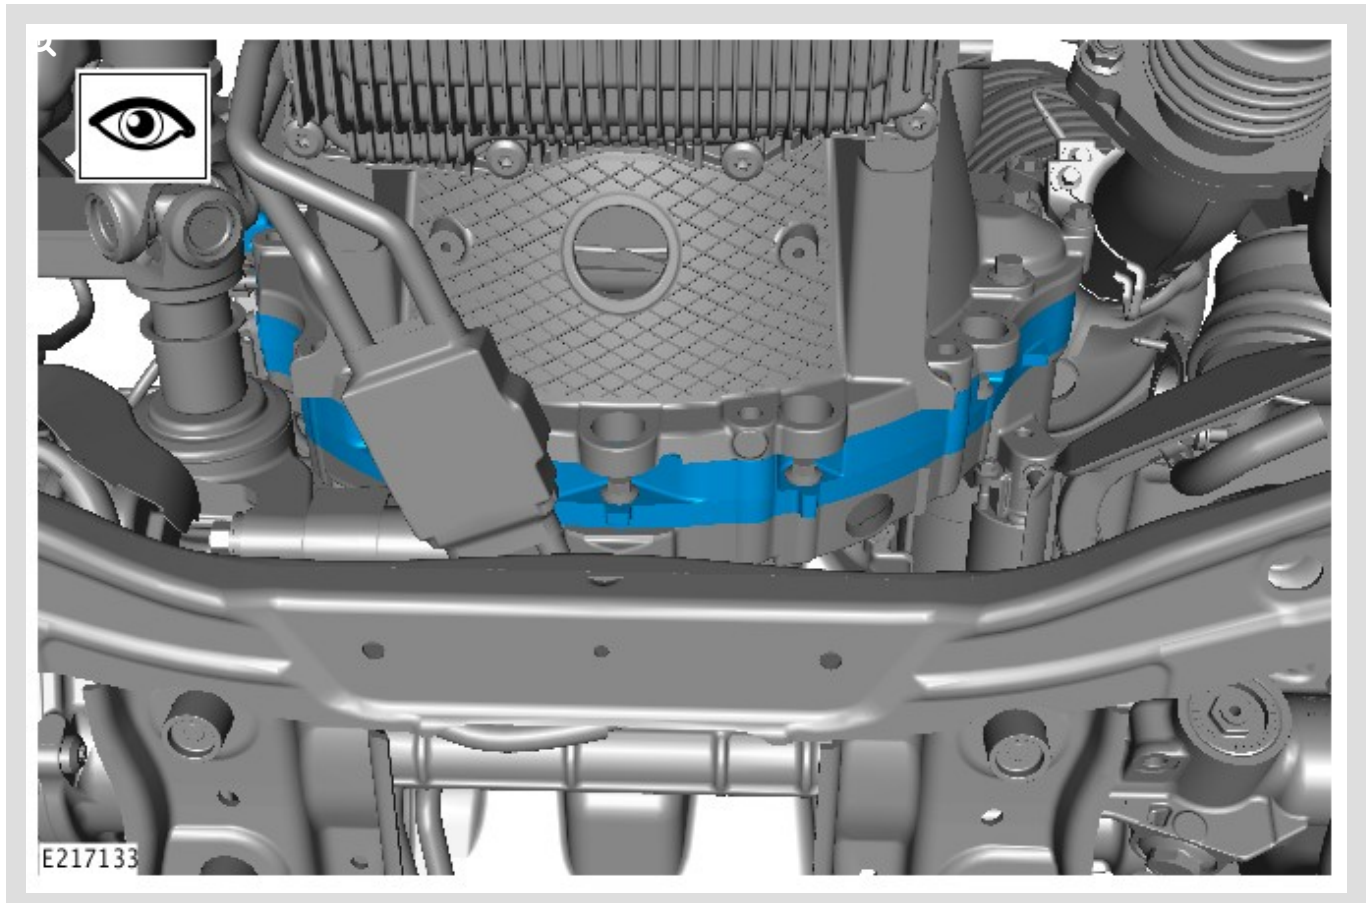
3

An issue has been identified on certain Jaguar vehicles within the listed Affected Vehicle Range may have inconsistent sealant application which could lead to an engine oil leak.

Inspect the engine lower timing cover area for an oil leak.

- If there is not an oil leak, go to the next Step.
- If there is an oil leak, go to the Workshop Procedure below.

- 1 Remove and re-seal the lower timing cover (see TOPIx Workshop Manual section 303-01A: Engine - INGENIUM I4 2.0L Diesel - Removal and Installation - Lower Timing Cover).
- 2 Release the vehicle.
