Date: 30.04.2013

Model: Elise/Exige & Evora fitted with Bosch ESP8 brake modules

Number: 2013/04

Generation of C0460 Pressure sensor failure fault code.

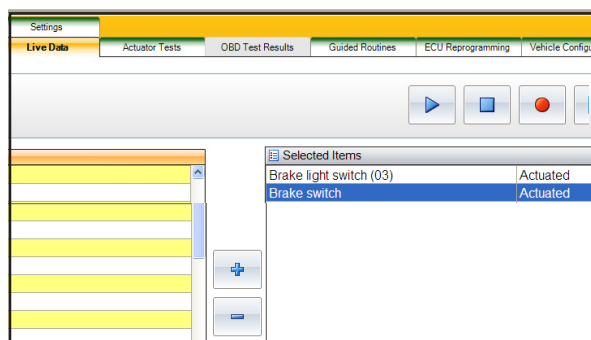
If the switch is operating correctly then the TechCentre live data readings should change in this order:

- Brake switch: (1st stage) - Actuated
- Brake Light Switch (03): (2nd stage) - Actuated

If moving the switch plunger produces the correct readings then it should be adjusted and refitted to the vehicle so it can be retested in situ, see adjustment procedure below.

If the correct readings cannot be displayed then the brake switch should be replaced, operation of the new switch checked (as above) before adjusting and fitting on the vehicle.

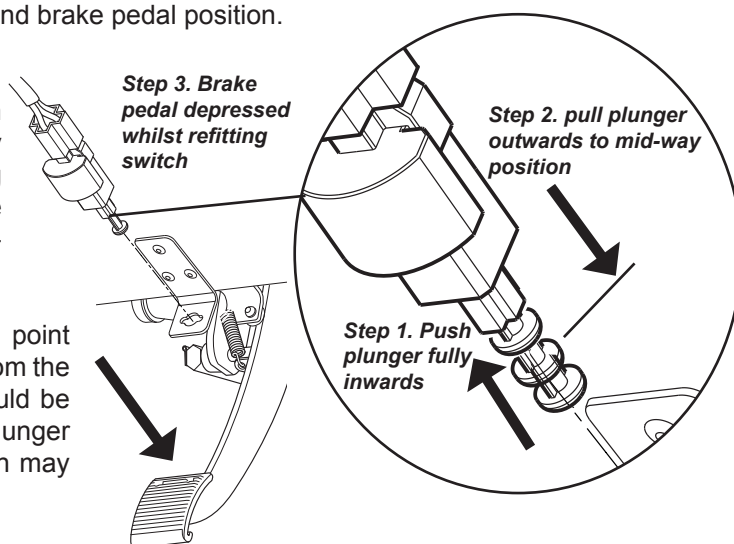
2. Pull the plunger outwards to its mid point setting (approximately half way out from the switch housing, 5 audible clicks should be heard as it is being pulled) note, the plunger is on a stiff ratchet mechanism which may take some effort to extend.

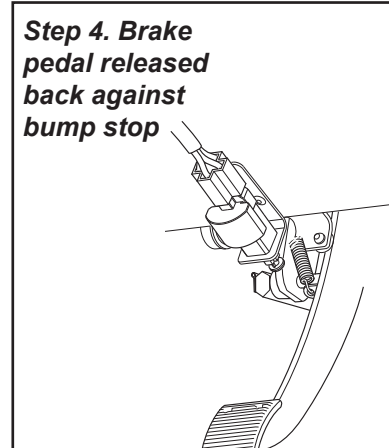
Normal Values Proportional To Brake Pedal Depression

- 'Brake Switch' (1st stage) No Actuation
- 'Brake Light Switch (03)' (2nd stage) No Actuation
- 'Pressure Sensor' (ABS brake line pressure) + or - 0.5 Bar

- 'Brake Switch' (1st stage) Actuated
- 'Brake Light Switch (03)' (2nd stage) No Actuation
- 'Pressure Sensor' (ABS brake line pressure) +/- 0.5 Bar

- 'Brake Switch' (1st stage) Actuated
- 'Brake Light Switch (03)' (2nd stage) Actuated
- 'Pressure Sensor' (ABS brake line pressure) + 2 - 6 Bar

7. If the readings are not within range then remove the brake light switch again repeating step 2 of the adjustment procedure but adjusting the plunger inwards or outwards against its ratched mechanism as necessary until the correct readings are achieved.
