# Warranty Field Campaign

## L9 2017 VG Turbo Speed Sensor Harness Routing Campaign

This campaign is being issued to address an incorrectly routed turbocharger speed sensor harness on certain L9 CM2350 L116B and L123B Engines, and authorizes the field to replace the harness and route correctly.

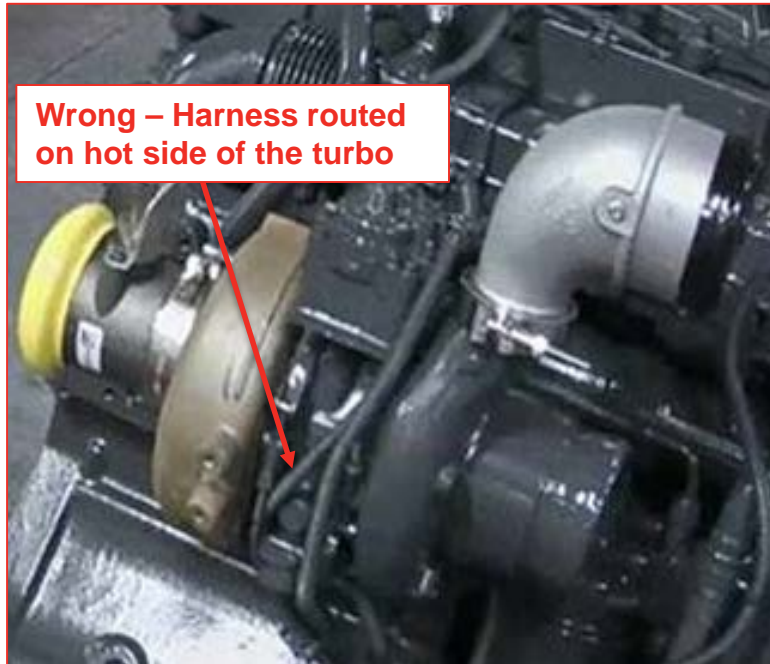
Image A – Incorrect routing

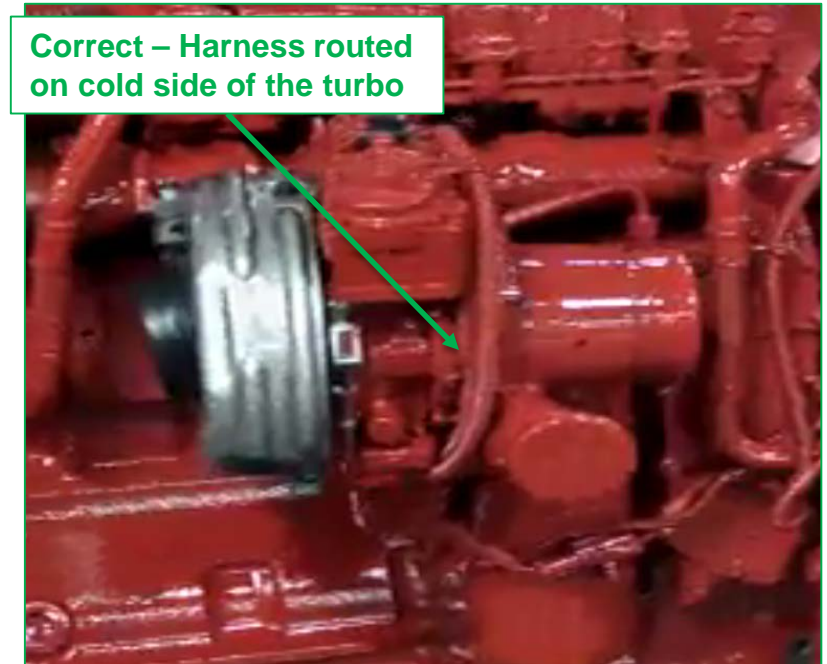
Image B – Correct routing

1. Remove and Install the Turbo speed sensor harness PN 4034198. Please refer to the appropriate Service Manual, Section 019-390 Turbocharger Speed Sensor.
2. Please refer to Attachment B. Route the new harness as illustrated in Routing Image B.
