**Symptom - Body Exterior - Seam on Convertible Top Covering Becomes Detached:
Reworking convertible top covering (SY 20/18)**

Vehicle Type: **Boxster Spyder (981)**

Model Year: **As of 2016**

Subject: **Convertible top covering**

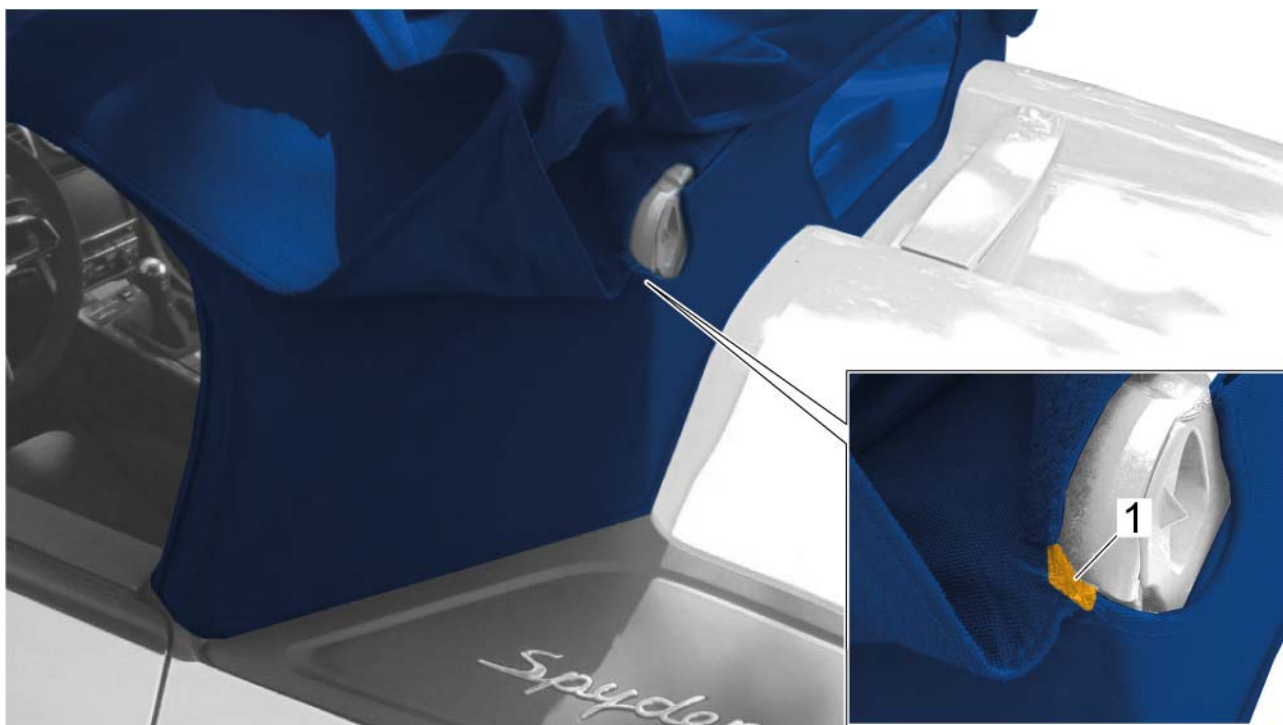
Overview

Symptom: **Seam ⇒ *Overview-1* - at the rear left of the convertible top covering becomes detached.**

Cause: The seam can become detached if the convertible top is opened and closed very often.

The convertible top covering must not be replaced if the seam has become detached.

Sew reinforcing strip into the convertible top covering.
