Symptom In Vehicle Interior - Outside Temperature Display Implausible: Reworking wire harness for outside temperature sensor (SY 38/18)

Model Line: **Macan (95B)**

Subject: **Outside temperature sensor**

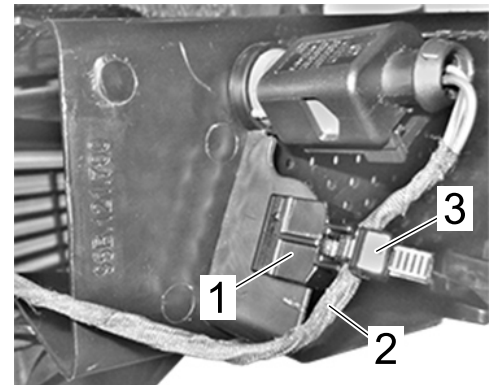
Branch of wire harness for outside temperature sensor

Cause: The outside temperature display can show implausible values because the wire harness for the outside temperature sensor is too long.

- 2.1 Secure tie-wrap holder ⇒ *Branch of wire harness for outside temperature sensor -1-* to the right flap of the air guide as shown.
- 2.2 Secure electric line ⇒ *Branch of wire harness for outside temperature sensor -2-* for the outside temperature sensor with a tie-wrap (958.606.838.10 – ⇒ *Branch of wire harness for outside temperature sensor -3-*).
