## Preliminary Information

### PIP4495F Cylinder Head Tick Noise And Or Damage - Possible Plugged Oil Feed Orifice

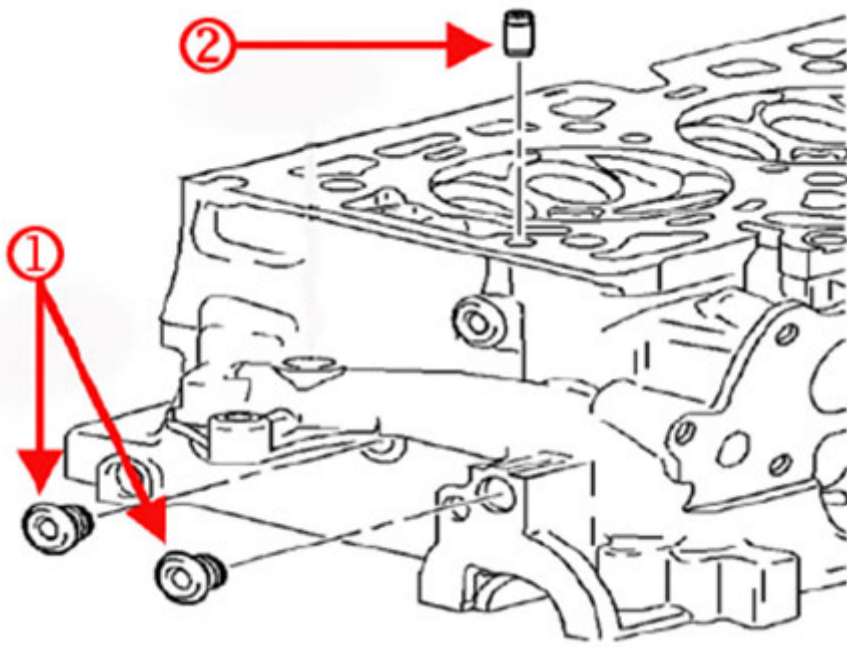
**The cylinder head is equipped with oil feed orifice (2) that may become plugged with debris, such as excessive RTV/sealer or broken down oil filter material.**

**If this occurs, this noise may occur as a result of no/low oil pressure to the valve train.**

- 5.2 If the upper end oil pressure is near 0 PSI/KPA but the lower end oil pressure is within SI specification, the oil feed orifice (2) is most likely plugged with debris. Please note that it is not uncommon for the upper end oil pressure of a normally functioning engine at idle to measure as much 35% less than the bottom end oil pressure. This is due to the large amount of oil pressure bleed off that normally occurs in the valve train, combined with the small size of the oil feed orifice (2).

If you suspect a plugged oil feed orifice after performing the test above, remove the cylinder head and visually inspect the oil feed orifice (2) for debris. If debris is present, it can normally be cleaned out to repair the noise. Please note that the orifice is not available separate from the cylinder head and cannot be inspected/cleaned without cylinder head removal.

**Important:** To prevent future concerns, care must be taken not to use excessive amounts of engine sealant during internal engine repairs, use the proper oil filter that is listed in the parts catalog, and change the engine oil/filter according to the schedule in the owner's manual.

**Notice:** The oil gallery plug port threads (1) on the back of the cylinder head are M12x1.75 and it is unlikely that a related oil pressure gauge adapter will be found at a hardware or auto parts store. The 509376 Kent Moore Fitting that comes with the Engine Preluber Kit (EN-45299/J-45299) will screw into the head and may be adapted to some oil pressure gauges. Or, there are also several online retailers that can supply a fitting that will work as an adapter - the male end has to be M12x1.75 while the female end has to be 1/8"x27 NPTF so a standard oil pressure gauge hose can screw into it. It has also been found that some automotive gauge companies, such as Auto Meter, offer the necessary adapter/fitting (M12x1.75 / 1/8"x27 NPTF) for \$5-\$20. Some technicians have also reported success in making a temporary fitting out of an oil pressure sender body.
