Bulletin No.: PIP5558B

### PIP5558B Clutch Pedal Stays On The Floor - Pedal Does Not Return To Top Of Travel Or Pedal Returns Slowly

Brand:	Model:	Model Years:	VIN:		Engine:	Transmissions:
			from	to		
Chevrolet	Cruze	2016 - 2018	Gen II VIN B	Current	All	MF3 MZ4 MZ0 M60

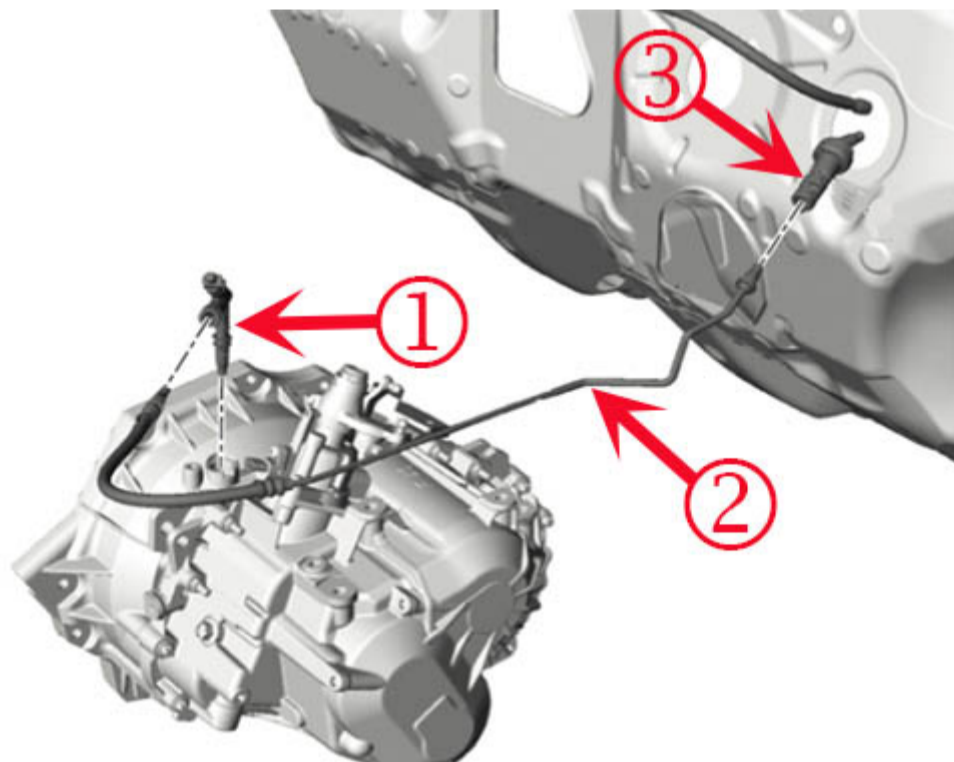
Involved Region or Country:	North America, South America, GMIO, China, Korea, Australia/NZ
Condition:	<b>Clutch Pedal stays on the floor, pedal does not return to top of travel or pedal returns slowly.</b>
Cause:	<b>Debris in orifice</b>

Item number 1 in the picture below has a small orifice internally that fluid passes through. If small pieces of debris in the fluid get pushed to or through the orifice then it will restrict oil flow. The debris may restrict the orifice then the pedal return will be affected. Customer may notice any of the following concern: Pedal stays on the floor, pedal does not return to top of travel or pedal returns slowly.

Engineering is currently investigating and a bulletin will be published when a repair is validated.
