**Noise Symptom - Noises From Plastic Rear Window: Replacing rear window (SY 75/17)**

Vehicle Type: **911 GT3 RS (991)**

Model Year: **As of 2015**

Subject: **Rear window**

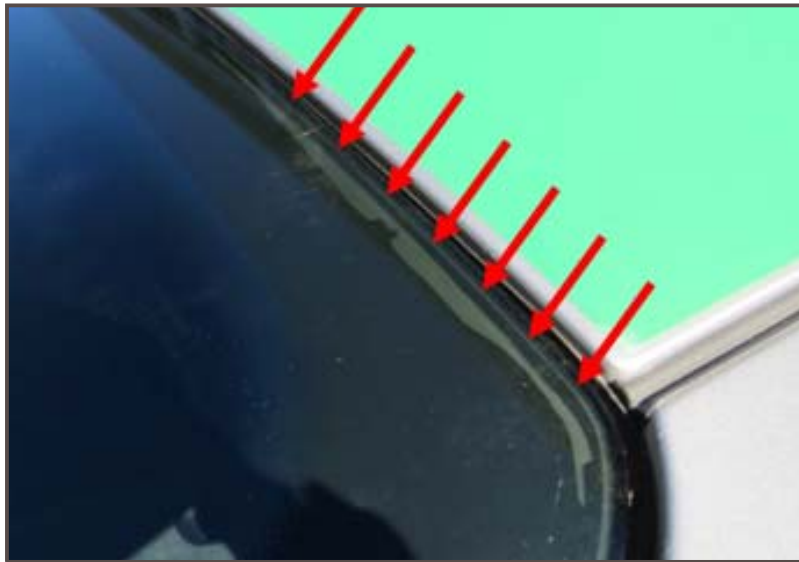
Symptom: The plastic rear window can become damaged or part of it can become visibly detached from the body due to different temperatures and tension while driving.  
This can cause wind noise.

Cause: The components of the rear window – plastic (polycarbonate), screen print and primer – are **not chemically compatible**.  
Impurities during the manufacturing process and tension due to temperature effects while driving result in noises and cause water to leak in.

- To do this, press lightly against the window all around the edge of the rear window from inside the vehicle using two fingers.
- If you feel the rear window lifting off in the bonding area (⇒ *Damaged screen print -area arrows-*), the bonding has become detached.

*Damaged screen print*

⇒ The rear window must be replaced, see Workshop Manual ⇒ *Workshop Manual '648655 Replacing rear window (Coupé)'*.
