911 Targa (991) Top Faults & Adjustment

Vehicles Affected

Model	Model Year	Model Type	VIN Range	Vehicle-Specific Equipment
911 Targa 4/4S /4 GTS	2015 - present	991	All	N/A

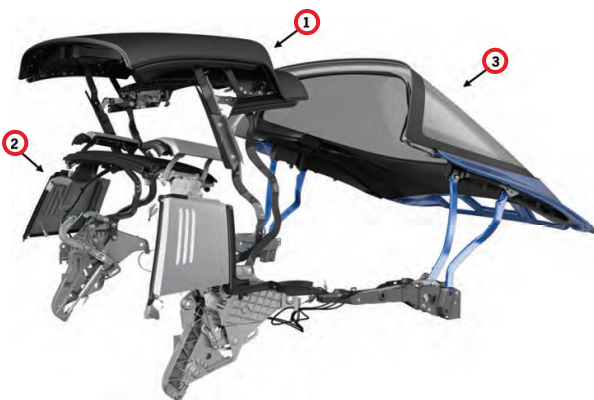
Adjustment of the top may cause its movement to be slower than the control unit expects. If the control unit does not see a changing signal from the rotation angle sensor within 3 seconds of the pump activation, FC 000042 may be set. Internal or external leaks in the system can also cause the issue (Internal check valve, lines, rams).

Adjustment of the top and lubrication of the seals should be performed before replacing any parts. Initial adjustment should be performed at the mounting points, typically in the forward and upward direction.
