Technical product information

| Topic | Bentayga - DTC C103129 - Air suspension warning displayed in Driver Instrument Panel |

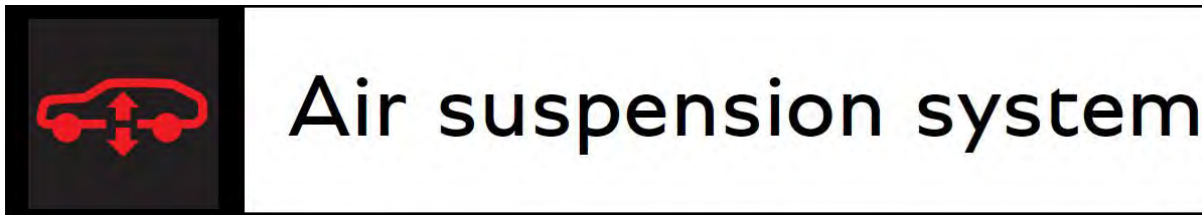
Air suspension system warning displayed in the Driver Instrument Panel (DIP)
