Preliminary Information

PIP5558C Clutch Pedal Stays On The Floor - Pedal Does Not Return To Top Of Travel Or Pedal Returns Slowly

Brand:	Model:	Model Years:	VIN:		Engine:	Transmissions:
			from	to		
Chevrolet	Cruze	2016 - 2018	Gen II VIN B	Current	All	MF3 MZ4 MZ0 M60

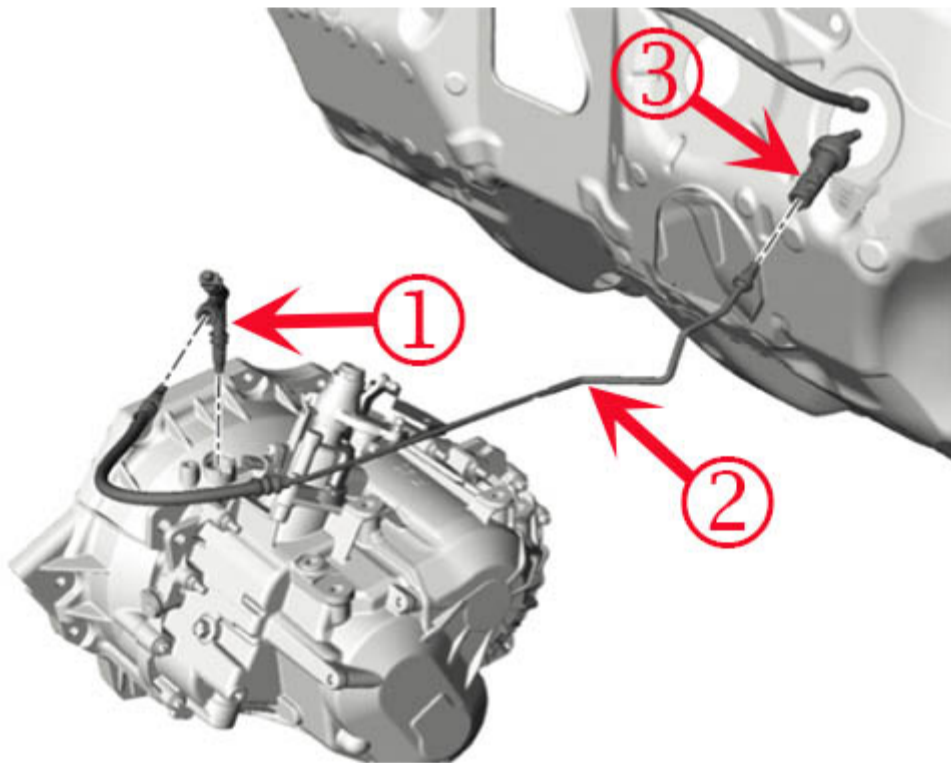
Involved Region or Country:	North America, South America, GMIO, China, Korea, Australia/NZ
Condition:	Clutch Pedal stays on the floor, pedal does not return to top of travel or pedal returns slowly.
Cause:	Debris in orifice

Item number 1 in the picture below has a small orifice internally that fluid passes through. If small pieces of debris in the fluid get pushed to or through the orifice then it will restrict oil flow. The debris may restrict the orifice then the pedal return will be affected. Customer may notice any of the following concerns: Pedal stays on the floor, pedal does not return to top of travel or pedal returns slowly.

The source of the debris is the dampener in the high pressure line (3).

FOR GASOLINE ENGINE equipped vehicles: Replace the Line, Elbow, Sleeve and slave cylinder with kit p/n 24295457. The new parts in the kit are not interchangeable with the original parts in the vehicle due to hydraulic connection variation between the parts.

FOR DIESEL ENGINE equipped vehicles: Replace the line and elbow with parts currently available in the parts catalog. Diesel equipped vehicles were originally built with the FTE parts so current part inventory will interchange.
