Mack Models

| Engine family | MP7 , MP8 |

| Title | Mack Chassis - Diagnostic Trouble Code (DTC) P0087-00 Illuminating The Malfunction Indicator Lamp (MIL) Or Stop Engine Light; Possible Engine Power /Torque Derate - US17+OBD16 And US17+OBD18 Emissions, Common Model Years 2018 And 2019 |

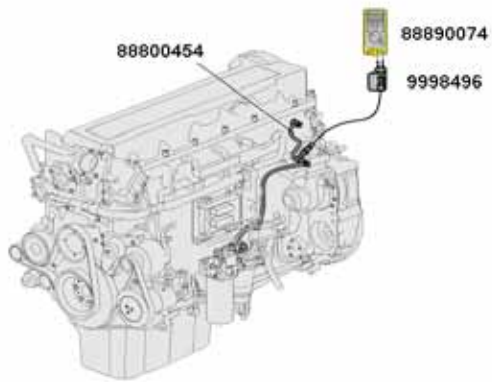
1. Connect the special tooling shown below to measure the fuel supply pressure before troubleshooting per Guided Diagnostics for P0087.

a. The fuel supply pressure can be measured stationary, but the vehicle may need to be road tested to monitor the low fuel supply system under load with higher fueling demands to identify a problem in the low pressure system, depending on severity of restriction in fuel filters.
