SERVICE BULLETIN

APPLICABILITY: 2012-2016MY Impreza
 2013-2017MY Crosstrek
 2014-2018MY Forester

NUMBER: 04-21-18

SUBJECT: Uneven Steering Effort

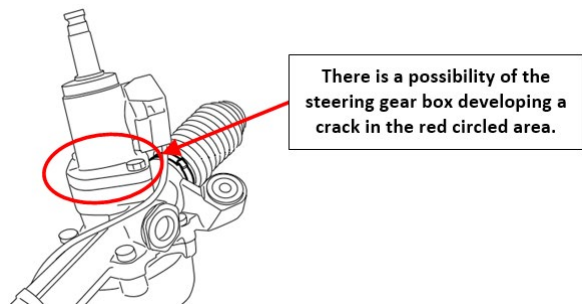
This bulletin announces availability of a new Electronic Power Steering (EPS) gear box assembly designed to address a VERY limited number of customer concerns regarding uneven steering effort felt when turning left or right. In areas where high concentrations of road salt are used to melt ice and snow, corrosion may develop and cause a portion of the gear box housing to crack if the vehicle were to suffer a large enough impact from hitting a pothole or similar type of road hazard.

If a vehicle is presented with a customer concern of uneven steering wheel effort felt when turning, after confirming the condition, inspect the steering gear box in the circled area shown in the illustration for any evidence of cracking.

If a crack is confirmed, the EPS steering gear box assembly must be replaced. The service procedures for replacing the assembly remain unchanged. Always refer to the applicable Service Manual and review the full requirements of the repair being performed. The Service Manual procedures contain information critical to performing an effective repair the first time and every time. This includes but is not limited to: important SAFETY precautions, proper inspection criteria, necessary special tools, required processes and related one-time-use parts needed for a complete and lasting repair.

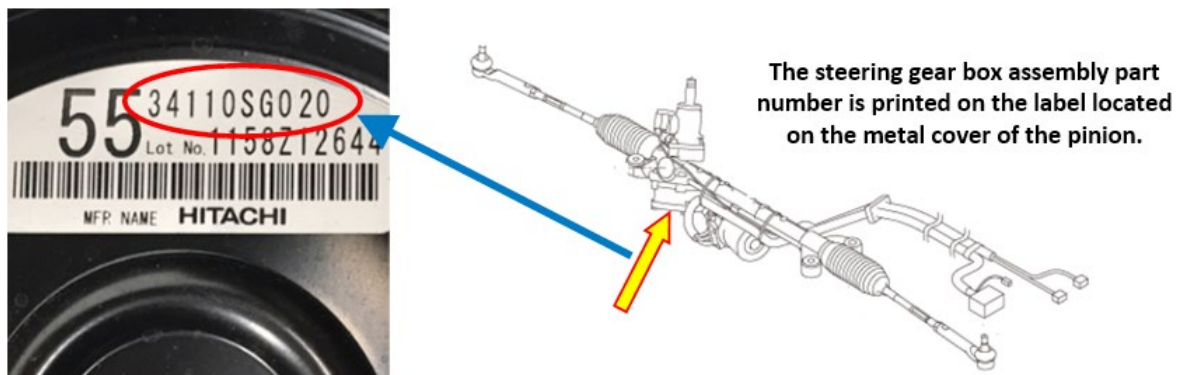
To determine if the steering gear box is a new-style unit, verify and compare the part number on the label located on the bottom cover of the pinion as shown below to the Part Information table on pg. 1. The new assemblies have been re-designed in addition to utilizing materials having improved rust and corrosion resistance.
