SERVICE INFORMATION BULLETIN

APPLICABILITY: 2015-2017MY Legacy and Outback
 2015-2016 Impreza
 2015-2017 Crosstrek
 2016-2018MY Forester
 2016-2018MY WRX

NUMBER: 15-205-16R

SUBJECT: Reprogramming File Availability to Address Operational Concerns with “Gen 2.0” and “Gen 2.1” Fujitsu-TEN (F10) Navigation and 7” Display Audio Units

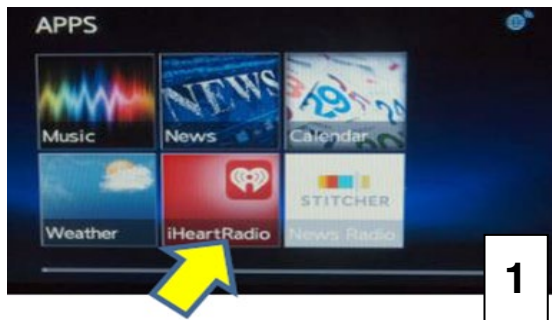
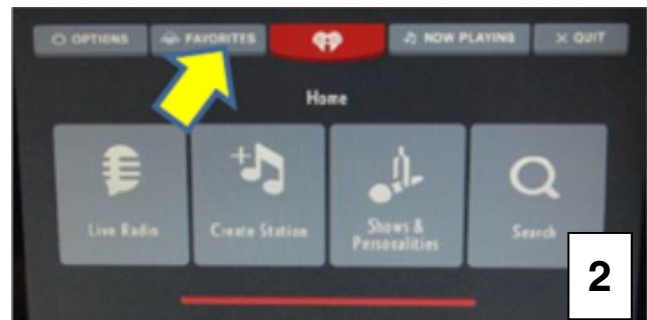
- SXM channels higher than 256 cannot be selected using the voice command feature.
- Additional characters appear (in this example, question ??? marks) after entering an e-mail address and password using the software keyboard when attempting to log in to an iHeart radio account as shown in the screen shot sequence below.

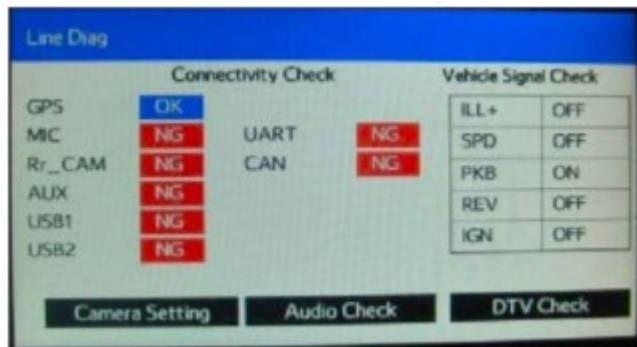
Symptom 14: “Line Diag” screen is intermittently displayed while driving.

Change: Logic change to prevent display of the “Line Diag” screen.

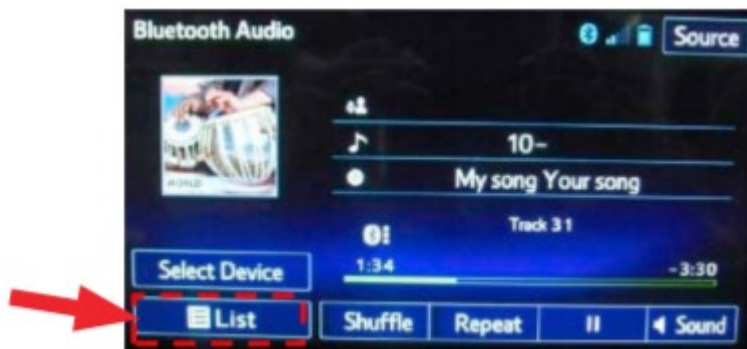
Symptom 15: “LIST” soft touch key is not displayed on Bluetooth Audio screen while using Bluetooth audio feature with an Apple device utilizing iOS8 software version.

Change: Logic change to enhance compatibility with iOS8 software.

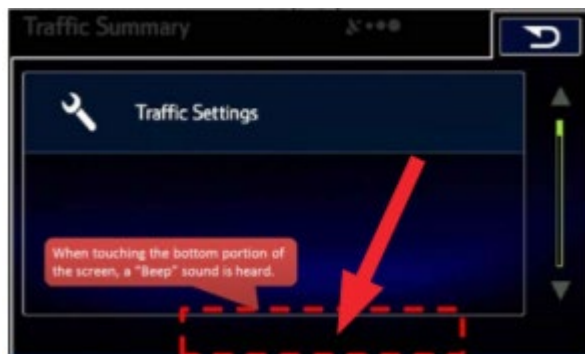
Symptom 16: “Beep” sound heard when touching the bottom of the display screen where no function soft touch keys are displayed.

Change: Logic change to eliminate beeping sound from inactive soft touch key screen areas.

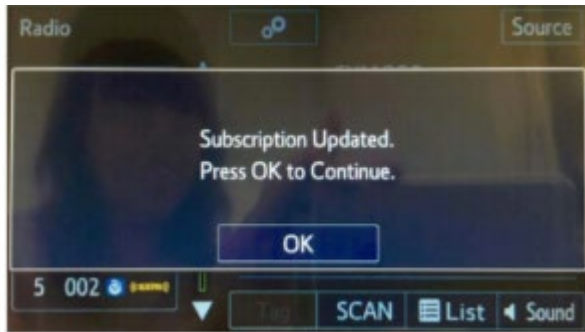
Symptom 17: SXM caution message screen is displayed in English even when French language operation settings are selected.

Change: Logic change to make all messages display in the selected operating language.

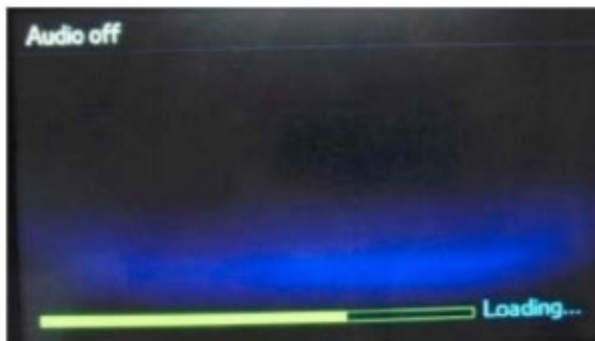
Loading Screen

Symptom 18: Repeated display of the “Loading” screen at initial unit start-up.

Change: Logic updates included where applicable to address each of the following conditions:
