## SERVICE BULLETIN

**APPLICABILITY:** 2014-15MY XV Crosstrek Hybrid Electric Vehicle (HEV) **NUMBER:** 16-94-15R  
**SUBJECT:** Diagnosis and Repair of DTCs P172A and P0B0B **DATE:** 07/30/15  
**REVISED:** 07/09/18

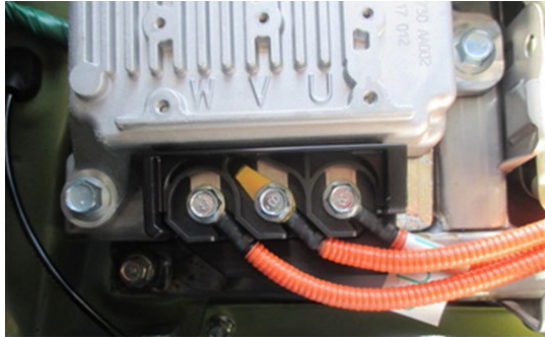
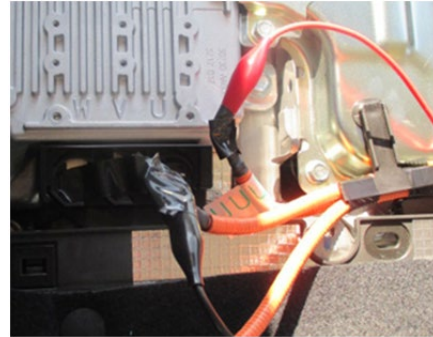
- Remove the rear cargo area floor mat and the sub-trunk (storage tray).
- Remove the orange HEV Service Disconnect plug and put it in your pocket.
- Remove the TORX screws and necessary trim clips securing the aluminum battery cover.
- **ONE AT A TIME**, remove the 3 bolts securing the orange “W”, “V”, and “U” cables to the electric oil pump inverter. As each cable is removed, cover each terminal end with one piece of electrical tape to insulate it. Connect the RED (+) test lead from the DVOM to the “U” cable end and BLACK (-) lead to the “V” cable end as shown. Confirm the “W” cable end is wrapped with insulating tape.

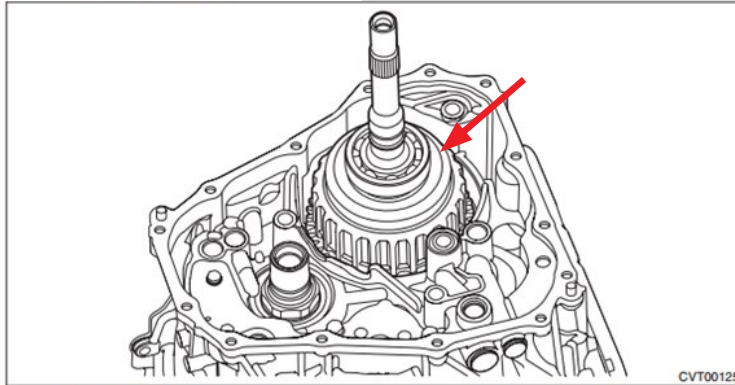
1) **Remove** the output clutch assembly

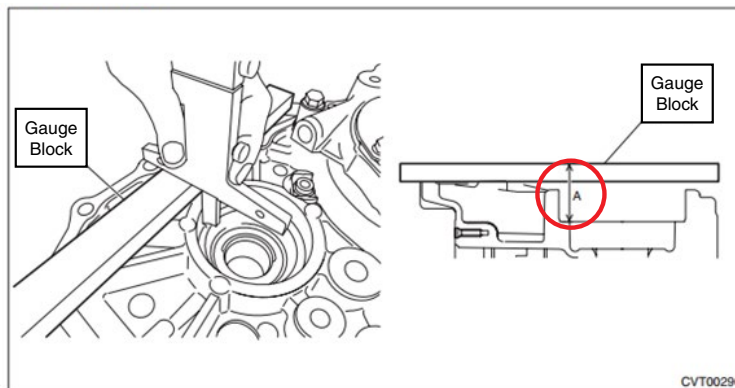
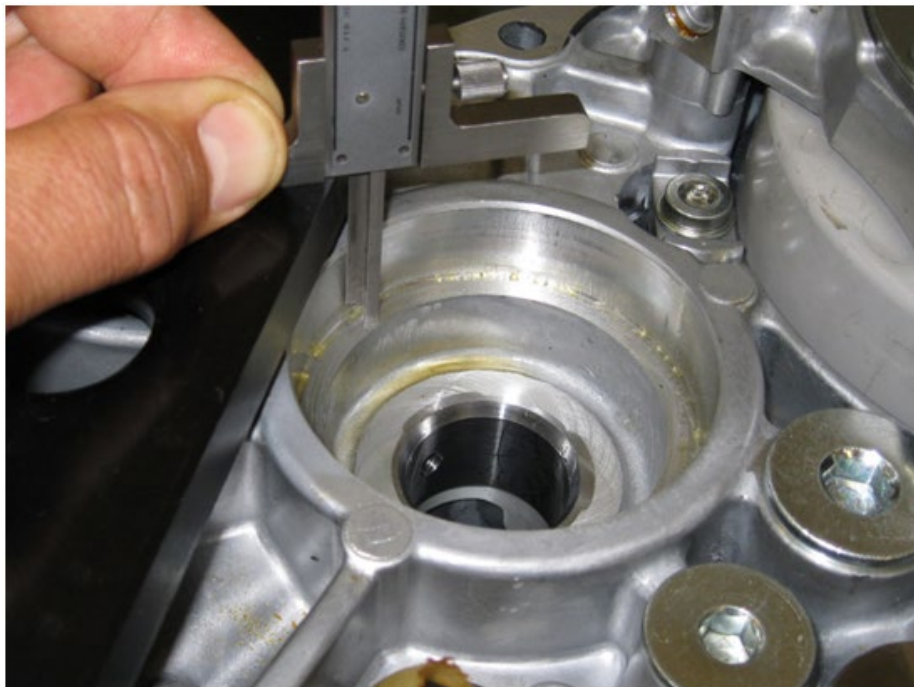
2) Measure the height "A" from the Gauge Block upper face to the ball bearing catch surface.

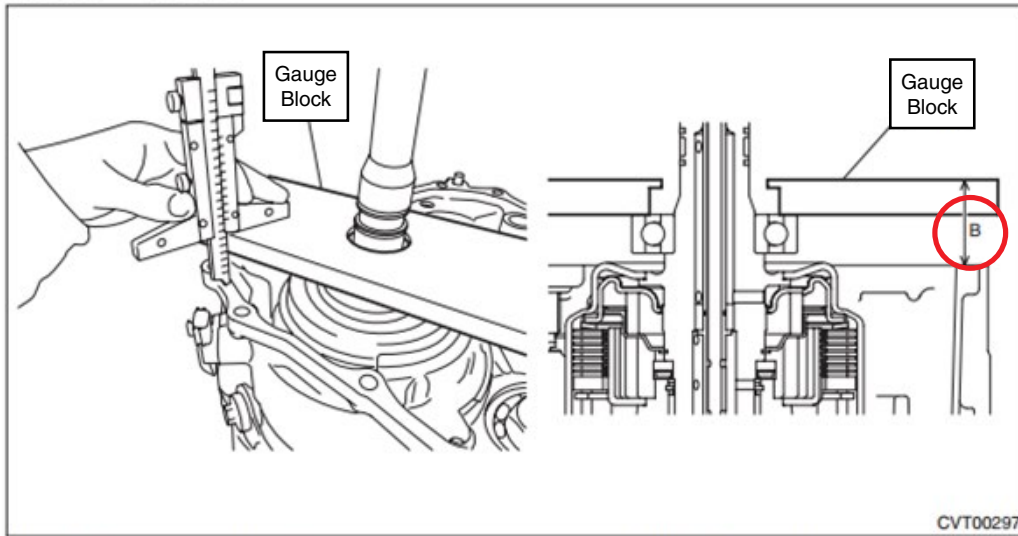
3) Reinstall the output clutch assembly then measure the height "B" from the Gauge Block to the mating surface of the transmission case.

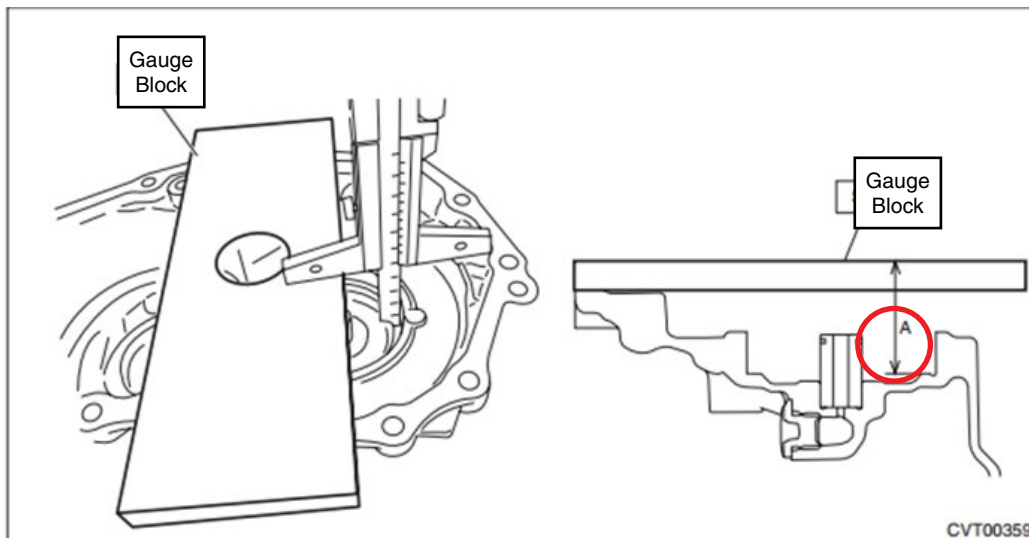
1) Measure the height "A" from the Gauge Block upper face to the ball bearing catch surface.

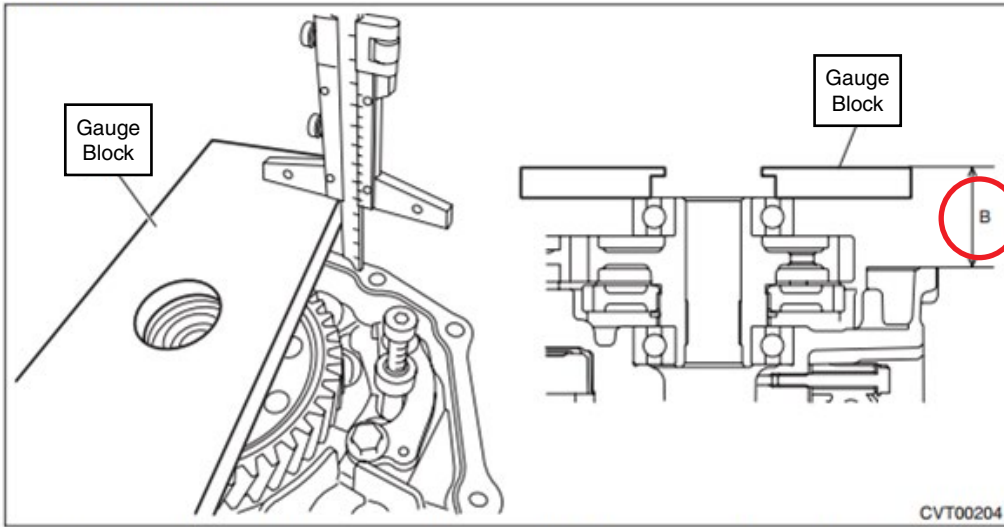
2) Measure the height "B" from the Gauge Block to the mating surface of the transmission case.

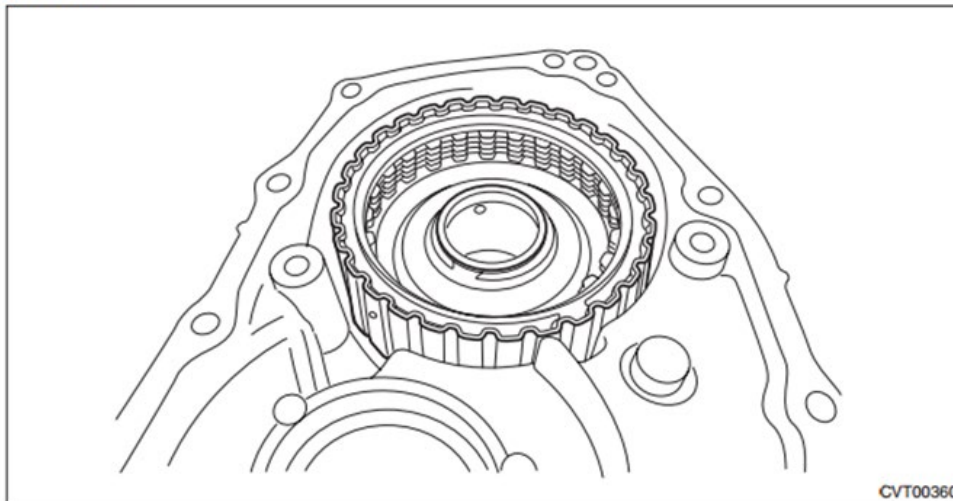
1) Install the transfer clutch assembly to the extension case with the transfer driven gear shims and thrust bearings removed.

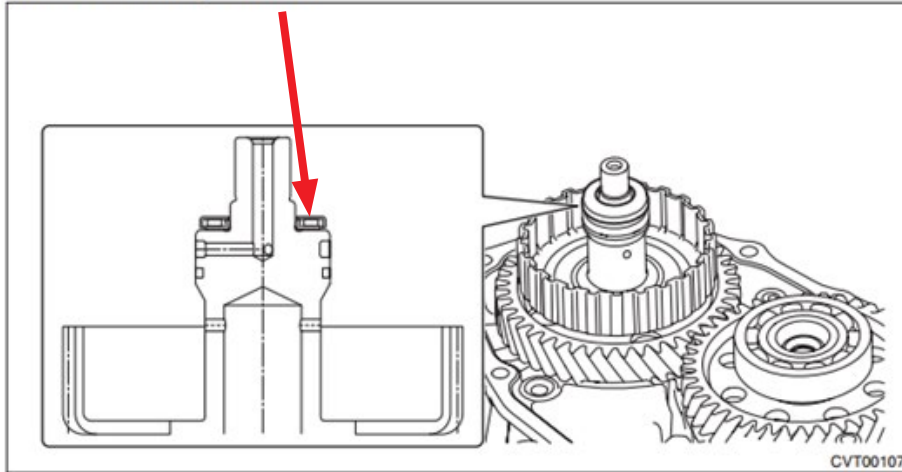
2) Install the thrust bearing to the transfer driven gear.

Make sure to install in the right direction.

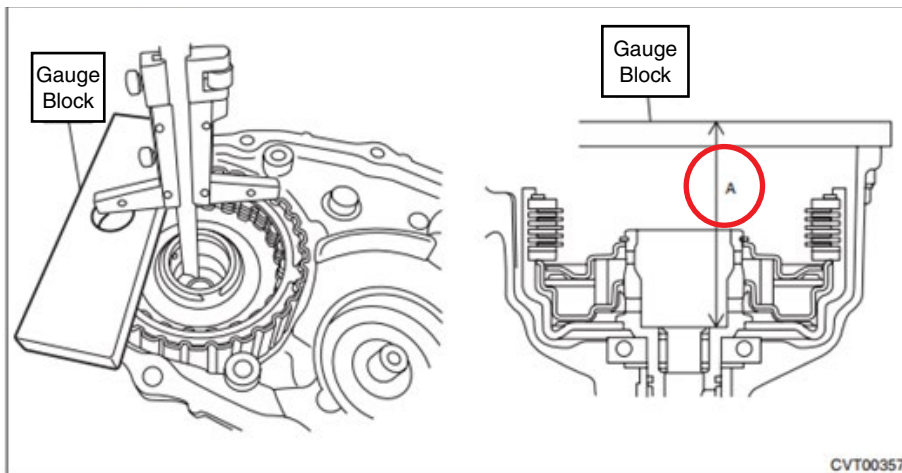
3) Using the Gauge Block, measure the height "A" from the ST end face to the thrust bearing catch surface of the transfer clutch assembly.

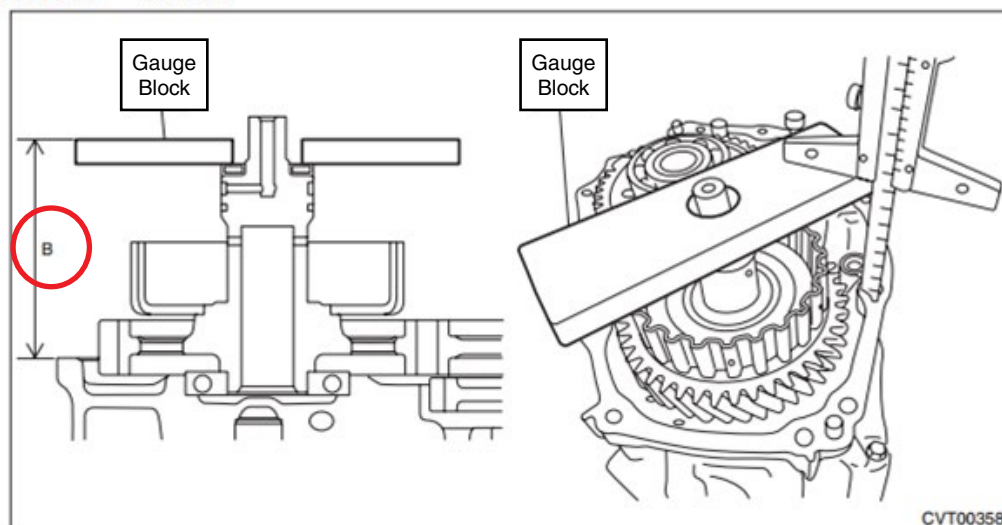
4) Using the Gauge Block, measure the height "B" from the transmission case mating surface to the end of the Gauge Block

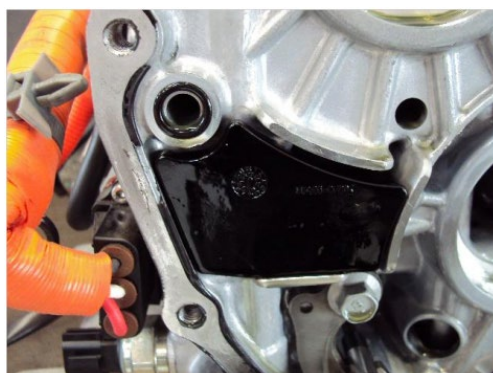
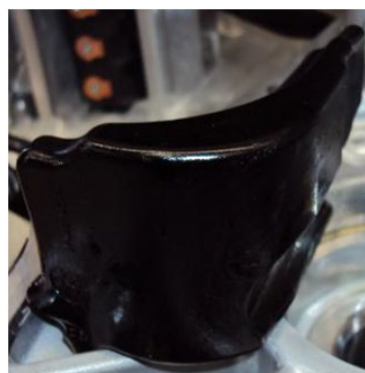
- When installing the secondary pressure sensor and inspection plugs, **ALWAYS** install a new o-ring (with some CVT fluid applied to it) and follow the proper torque specifications as they do vary.
- Remember to transfer both of the oil baffles shown below over to the new assembly.

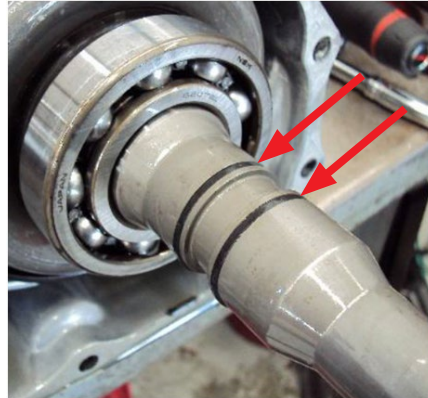
- Never expand the output clutch output shaft interlocked split sealing rings any more than necessary to get them onto the shaft. Use caution and patience as they can be tricky to install. **NOTE:** If these sealing rings become deformed during installation, they **MUST** be replaced.

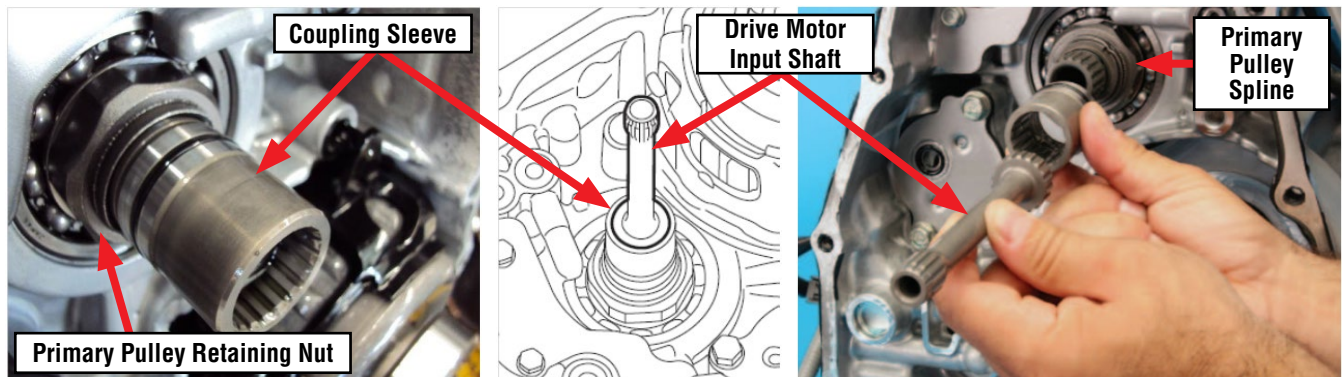
**IMPORTANT: BEFORE** applying any sealer to the cases, always trial fit them together to confirm proper spline alignment between the coupling sleeve, the drive motor input shaft and the primary pulley. The cases are too close together to facilitate turning the primary pulley retaining nut to get the splines aligned properly, especially when there is fresh sealer applied.

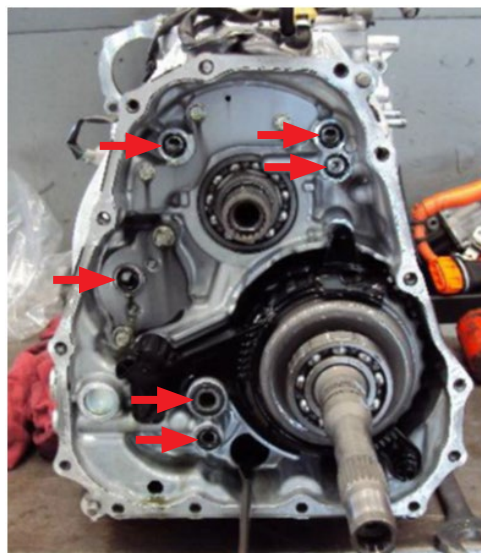
- Once proper spline alignment is confirmed, use some CVT fluid to hold the 6 o-rings in place between the cases during reassembly.

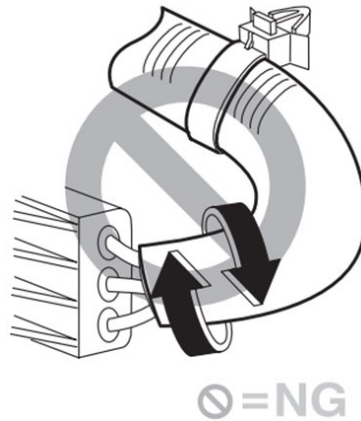
- Use the **GRAY** ThreeBond sealer (004403007) to seal the case assemblies and the **PINK** (K0877YA020) sealer for the small output clutch control valve body fluid pan.
- Torque the 14 case bolts to 18.4 ft. lbs.
- Never twist the electric oil pump harness more than 360 degrees to avoid damaging it.
