XENTRY TIPS

BR213, 217, 222 [E63/S63] Check Engine Light on with Misfire DTC's

Topic number	LI07.61-P-067717
Version	4
Function group	07.61 ME fuel injection/ ignition system
Date	05-08-2018
Validity	BR213 E63 Models BR222 S63 Models BR217 S63 Models
Reason for change	Specified grounding rework process.
Reason for block

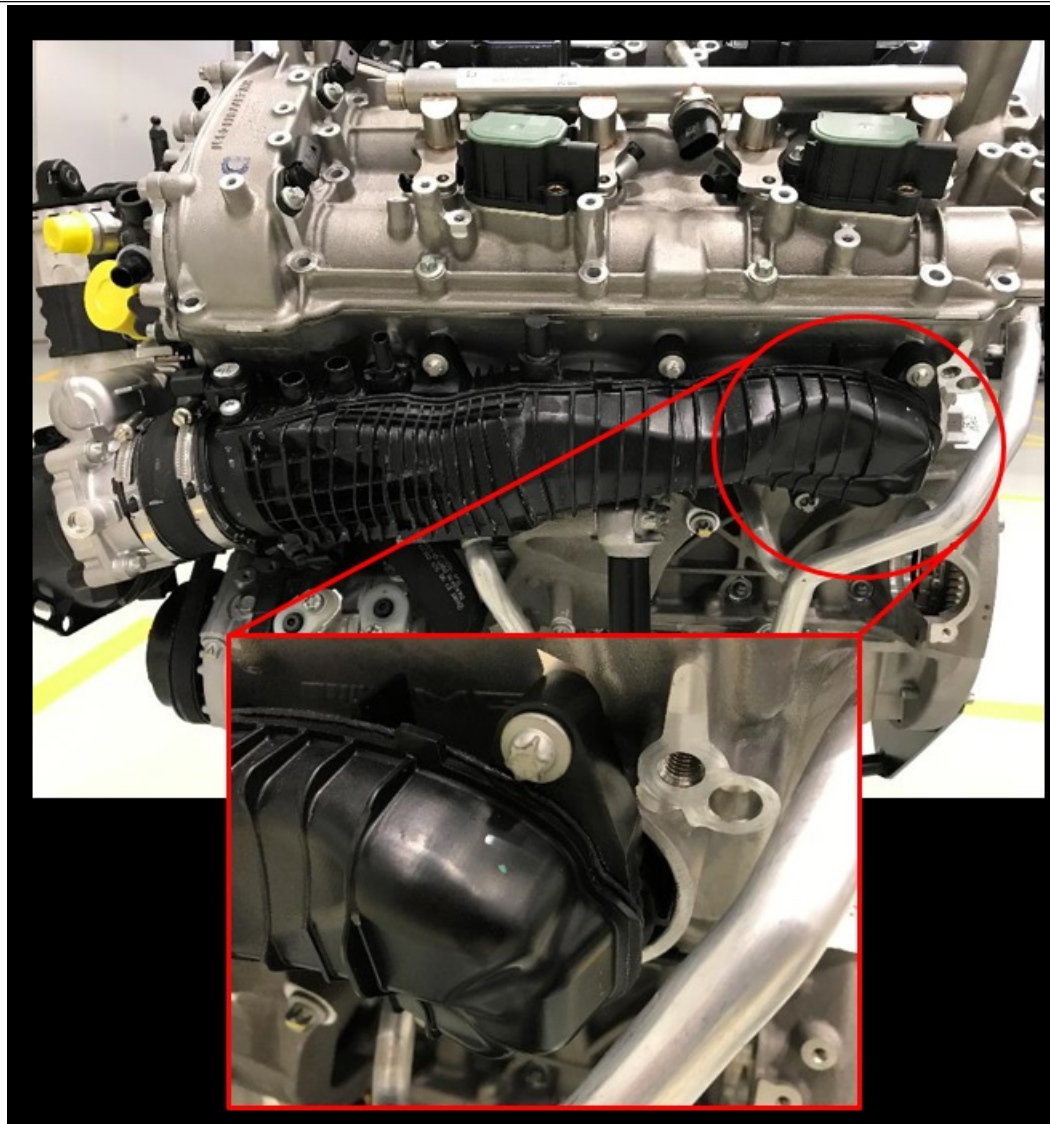
M177LS2 Intake Manifold
Leak Area.jpg:

- Repair as necessary.
 - If no leaks are found, or repair does not remedy complaint proceed to step (2).
- 2) Check driver's side intake manifold for cracks near the rear (see attachments) of the engine.

- If damage is found, order a new manifold for the driver's side bank from EPC and OPEN PTSS case with pictures of damage. Include the following:
 1. Production stamp on the damaged manifold (looks like a pair of clocks)
