XENTRY TIPS

BR213/BR222 E63/S63 Check Engine Light on with Misfire DTC's

Topic number	LI07.61-P-067717
Version	2
Function group	07.61 ME fuel injection/ ignition system
Date	03-02-2018
Validity	BR213 E63 Models BR222 S63 Models
Reason for change	Added "Graphical Readout of Fault Counter" to required attachments upon PTSS case creation. Added 222 to validity
Reason for block

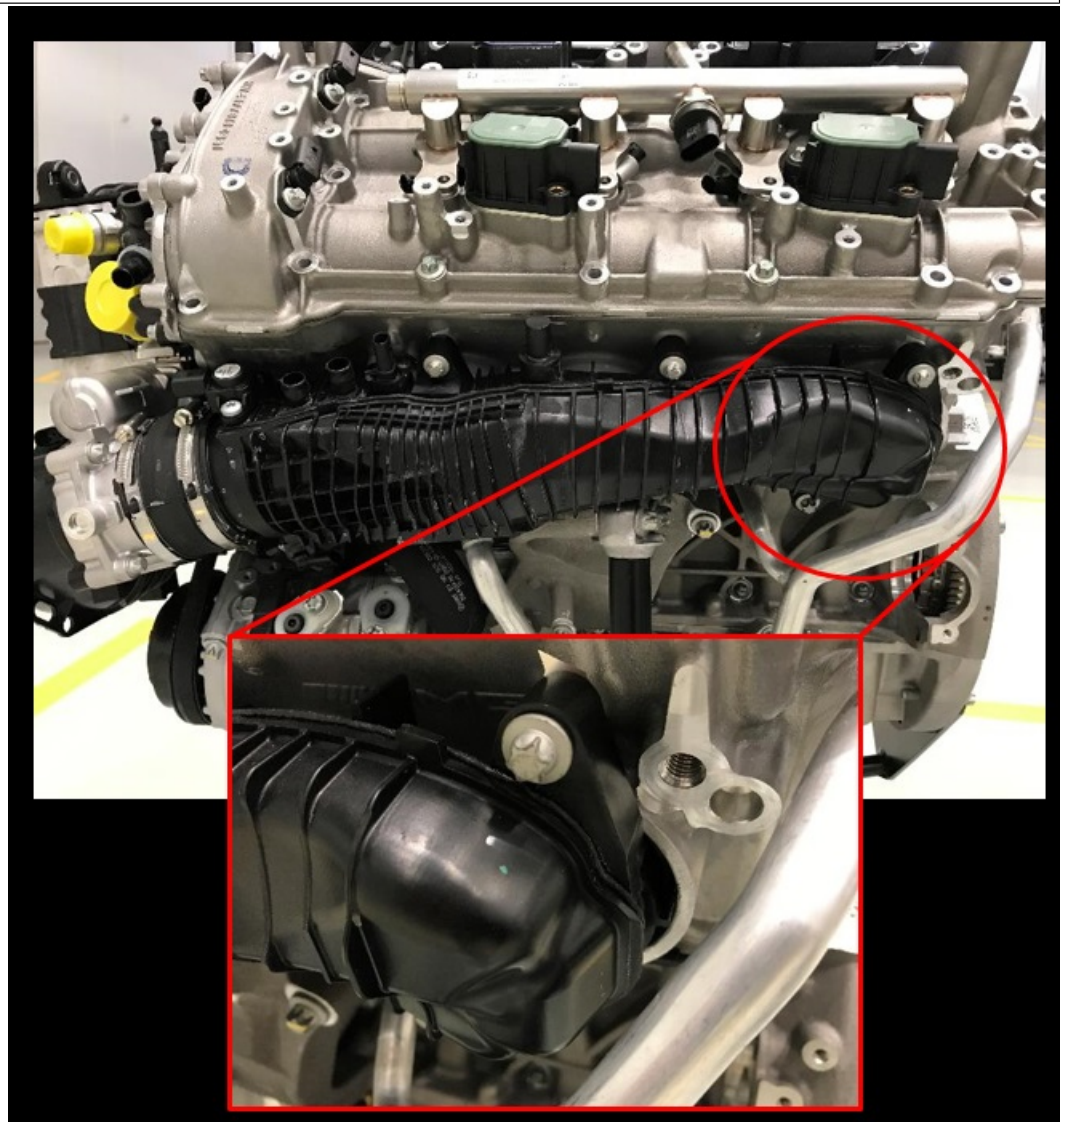
M177LS2 Intake Manifold Leak Area.jpg:

- Repair as necessary.
 - If no leaks are found, or repair does not remedy complaint proceed to step (2).
- 2) Check driver's side intake manifold for cracks near the rear (see attachments) of the engine.

- If damage is found, order a new manifold for the driver's side bank from EPC and OPEN PTSS case with pictures of damage.
 - If no damage is found, or repair does not remedy complaint proceed to step (3).
