B-pillar trim chafed through at height of seat belt outlet

Topic number	LI68.30-P-059216
Version	6
Function group	68.30 Coverings, trim
Date	03-16-2018
Validity	Model series 117 up to VIN end number 204196 BR 292 up to production month 11/2017
Reason for change	BR292 added
Reason for block

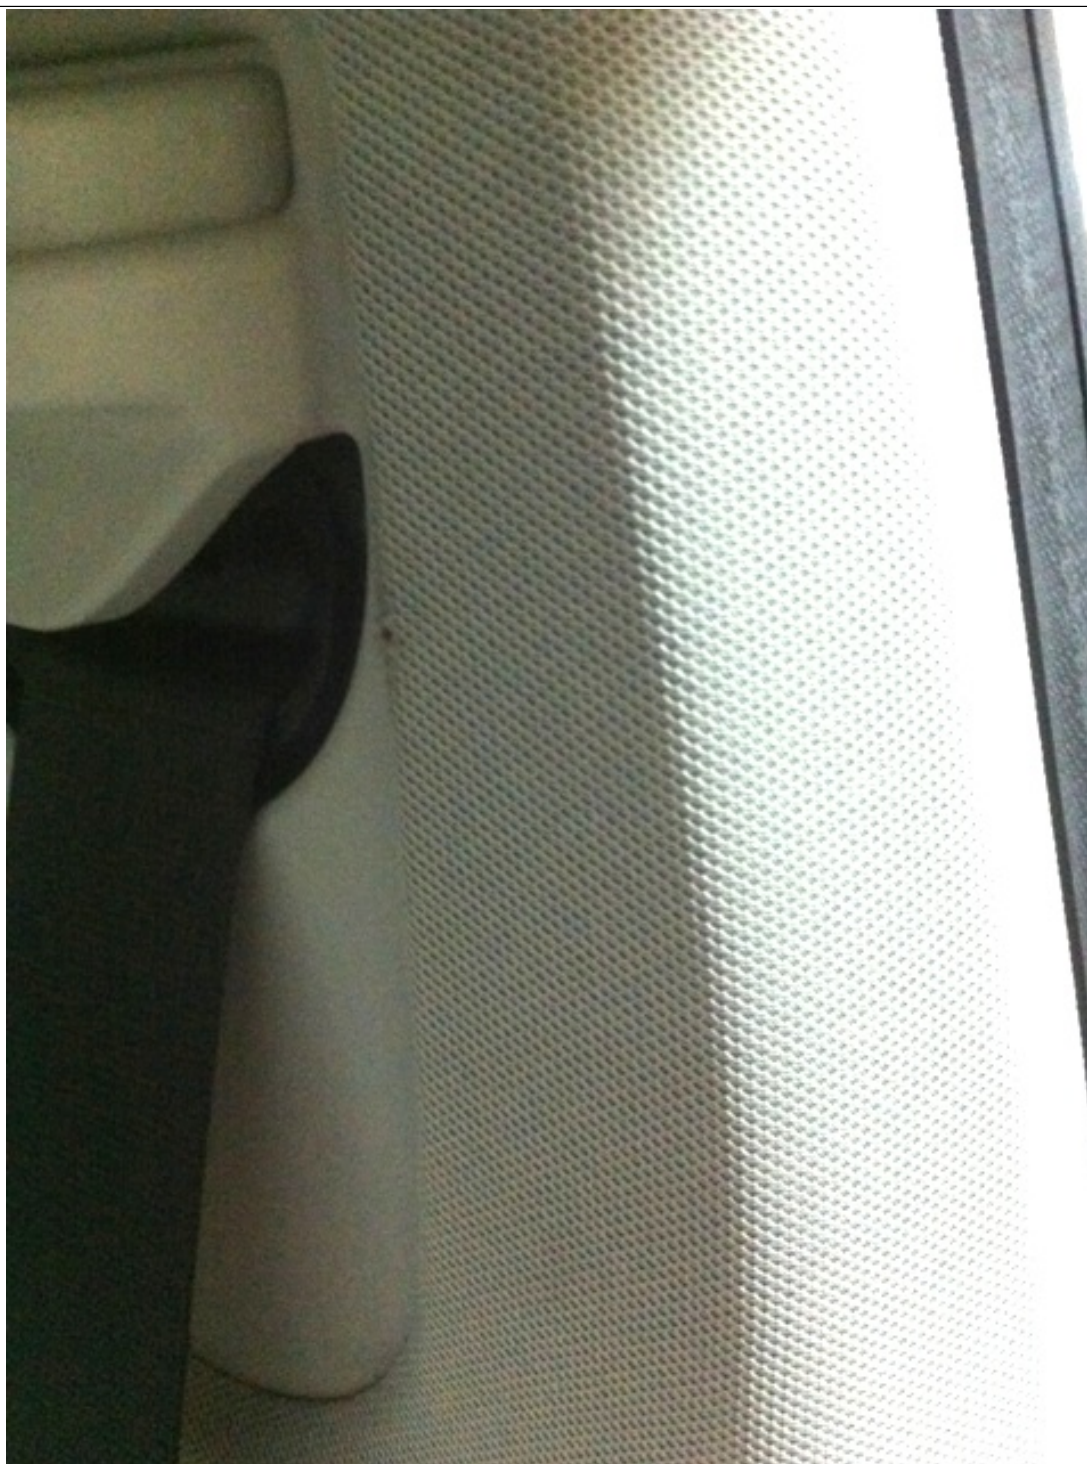
CLA 001.jpg:

The B-pillar trim is chafed through at the height of the belt outlet.

The seat belt may chafe through the B-pillar trim.

Replacement of B-pillar trim with modified parts.
