Trunk lid does not open/close

Topic number	LI88.50-P-067885
Version	1
Function group	88.50 Trunk lid
Date	03-16-2018
Validity	MODEL 238.3 with code 881 produced before Feb 16 2018
Reason for change	
Reason for block

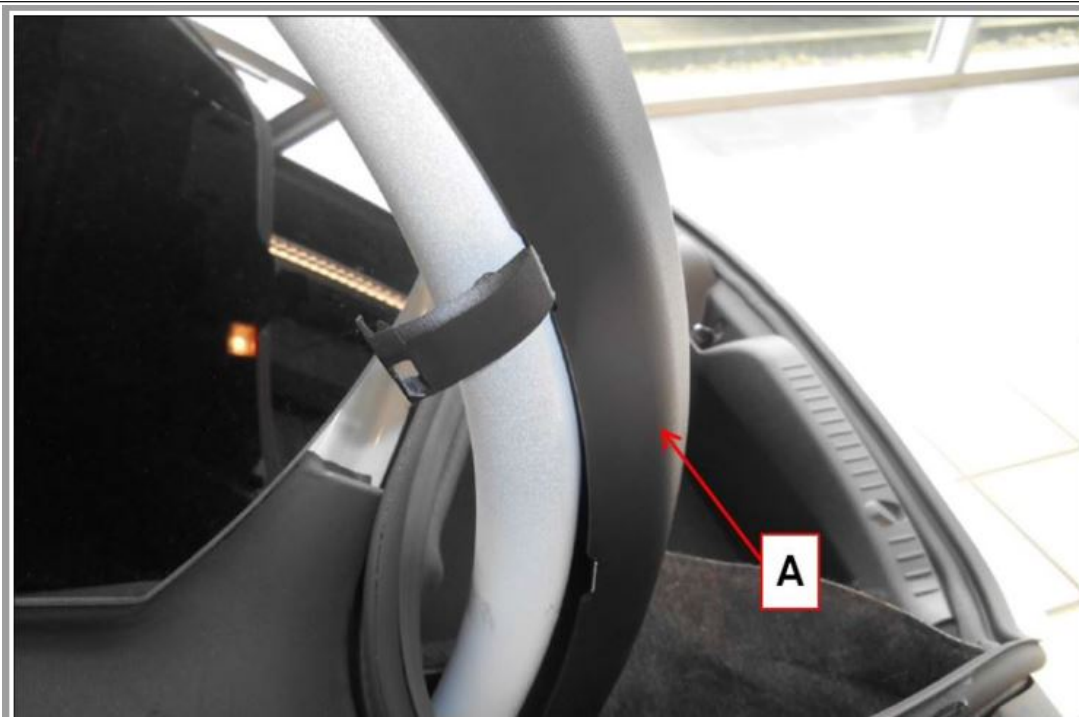
Bild 1.JPG:

- Trunk lid does not open/close completely.
- Noises when the trunk lid is operated.
- Left trunk lid hinge cover (picture 1, A) damaged.

Replace the installed molded bearing on the bodyshell with the new version.
If necessary, also replace the trunk lid hinge cover.

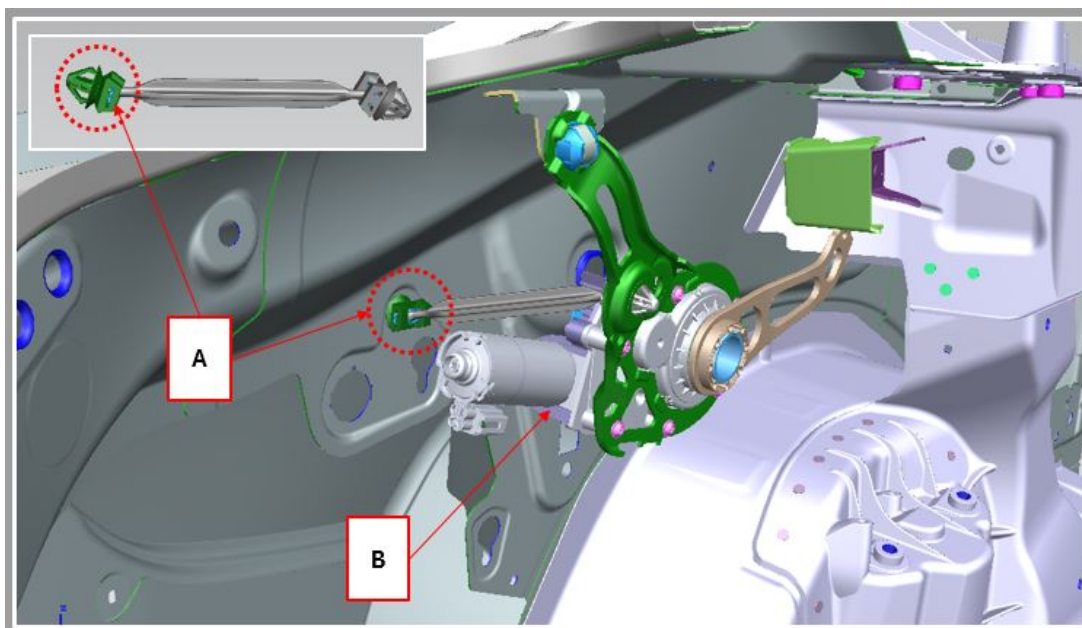
Bild 2.JPG:

In isolated cases, the molded bearing (picture 2, A) of the trunk lid control drive unit (picture 2, B) can detach from the bodyshell.
