Coolant Loss at the Hose Connection of the Low-Temperature Circuit Heat Exchanger

Topic number	LI20.20-P-067930
Version	1
Function group	20.20 Radiator, coolant hoses
Date	03-23-2018
Validity	Model 190.379
Reason for change	
Reason for block

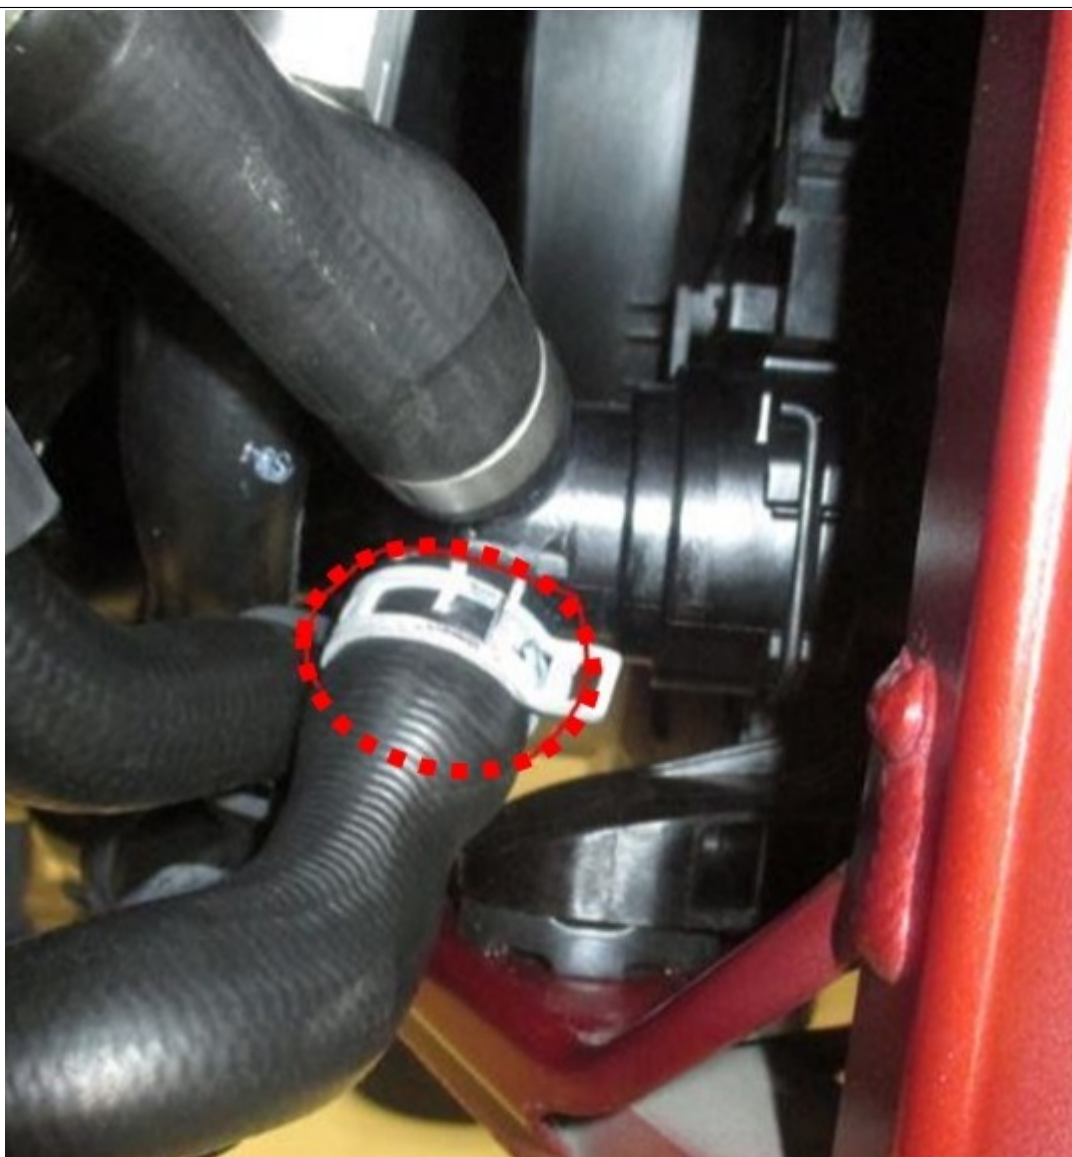
Bild Schelle.jpg:

Gradual coolant loss at the hose connection at the bottom on the right of the full-flow radiator.

The loss of coolant may be evident from dried or crystalized deposits at the connection location.

The clamp may not be completely sealing the hose connection.

Attachments	
File	Description
Bild Schelle.jpg	Picture of affected hose connection

Replace the clamp with a screw clamp.

Replace the coolant hoses with new units.
