Mack Model TE-TerraPro , LR , LEU , MRU , GR-Granite , PI-Pinnacle , AN-Anthem , CHU , CXU , GU , TD

Volvo Model VNR , VT , VNX , VNL , VNM , VHD , VAH

Title Variable Geometry Turbo (VGT) Calibration: Premium Tech Tool (PTT) Displays "Motor Disabled" Message, Operation Will Not Run, Will Not Complete When Running Operation; Poor Performance Following Calibration - **US10 And Newer Emissions, Common Model Years 2014 And Newer**

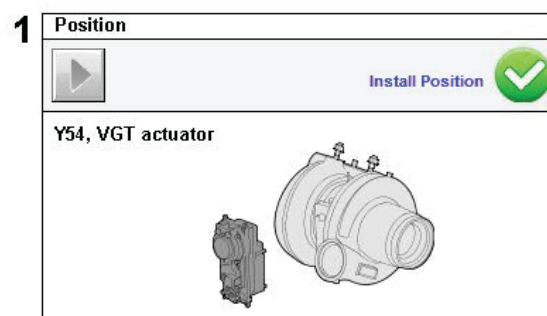
A. A **Green Circle with Check Mark** and **Install Position** message **must be displayed** as shown below before proceeding further. **If the correct status is observed, proceed to Step 3 of the PTT operation.**

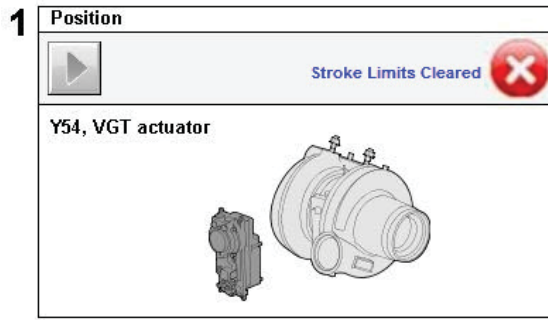
B. If an error message and/or a **Red Circle with an X** is displayed as shown below, Operation Step 1 did not complete correctly.

1. Stop the calibration.
2. Exit the operation.
3. Restart the calibration operation.
4. Perform Operation Step 1 again until the conditions in Part A are observed.

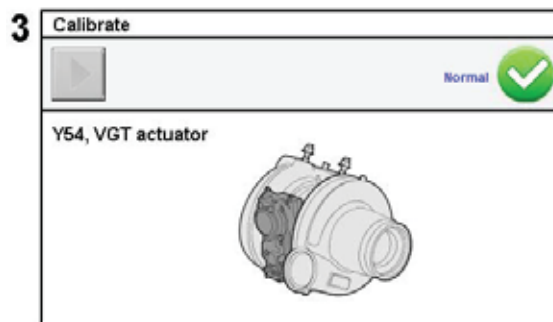
B. When the calibration completes, a **Green Circle with Check Mark** and **Normal** message should **display** after calibration completes. There may be a delay between the test completion and the message display.

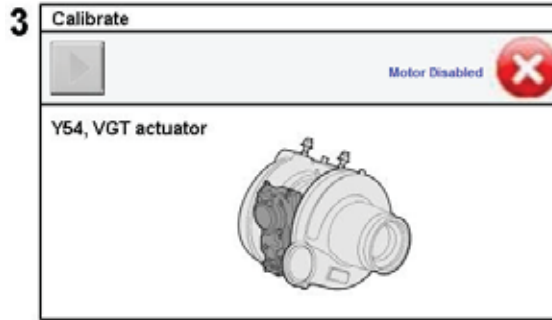
C. If the operation fails and a **Red Circle with an X** is displayed with a "Motor Disabled" message, proceed to Section IV below.

IV. If a "Motor Disabled" message is observed (most common when the actuator is unbolted from the turbocharger) at any time during the Operation:

- A. Ensure the ignition key is turned ON.
- B. **By hand**, spin the actuator output gear at least one full revolution as shown below. This allows the motor to find the internal reference magnet on the output shaft.

- C. Rerun Step 1 of the operation.
