**Mack Model** TE-TerraPro , LR , GR-Granite , PI-Pinnacle , AN-Anthem , CHU , CXU , GU

**Volvo Model** VNR , VNX , VNL , VHD , VAH

**Title** Common Rail Fuel System - Engine Wiring Harness Will Not Reach / Is Not Long Enough To Connect To Electronic Pressure Relief Valve (EPRV) Connector, Wiring Harness Pulled Tight At EPRV; Correct Clocking, Symptoms, Repair - [US17+OBD16 And Newer Emissions, Common Model Years 2018 And Newer](#)

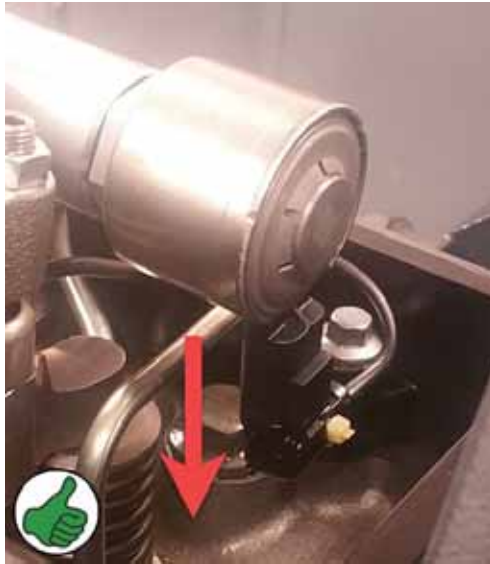
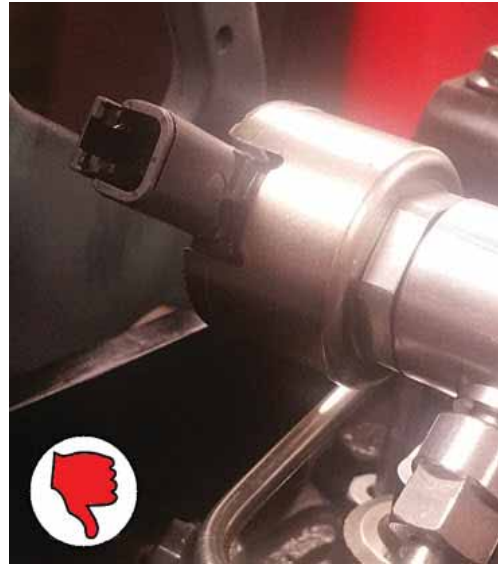
**Cause** When installing an Electronic Pressure Relief Valve on the fuel rail of a US17 or newer chassis, it may be observed that the engine wiring harness is very tight after the connector is put in place, or that the pigtail with the EPRV connector will not reach the connector on the EPRV itself. Excessive tension on the harness or pins pulled out of connectors may also be seen when the valve cover is removed to inspect fuel system components.

This issue can be caused by an incorrectly oriented—or clocked—EPRV. The housing of the EPRV is able to rotate independently of the fitting that is threaded and torqued to the rail.

The EPRV should be oriented with the connector directed downward toward the cylinder head and angled slightly toward the right side of the engine.
