Technical Service Bulletin

Technical Service Bulletin: TSB180095	Released Date: 06-Aug-2018
Repeat Occurrences or Troubleshooting Exhausted: Fault Codes 1682, 3574, and 3596.

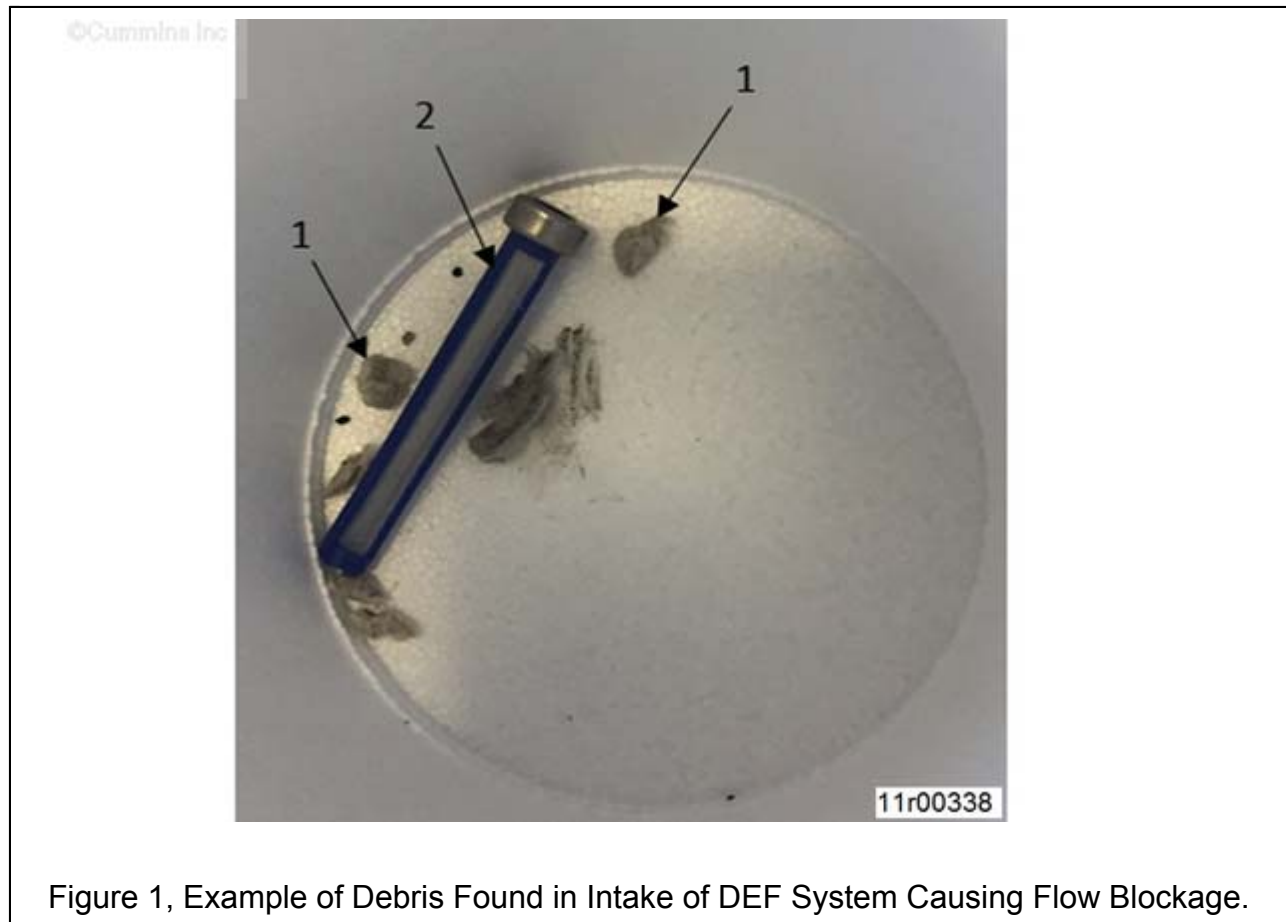
1. Debris builds up in intake fitting screen of aftertreatment DEF dosing unit and restricts flow into pump. Debris can be paper, fibers, or smaller particles of sand, rock, or dirt that build up over time.

1. Paper debris.
2. Aftertreatment DEF dosing unit intake fitting screen.

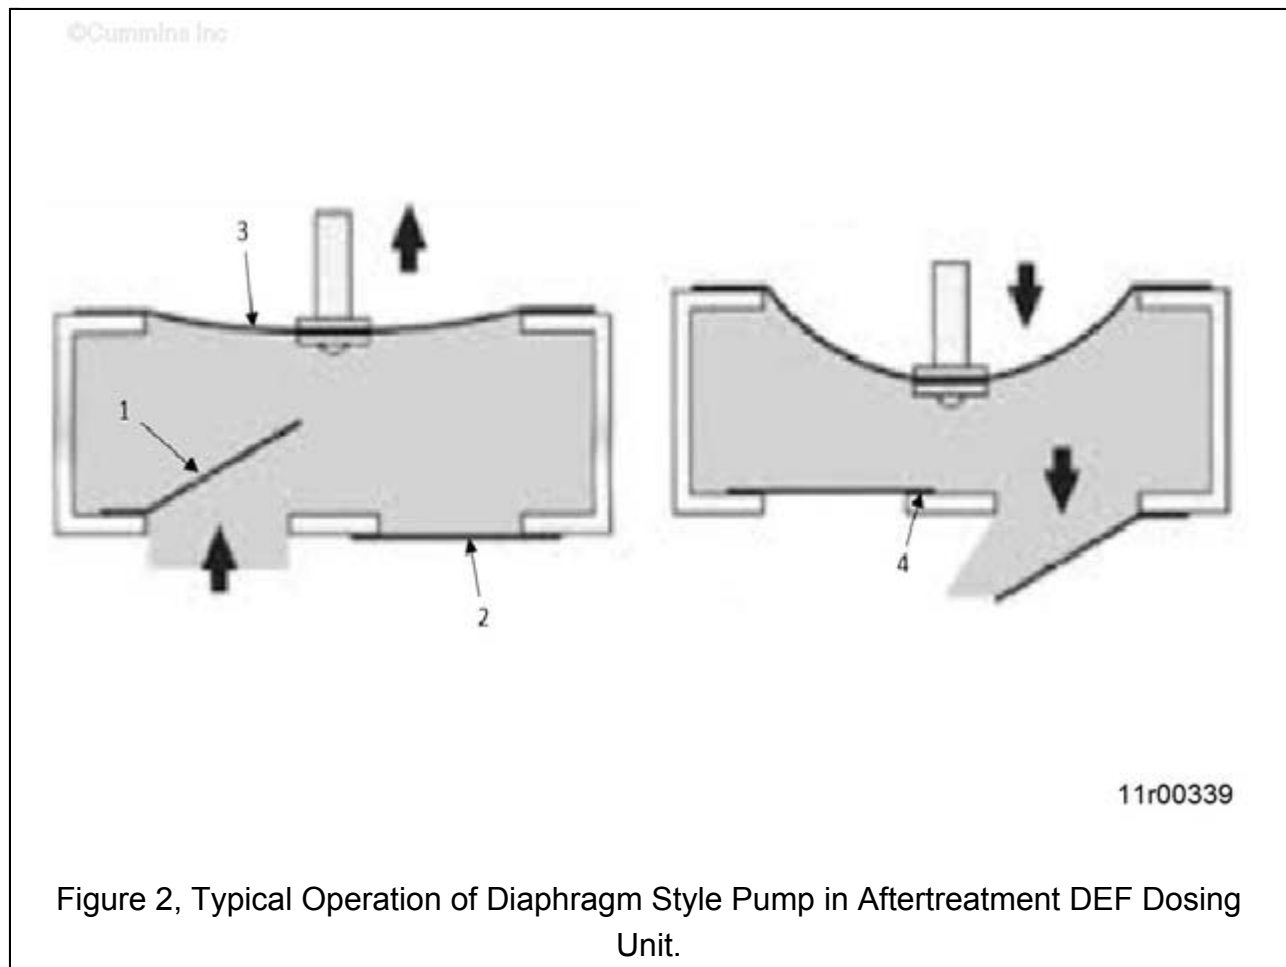
2. Debris collects on the pump intake valve in aftertreatment DEF dosing unit and prevents the intake valve from sealing properly. This form of debris will be small because debris has to pass through the 103 micron aftertreatment DEF dosing unit intake screen to get to the intake valve. Particles larger than 40 microns can cause pump performance issues (a human hair is approximately 50-70 microns wide).

1. Intake valve (membrane style).
2. Outlet valve (membrane style).
3. Pump diaphragm.
4. Location where debris builds up causing intake valve **not** to seal.

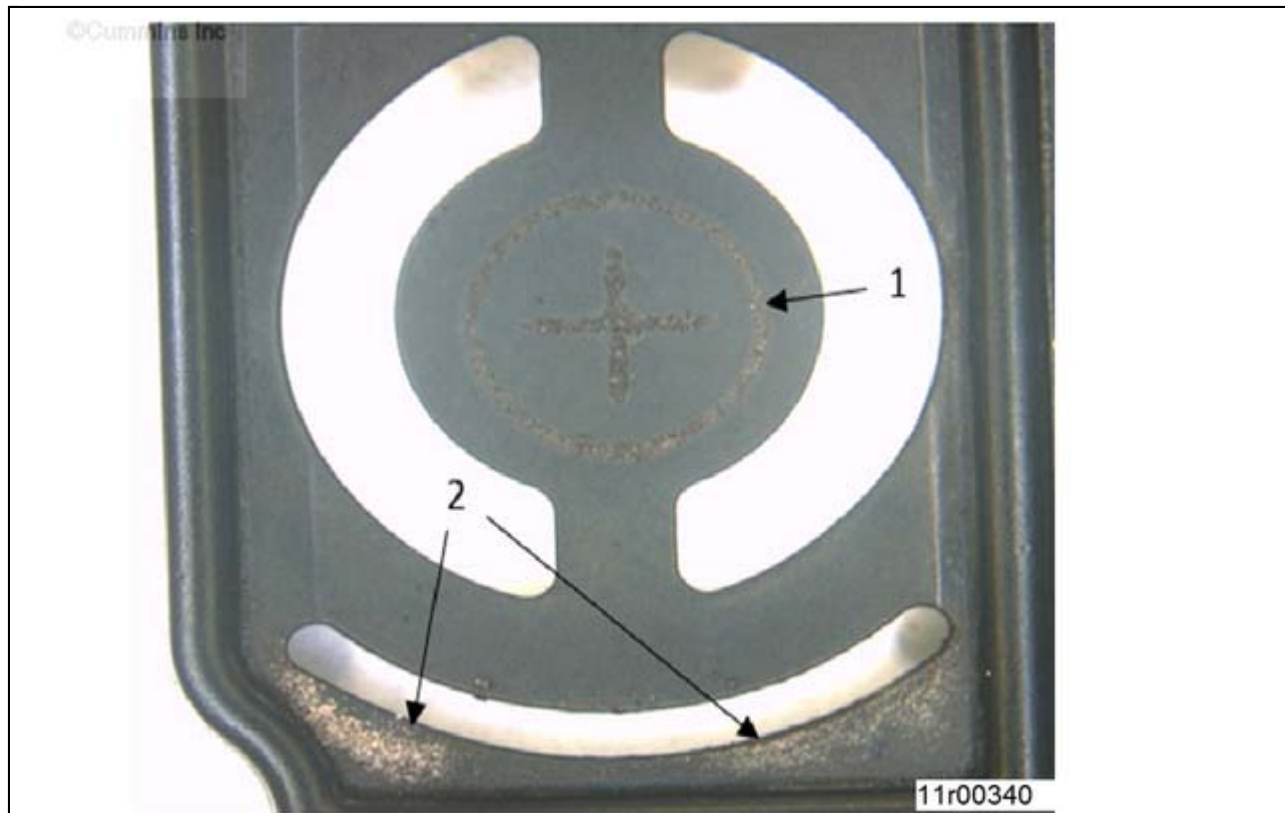
Figure 3, Debris Build Up on Aftertreatment DEF Dosing Unit Pump Intake Valve Plate. Intake Membrane (Valve) Seals Over this Plate On Pump Pressure Stroke.

1. Debris causing pump performance issue. This is what is flushed out when performing dosing unit non-air flush.
2. Loose debris that settled on the edge of the valve plate.

Perform following steps simultaneously:

- Drain DEF tank and discard DEF. See equipment manufacturer service information.
- Steam clean inside of DEF tank and then rinse thoroughly with clean water. If the design of the tank does **not** allow all of the water to drain out, use a wet/dry shop vacuum to remove any remaining water. Make sure any vacuum attachments used are clean.
- Inspect the inside of the tank and verify there is no remaining debris.
- Remove and discard DEF tank filter.
- Rinse DEF tank header and flush tank header pickup tube with clean water.
- Flush intake line with clean water.
- Remove and replace aftertreatment DEF dosing unit intake fitting. Before removing intake fitting, verify area around fitting on aftertreatment dosing unit is clean so dirt is **not** knocked into intake port.

- Remove and discard aftertreatment DEF dosing unit filter. See corresponding Service Manual. Reference Procedure 011-060 in Section 11.
- Perform aftertreatment DEF dosing unit non-air flush three times. See corresponding Service Manual. Reference Procedure 011-058 in Section 11.

- Perform the aftertreatment diesel exhaust fluid dosing unit suction test. See corresponding Service Manual. Reference Procedure 011-121 in Section 11. If out of specification, replace the DEF dosing unit. See corresponding Service Manual. Reference Procedure 011-058 in Section 11.
