Preliminary Information

PIP5163D Alleged Cylinders Out Of Round

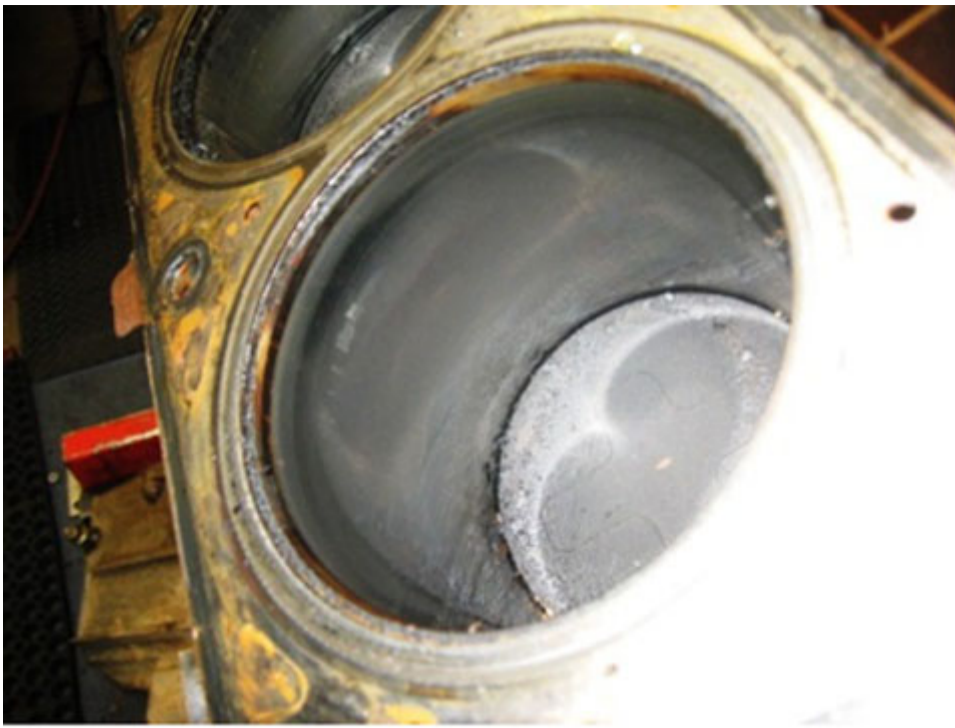
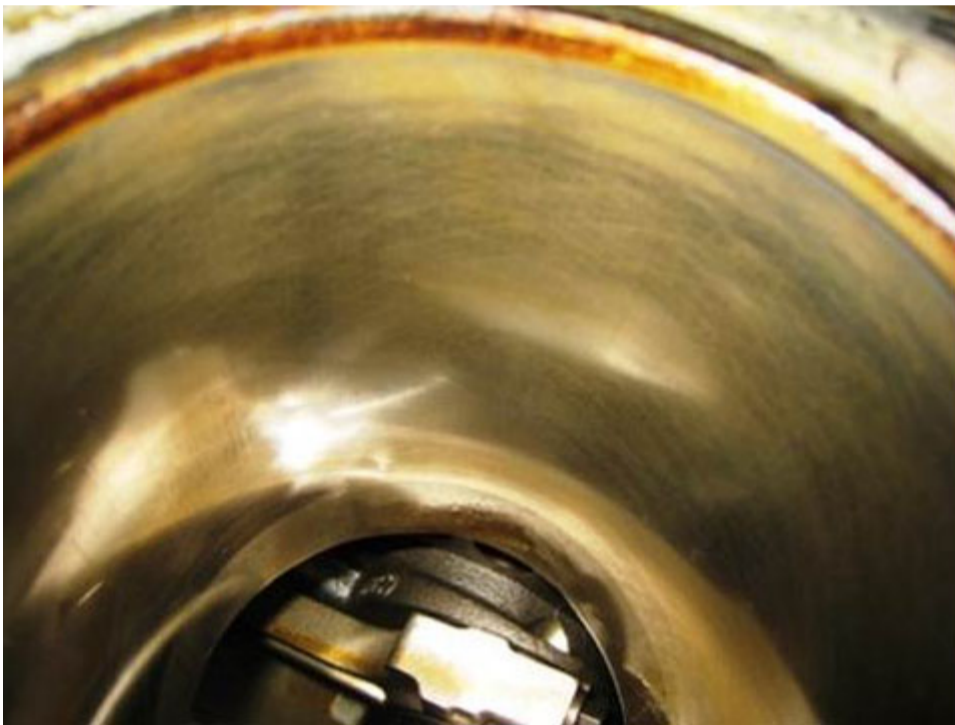
- 1. Cylinder damage or scoring-** the cylinder walls will contain grooves deep enough to catch with a finger nail.
- 2. An out of round cylinder bore-** will contain areas where the cross hatch is missing or worn from different section of the cylinder bore. If there is crosshatch all the way around the bore from top to bottom the cylinder bore is not out of round.

- 3. Dirt intrusion-** If the filtering system has been compromised the engine will wear out very quickly. You will find grit in the intake Runners and the cylinder bores will look lightly sand blasted. The crosshatch will be faint and there will not be sharpness. At high mileage this Should be an insurance claim if the air filtering system has been opened numerous times for service in dusty climates.

- 4. Catalytic Converter failure-** If a converter fails and the brick is broken, the dust can be drawn back into the engine. A block showing this type of failure, will have bores that look to be sand blasted. Back cylinders go first if caught early. Otherwise there will be no Crosshatch and the engine will need to be replaced.
