SERVICE BULLETIN

Classification: EM16-005a	Reference: NTB16-083a	Date: June 1, 2018
------------------------------	--------------------------	-----------------------

2013 – 2018 SENTRA; REAR TORQUE ROD SERVICE

APPLIED VEHICLE: 2013 – 2018 Sentra (B17)
APPLIED TRANSMISSION: CVT
APPLIED ENGINE: MRA8DE

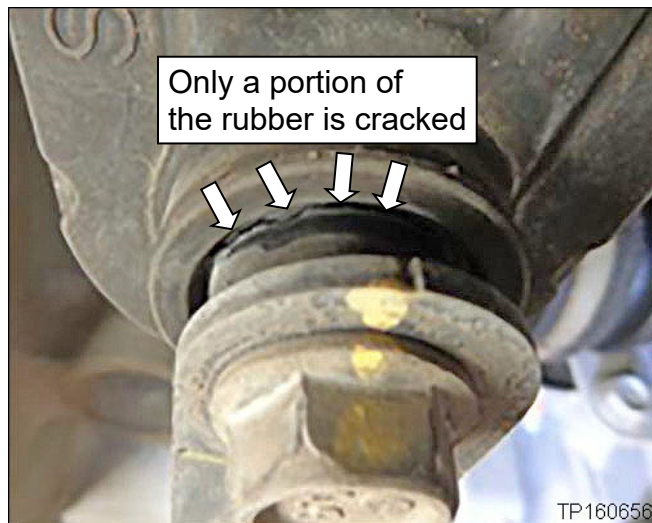
The forward end of the rear torque rod on applied vehicles may develop a crack in the rubber during its normal service life.

Figure 1 shows a crack in the rubber of the forward end of the rear torque rod that **does not extend** the complete circumference (all the way around) the rubber. This may occur during normal service life.

- **Do not** replace the torque rod for a crack that **does not** extend all the way around the rubber part of the forward end.
