Technical Service Bulletin

91 Audi connect is not functioning and the message "Please wait.." continually appears

91 18 01 2042942/2 June 20, 2018. Supersedes Technical Service Bulletin Group 91 number 16-27 dated January 26, 2016 for reasons listed below.

Model(s)	Year	VIN Range	Vehicle-Specific Equipment
All	2016 - 2017	All	With Audi connect

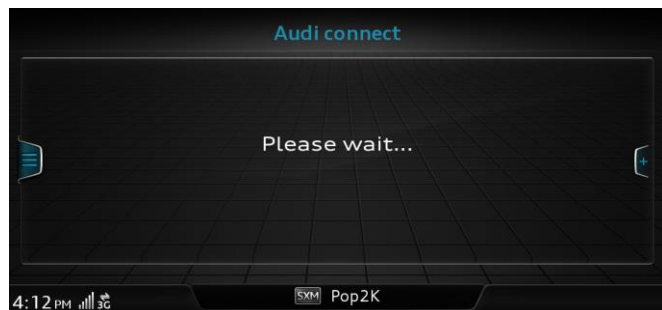
- The Audi connect Gen 2 system does not function.
- The message "Please wait..." continually appears (Figure 1).
- The system might only receive a 3G cellular connection in areas with strong 4G LTE reception.

Figure 1. "Please wait..." message.

It is possible that the Audi connect configuration is incorrect due to a communication issue with the backend server in Germany. A full factory reset of the MMI system is required to fix the incorrect configuration, as a factory reset of only the Audi connect settings may not correct the issue.

Perform a full factory reset of the MMI system using the following instructions.

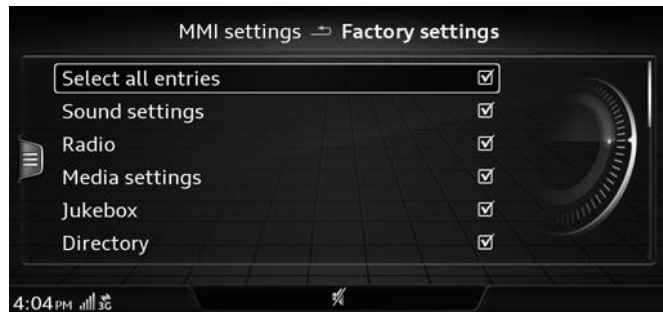
Figure 2. Choose “Select all entries”.

1. In the MMI settings, select “Factory settings”, then “Select all entries” (Figure 2).

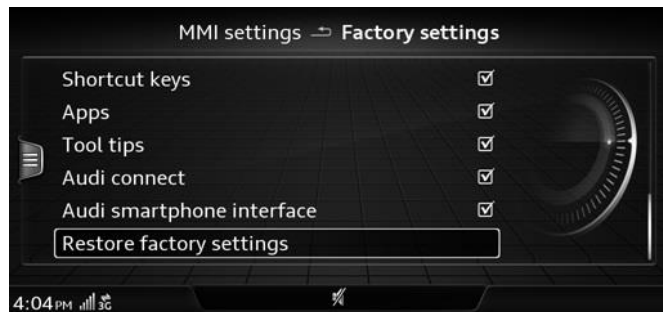
Figure 3. Select “Restore factory settings”.

2. Next, select “Restore factory settings” (Figure 3).

The MMI screen will retract after about 10-15 seconds, then the system will take 1-2 minutes to fully reset.

After the reset, the screen will open. If the screen fails to open after two minutes, press down on the volume knob to force the system to power on.
