SERVICE INFORMATION BULLETIN

APPLICABILITY: 2015-2017MY Legacy and Outback
 2015-2016 Impreza
 2015-2017 Crosstrek
 2016-2018MY Forester
 2016-2018MY WRX

NUMBER: 15-205-16R

SUBJECT: Reprogramming File Availability to Address Operational Concerns with “Gen 2.0” and “Gen 2.1” Fujitsu-TEN (F10) Navigation and 7” Display Audio Units

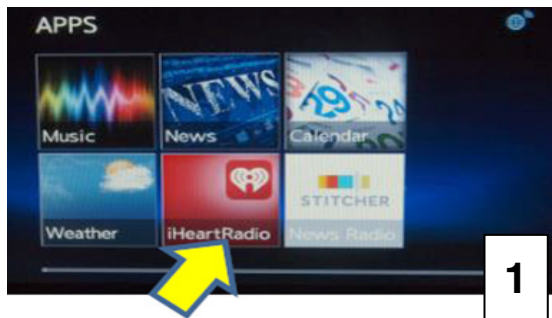
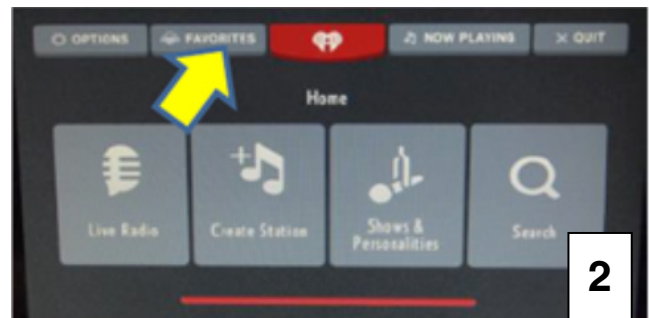
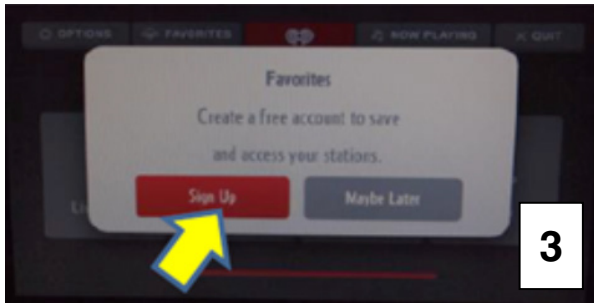
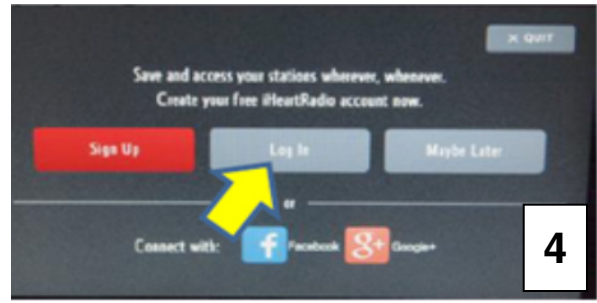
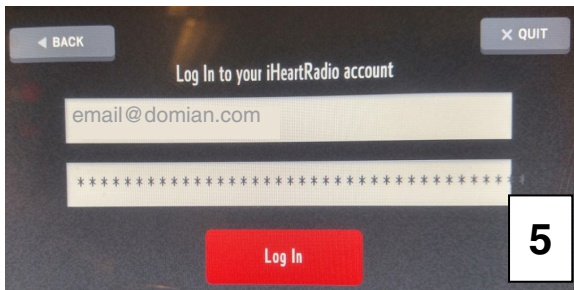
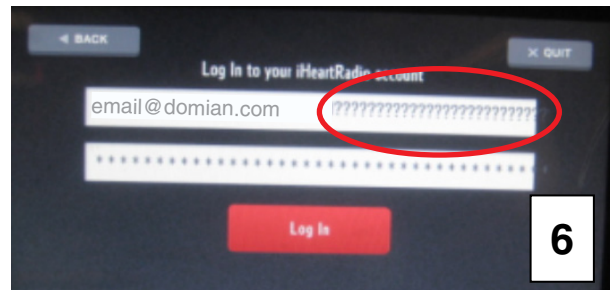
- SXM channels higher than 256 cannot be selected using the voice command feature.
- Additional characters appear (in this example, question ??? marks) after entering an e-mail address and password using the software keyboard when attempting to log in to an iHeart radio account as shown in the screen shot sequence below.

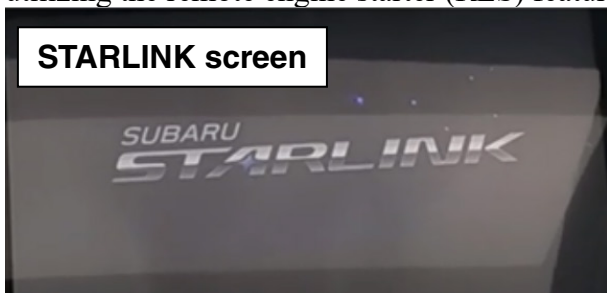
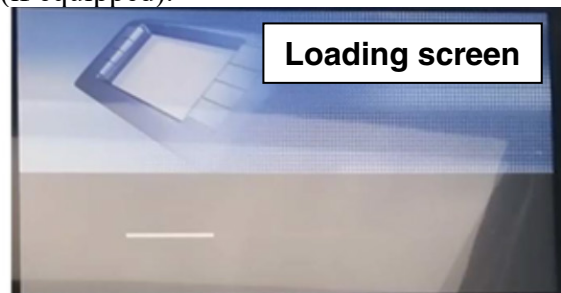
- The Navigation system re-boots from the Loading screen (not the STARLINK screen) when utilizing the remote engine starter (RES) feature (if equipped).

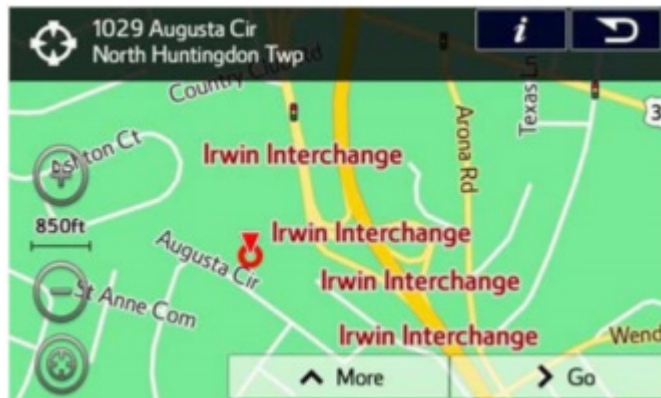
Symptom 6: Roads or interchanges have the same name displayed multiple times.

Change: Logic update to show only one road or interchange name at the same time.

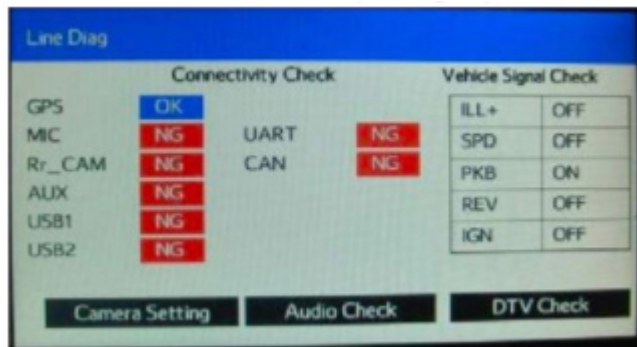
Symptom 14: “Line Diag” screen is intermittently displayed while driving.

Change: Logic change to prevent display of the “Line Diag” screen.

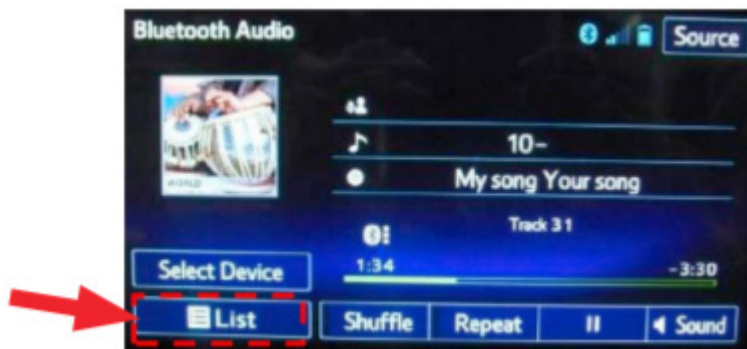
Symptom 15: “LIST” soft touch key is not displayed on Bluetooth Audio screen while using Bluetooth audio feature with an Apple device utilizing iOS8 software version.

Change: Logic change to enhance compatibility with iOS8 software.

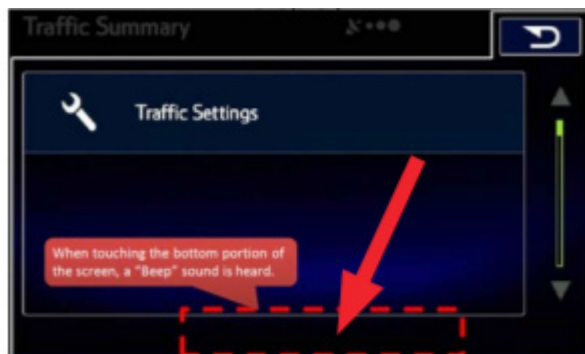
Symptom 16: “Beep” sound heard when touching the bottom of the display screen where no function soft touch keys are displayed.

Change: Logic change to eliminate beeping sound from inactive soft touch key screen areas.

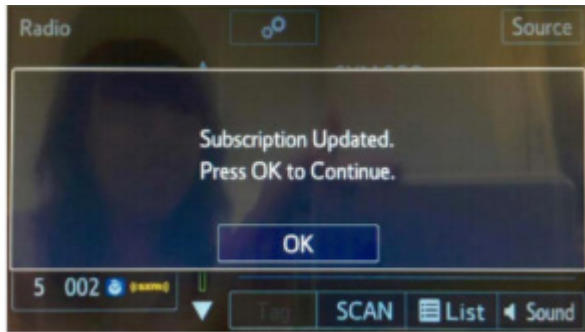
Symptom 17: SXM caution message screen is displayed in English even when French language operation settings are selected.

Change: Logic change to make all messages display in the selected operating language.

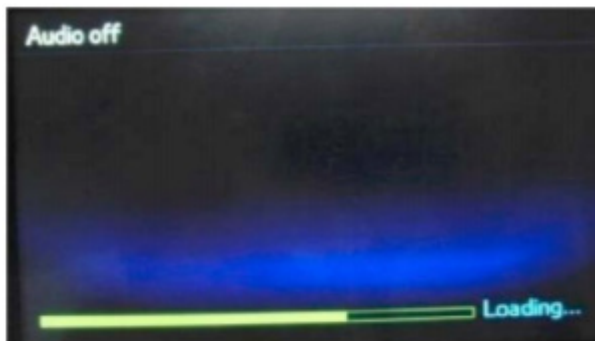
Loading Screen

Symptom 18: Repeated display of the “Loading” screen at initial unit start-up.
