SERVICE BULLETIN

APPLICABILITY: All Models with Harman Audio / Infotainment **NUMBER:** 15-226-18
SUBJECT: USB Functionality Concerns and Troubleshooting **DATE:** 08/21/08

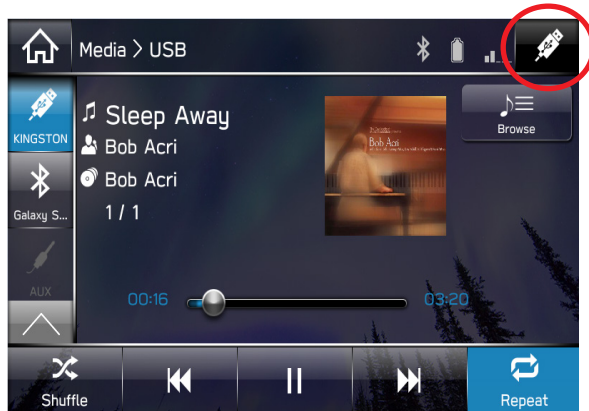
- 1) Always confirm the condition as reported by the customer.
- 2) This section addresses USB detection symptoms.
 - a. Confirm the USB is recognized (USB icon appears) on the Media screen as shown in the figure below.

- b. If the USB is not recognized, follow Service Diagnostic Mode from the Service Manual:
 - i. Turn the ignition switch to ACC.
 - ii. Press the “TUNE/SCROLL” button six times while pressing the “HOME” button.

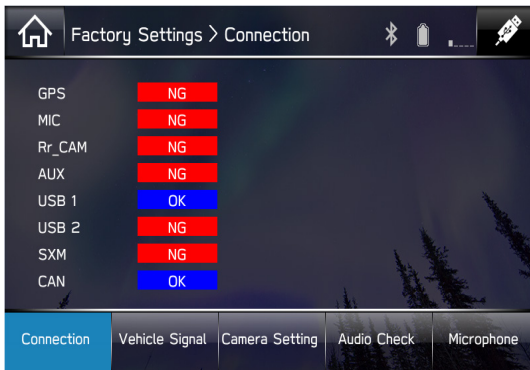
- a. CONNECTION

- i. On Service Menu, press “**Connection**” to display the list of items.
- ii. **OK**: Each device is connected properly.
- iii. **NG**: Connection is not established, or connection status (possibly including the related harness) is faulty.

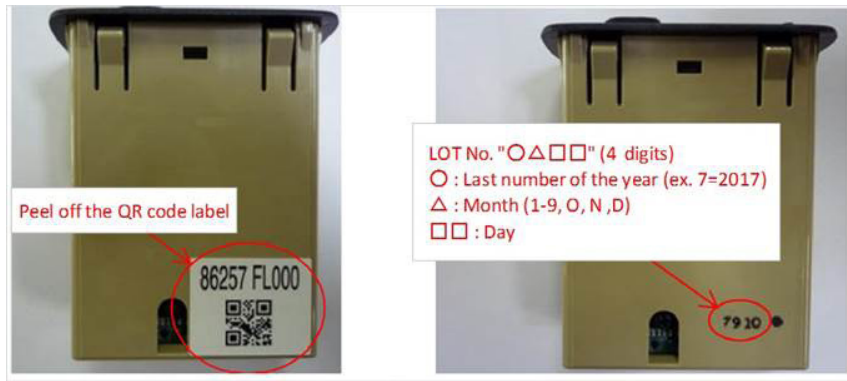
New firmware was released during late 2017 to enhance connectivity for Auxiliary Terminal part numbers: **86257FL00A** and **86257FL101** (MID, HIGH).

How to determine if the Auxiliary Terminal is pre- or post-countermeasure (CM):

- CAREFULLY peel off the QR code / part number label.
- Check the Lot# as shown below. If the number is after “**7411**” it is post-CM.
