**NUMBER:** 19-001-15 REV. A

**GROUP:** Steering

Loss Of Power Steering Assist

2015 (LA) Dodge Challenger

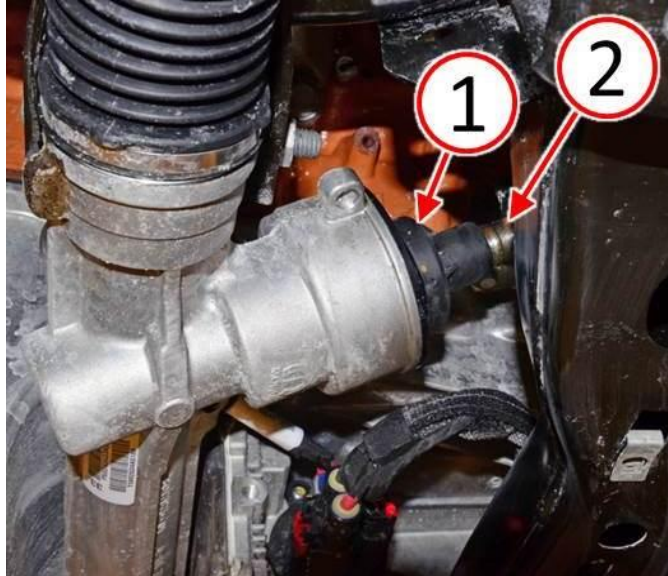
**Fig. 1 Locate Dust Cover**

- 1 - Dust Cover
  - 2 - Intermediate Shaft
-

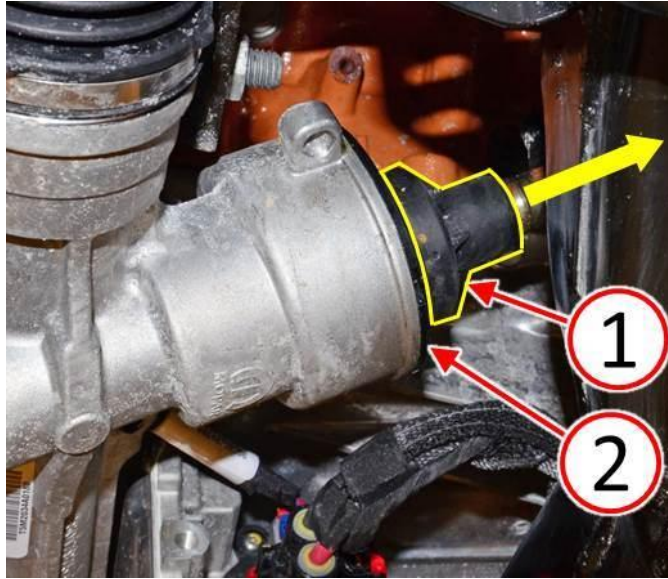
**Fig. 2 Reposition Dust Cover**

4. By hand, pull the dust cover (1) away from EPS gear pinion cover (2) and slide the dust cover along the pinion shaft until the top edge of the pinion cover is visible (Fig. 2).

- 1 - Dust Cover
  - 2 - Pinion Cover
-

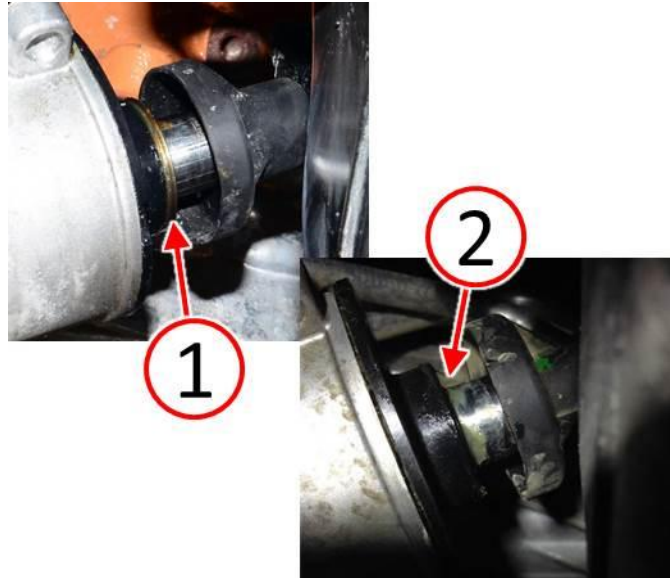
**Fig. 3 Inspect Washer**

5. Check if the pinion cover retaining washer is present (1) or missing (2) at the top edge of the pinion cover ([Fig. 3](#)).

**NOTE: It may be necessary to wipe away some grease in order to detect if washer is present. The retaining washer color may range from bronze to silver.**

- 1 - Washer Present
- 2 - Washer Missing

- 
6. Is the pinion cover retaining washer missing?
    - a. YES>>> Replace the steering gear. Continue with [Step #7](#).
    - b. NO>>> The inspection has been completed, Proceed to [Step #8](#) for vehicle reassembly.
  7. If the pinion cover retaining washer is missing, the steering gear must be replaced. Refer to the detailed service procedures available in DealerCONNECT> TechCONNECT under: Service Info> 19 - Steering> Gear> Removal/Installation > ELECTRIC POWER STEERING.
  8. Slide the dust cover (1) back over the pinion cover (2) and secure the dust cover into place ([Fig. 4](#)).

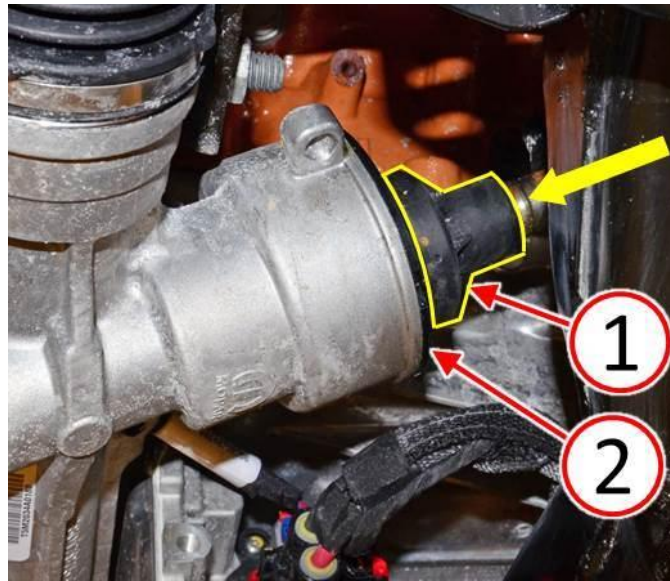
**Fig. 4 Reinstall Dust Cover**

- 1 - Dust Cover
- 2 - Pinion Cover
