## Technical Information Bulletin

### E214

MY17/18 PACCAR MX-13 EGR DTC's P103C, P1711, P1719, and/or P3818; DPF/SCR restrictions; and/or high oil consumption.

8/23/2018

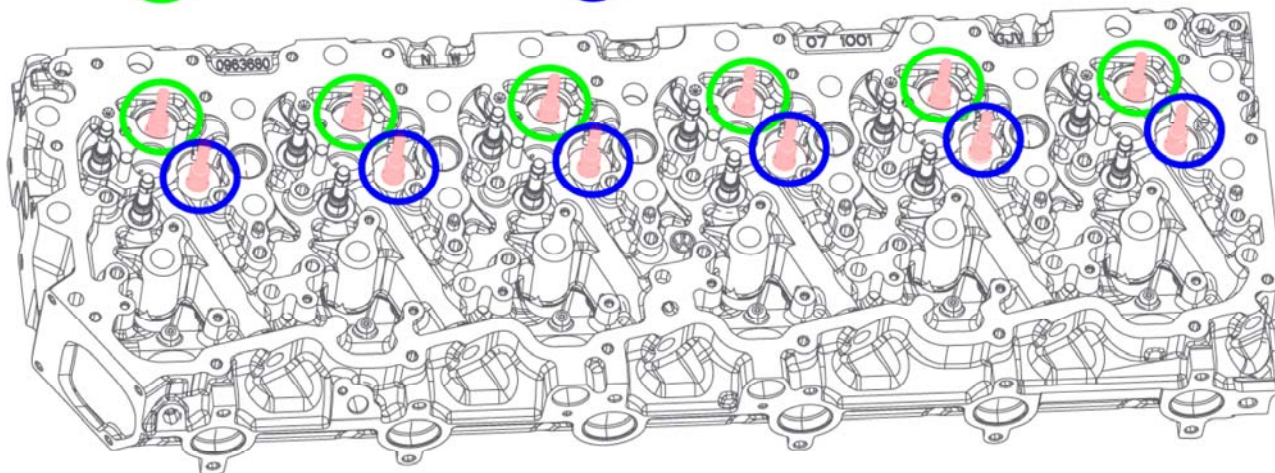
Figure 1 Valve Guide Seal Locations

Valve	Spring Washer	Seal
Non-Brake Exhaust Valve	2182962PE	1819065PE
Brake Exhaust Valve	N/A	2162785PE

1. If directed to replace the valve guide seals, replace only the exhaust seals. See Engine Rapido for instructions and refer to the following figure for the location and part number of the new seals and the Non-Brake spring washer.
  - As you replace the seals, inspect the valves for visible wear. Valves with visible wear must be replaced. Contact RESM if valve stem wear is found
