SERVICE BULLETIN

APPLICABILITY: 2017-18MY Impreza
 2018MY Crosstrek
 2018MY Legacy and Outback
 2018MY BRZ

NUMBER: 15-211-17R

SUBJECT: Reprogramming File Availability for Additional Optimization of Harman Gen 3 Audio and Navigation Head Units

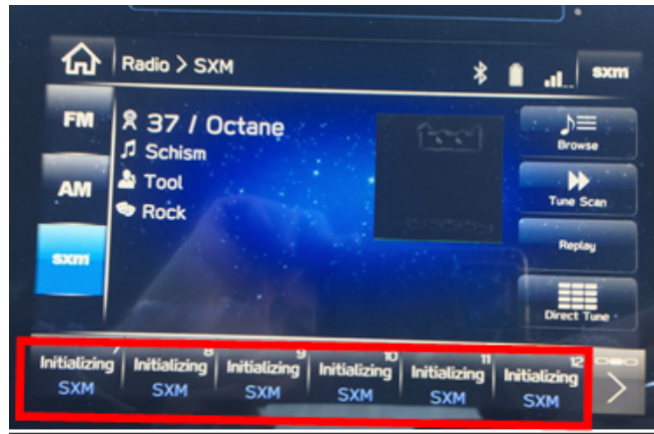
- On 2018MY Legacy / Outback models with Navigation (High) head units, the update corrects a condition where the head unit remains powered even after the ignition is OFF and the driver door is opened.
- Corrects for a condition where the SXM presets become lost and only “Initializing” appears as shown below.

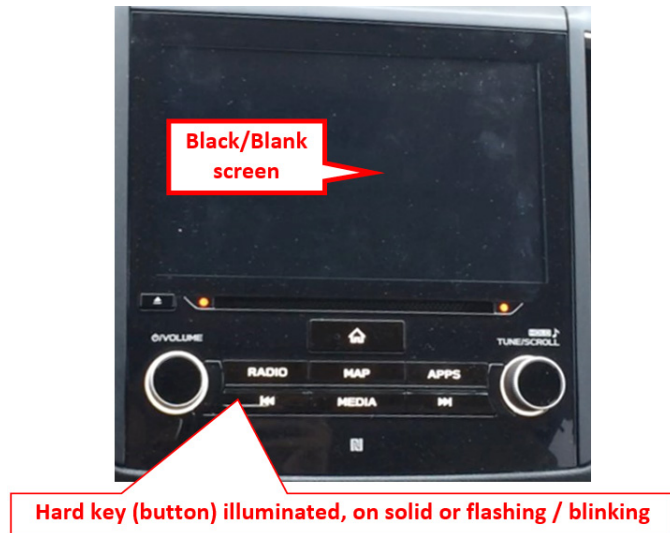
- 1) After switching the vehicle (ACC or IGN) on, the display screen goes black with no audio output and the hard key buttons are illuminated (on solid, or flashing / blinking).

- If a vehicle presents with a current blank or black screen condition, perform a capacitive discharge **FIRST** to see if head unit can be recovered. If head unit function is recovered, proceed with installation of the version 4 software. Version 4 software will prevent recurrence of this condition. If the software update cannot be installed for any reason after head unit recovery, request an exchange unit. If head unit does **NOT** recover following capacitive discharge, an exchange unit will need to be requested and installed.
- The number of update files for these vehicles has been reduced from a total of six (6) files to just three (3) due to software consolidation.
- Be sure to locate and re-format any existing USB drives used for updating Harman audio units in order to fully clear them before adding these new files to them.

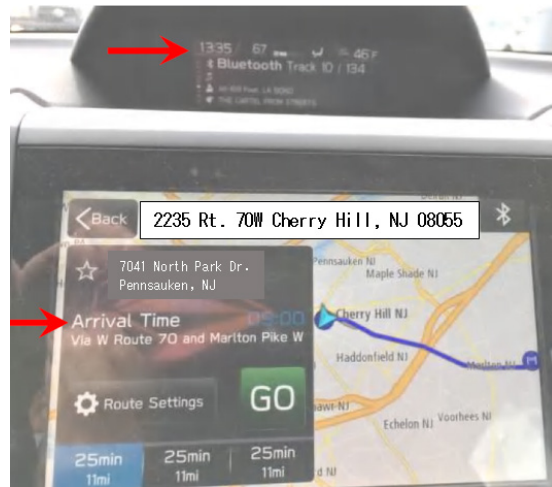
- 2) Time of day displayed in the MFD (Multi-Function Display) is incorrect and the arrival time displayed in Navigation units is also incorrect.

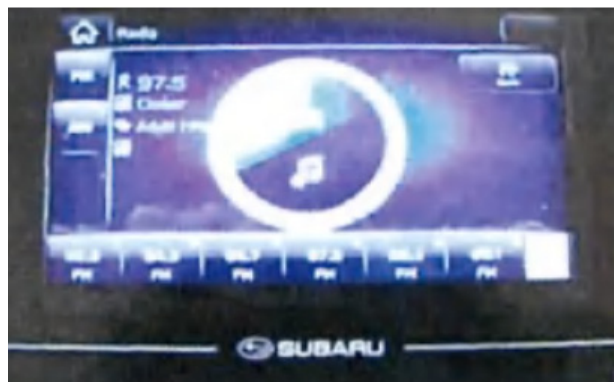
- 3) The time in the MFD automatically reverts to a "default" setting, even after setting the time using "Manual" mode.
- 4) Audio volume goes to maximum automatically after one click of the volume up button on the steering wheel. In some cases, this condition may also occur without input from the operator. Maximum volume is also displayed on the screen.
