Subject: ENGINE NO START (KEY NOT DETECTED)	M-Tips No.: MT-008/18
	Last Issued: 09/14/2018

2014-2018 Mazda3
 2014-2018 Mazda6
 2016-2019 CX-3
 2013-2018 CX-5
 2016-2019 CX-9
 2016-2019 MX-5

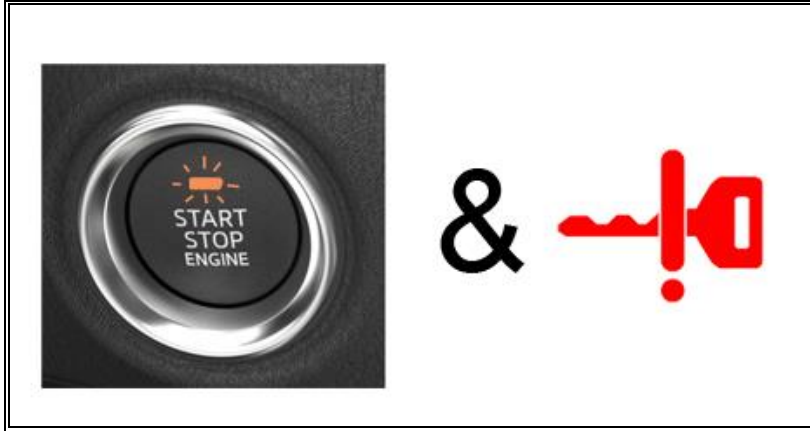
- Intermittent engine no start
- Instrument cluster red security indicator light ON
- Engine Start/Start Button Amber indicator light flashing
- Battery discharge
- Electrical relay buzzing noise

Engine Start/Start Button Amber indicator light flashing	Instrument cluster red security indicator light ON
---	---

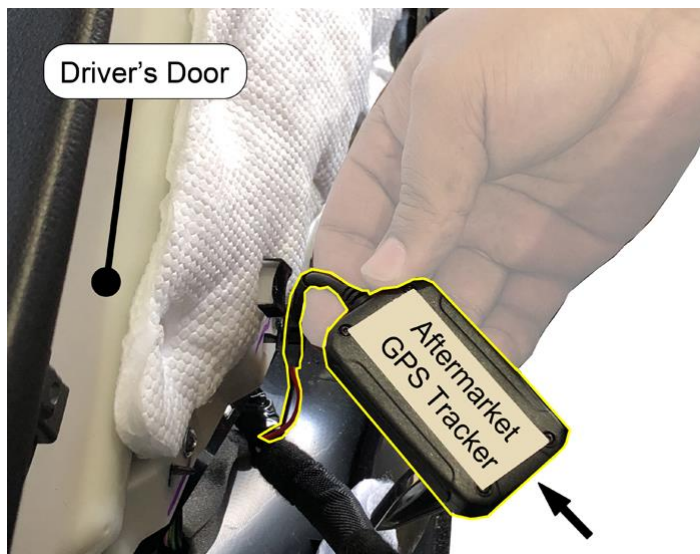
- A key in a purse near a cell phone. The cell phone radio waves may interrupt the immobilizer system.
- An aftermarket cell phone charger. The charger may produce electrical noise that interrupts the immobilizer system.
- An aftermarket GPS tracker. Some aftermarket devices that are wired to the vehicles's wiring harness may create unusual electrical symptoms.

1. Remove the key from the customers purse. Does the engine start?

- Yes - Advise customer that the key cannot be detected inside of purse. Possible out of range or an electrical devise in the purse is causing immobilizer interruption.
- No - Check the key battery. Is the key battery dead?
 - Yes - Replace key battery.
 - No - Proceed to next step.

2. Remove the customers aftermarket device from the customers vehicle. Does the engine start?

- Yes - Advise customer that the aftermarket device is causing an electrical malfunction.
- No - Refer to Workshop Manual Immobilizer System diagnosis.
