Technical Service Bulletin

Subject: SQUEAK NOISE FROM RIGHT FRONT DRIVESHAFT	Bulletin No.: 03-002/18
	Last Issued: 09/05/2018

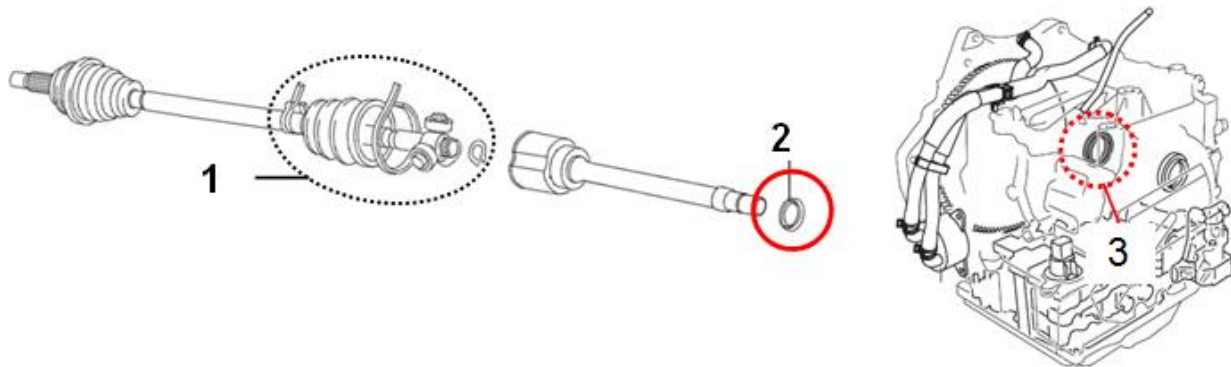
Some vehicles may exhibit a squeak noise from the right front driveshaft at the transaxle when driving. This concern is likely to occur when driving at speeds between 37-50 mph (60-80 km/h) with the ATF at normal operating temperature. The noise is caused by stick/slip between the oil seal at the transaxle and the dust cover of the driveshaft. To correct this issue, the thickness of the dust cover has been increased.

1	Inner joint boot set
2	Dust cover
3	Oil Seal

1. Verify concern
2. Replace the dust cover and the transfer oil seal with modified ones according to the instructions on MGSS (FRONT DRIVE SHAFT REMOVAL/INSTALLATION) and (FRONT DRIVE SHAFT (TRIPOD JOINT) DISASSEMBLY/ASSEMBLY).
