June 2018 Technical Service

THE INSTRUMENT CLUSTER DISPLAYS VARIOUS CHECK CONTROL MESSAGES

This Service Information bulletin replaces SI B61 21 15 dated August 2017

F25 (X3)	F26 (X4)	
Produced up to July 31, 2016

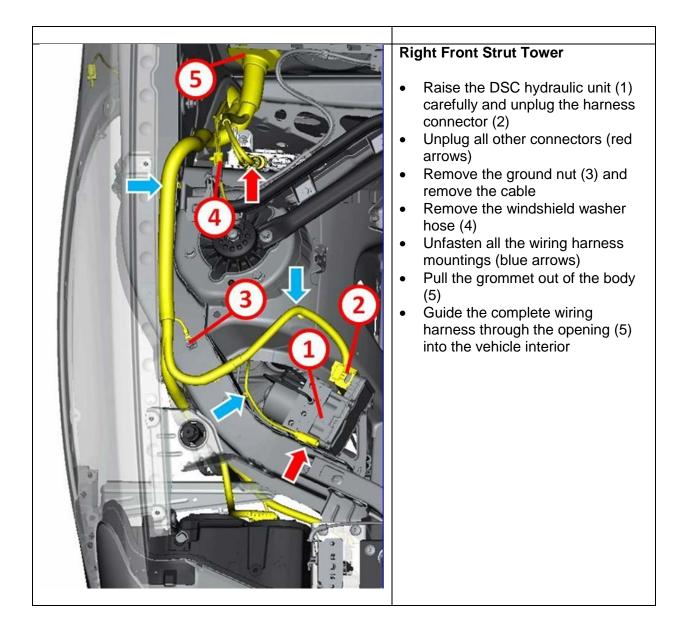
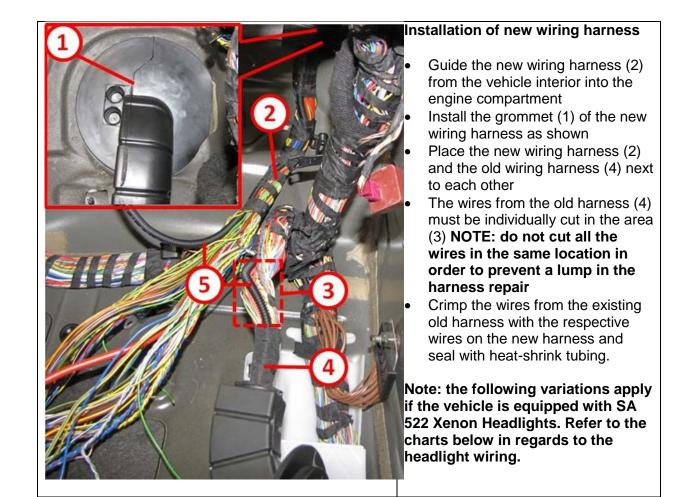
Remove the nut (4)
 Disconnect the wiring harness (5)
 Front of Right Front Wheel well Unplug all the wiring harness plug connections (red arrows). Based on the vehicle options there might be more connections to unplug Unfasten all the wiring harness mounting points (blue arrows) Guide the wiring harness up and out of the wheel arch area
 Rear of Right Front Wheel well Unplug all the wiring harness plug connections (red arrows). Pull the grommet out of the body (1) Guide the wiring harness through the opening (1) into the engine compartment
 Behind Right Front Headlight Remove the nut from the ground comb connector (1) and remove the ground comb
