**September 28, 2018**

## 2012-13 Odyssey: Judder from the Torque Converter Lock-Up Clutch (Snapshot Required)

Supersedes 17-052, dated February 24, 2018 to revise the information highlighted in **yellow**

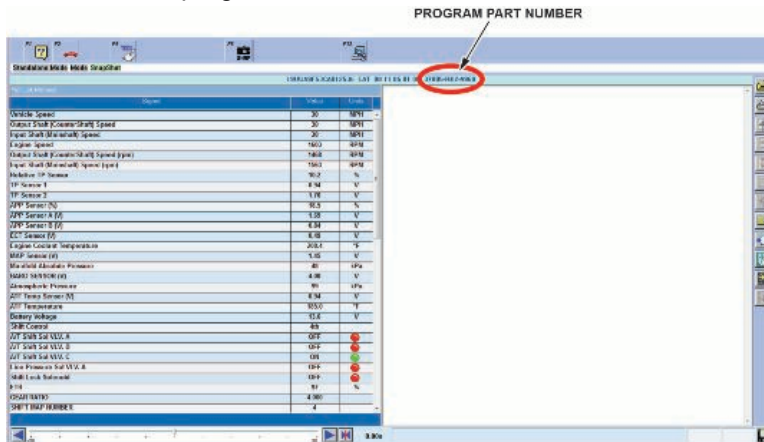
1. Connect the i-HDS, and go to the **A/T Data List**. Check the program P/N.
  - If the software program P/N starts with **37805**, it is a Continental PCM.
  - If the software program P/N starts with **37806**, it is a Keihin PCM.
