September 28, 2018

2012-13 Odyssey: Judder from the Torque Converter Lock-Up Clutch After Software Update (Snapshot Required)

Supersedes 18-017, dated February 24, 2018 to revise the information highlighted in **yellow**

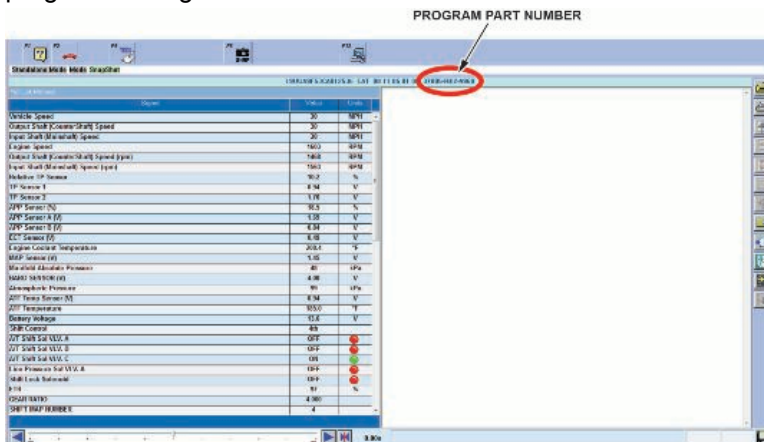
1. Connect the i-HDS, and go to the **A/T Data List**. Check to see if the software has been updated by comparing the program P/N against the table below.

- If the program P/N is listed below (or later), the vehicle has been updated. Go to step 2.

- If the program P/N is not listed, or if the program P/N starts with a **37805** the vehicle has not been updated. Go to Service Bulletin 17-052, 2012-13 Odyssey: Judder from the Torque Converter Lock-Up Clutch.
