**October 4, 2018**

Version 3

## A/C Does Not Blow Cold Air and Condenser Leaks at Receiver Dryer Cap

Supersedes 18-080, dated August 25, 2018, to revise the information highlighted in yellow

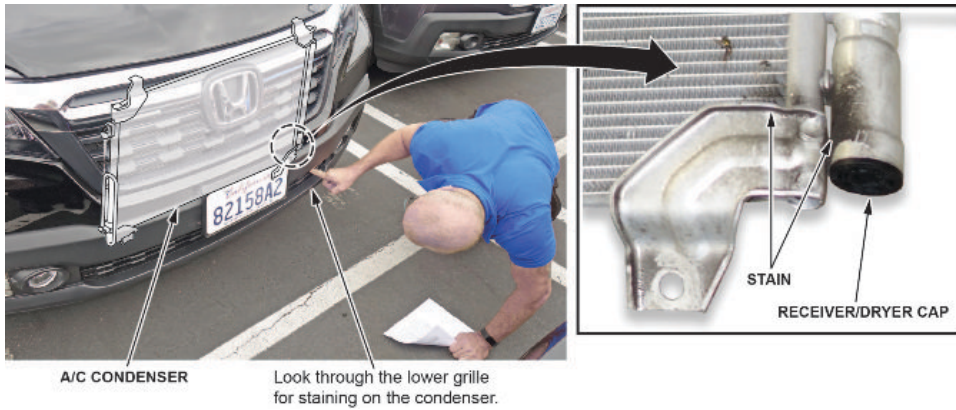
The A/C does not blow cold air, and the lower corner of the condenser around the receiver/dryer cap is stained.

There is poor O-ring compression against the receiver/dryer barrel wall.

Check if the A/C is blowing cold air and there is staining around the receiver dryer cap on the condenser.

- If the A/C is not blowing cold air and there is staining around the receiver dryer cap on the condenser, go to REPAIR PROCEDURE.
- If the A/C is not blowing cold air and there is no staining around the receiver dryer cap, continue with normal system troubleshooting.

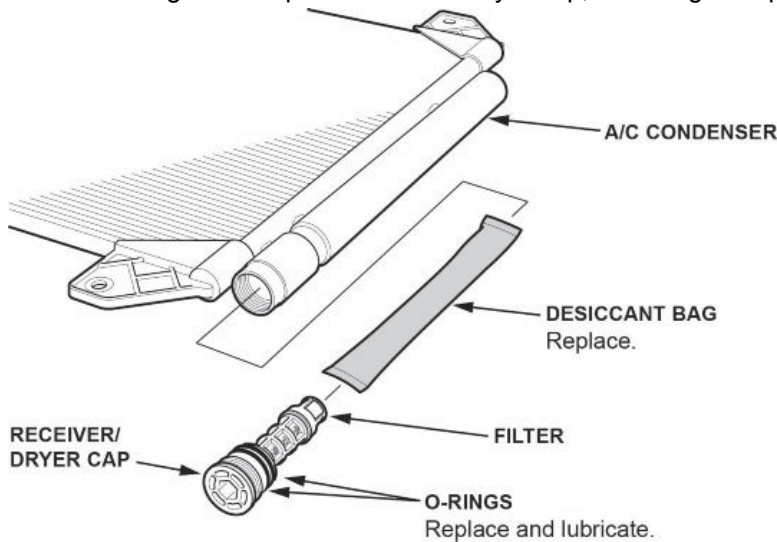
4. Remove the sub-assembly (cap, filter, and desiccant bag) from the condenser.

- Install the new desiccant bag as quickly as possible to prevent the system from absorbing moisture from the air.
- You will need to add **10 ml** of refrigerant oil (P/N 38899-RLV-A01) with the replacement of the desiccant bag.
- Do not over tighten the plastic receiver/dryer cap; it could get stripped.

5. Wipe the interior threads and sealing area of the receiver/dryer barrel with a lint-free cloth to remove all debris.
6. Apply a thin layer of refrigerant oil to the O-rings. Then install the new filter sub-assembly, and torque the cap to **12 N·m (9 lb-ft)**.
7. Install the A/C condenser. Refer to the service information.
8. Evacuate and recharge the A/C system. Refer to the service information.
9. Make sure the A/C system is operating properly.
10. **With Honda Sensing: Do the millimeter wave radar aiming procedure. Refer to service information.**
