<b>Technical Service Bulletin:</b> TSB130159	<b>Released Date:</b> 05-Sep-2018
<b>Fault Code 3167 or 1691 Caused by a Missing Poppet in the EcoFit™ Aftertreatment Fuel Injector</b>

## Fault Code 3167 or 1691 Caused by a Missing Poppet in the EcoFit™ Aftertreatment Fuel Injector

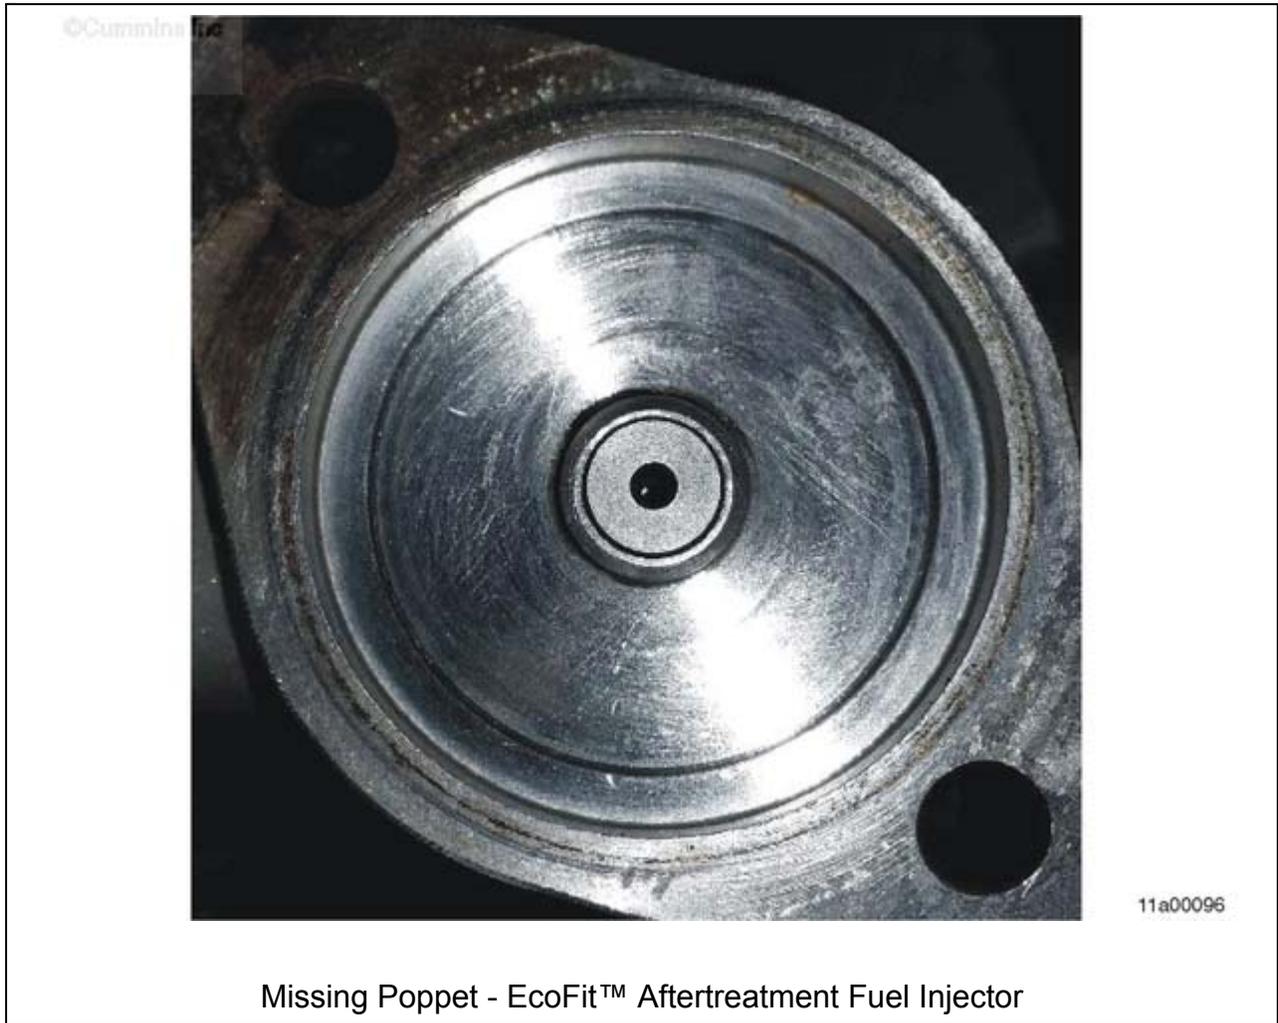
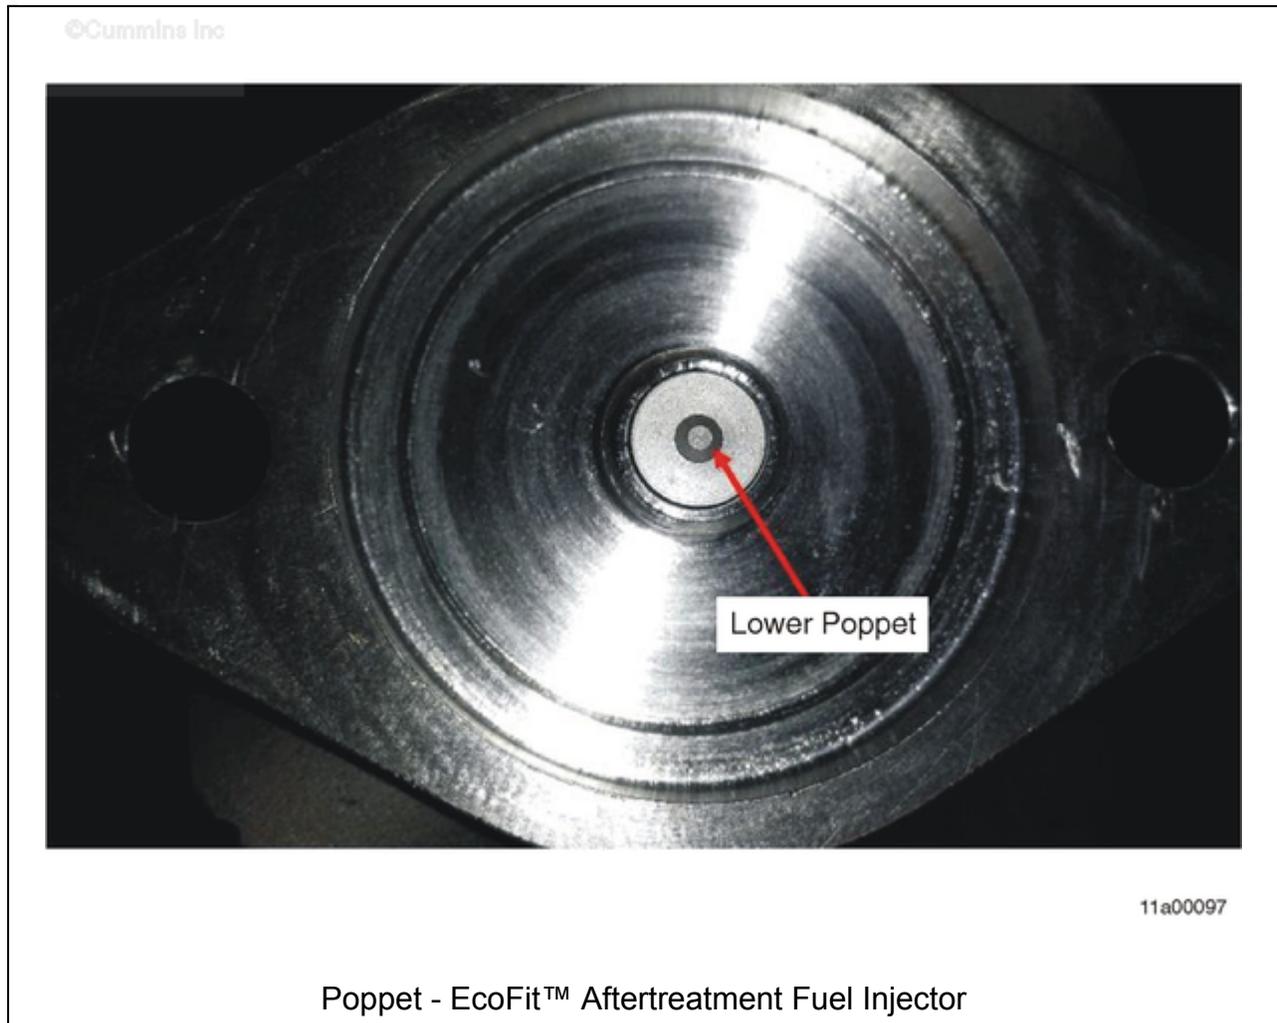
This issue is isolated to the new EcoFit™ aftertreatment fuel injector design. The new EcoFit™ aftertreatment fuel injector is susceptible to the inner poppet falling out due to a worn retaining spring retainer. This situation can increase the probability of fouling that can cause a high restriction of the injection of fuel into the aftertreatment system.

Malfunctioned EcoFit™ aftertreatment fuel injectors will have a hole in the center of the injection point. A normal EcoFit™ aftertreatment fuel injector will have a visible plunger (poppet) at the center of the injection point.

If the EcoFit™ aftertreatment fuel injector is missing the lower poppet, replace the aftertreatment fuel injector.
