PIP5553A SES Lamp With Camshaft or Oil Pump System Related DTCs

Product Investigation Review Required

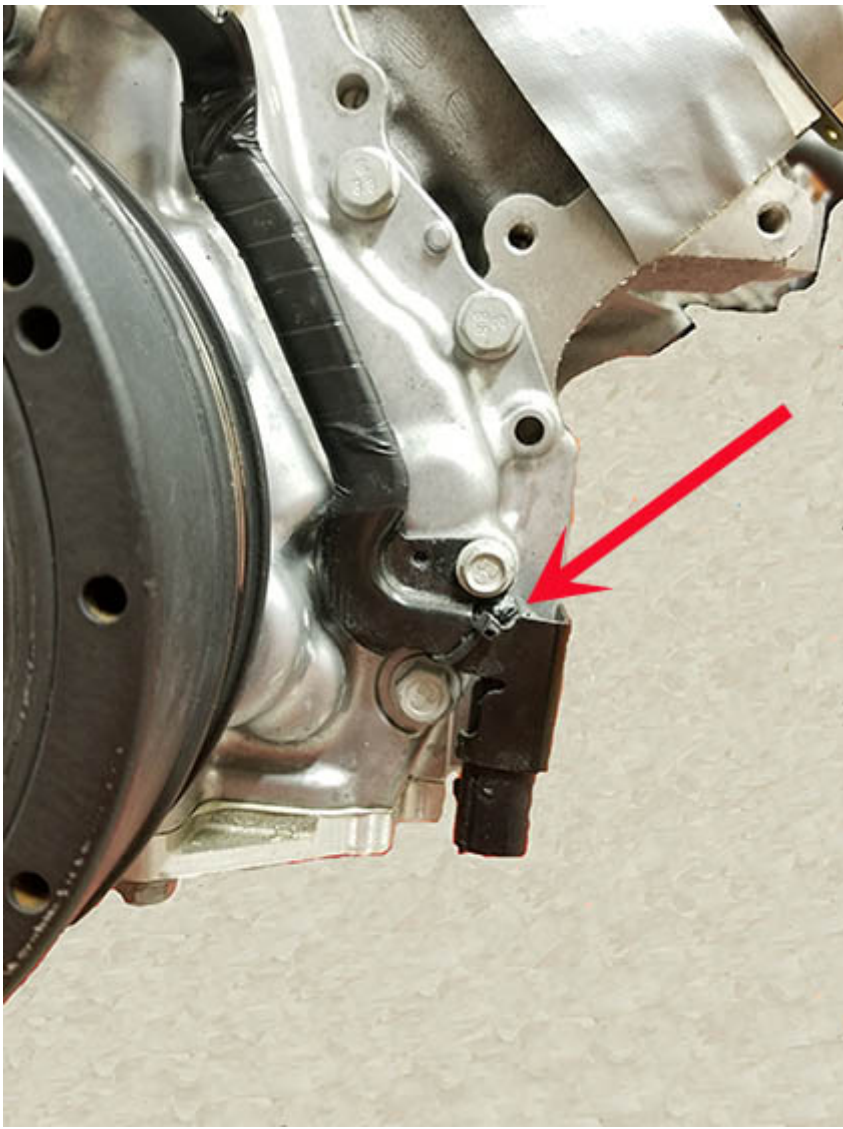
| Cause | Possible wiring jumper harness chaffed at the bolt at the X154 connector on lower left side of the engine front cover. |

Inspect for the wiring harness being chaffed or pinched under the bracket on the location below.

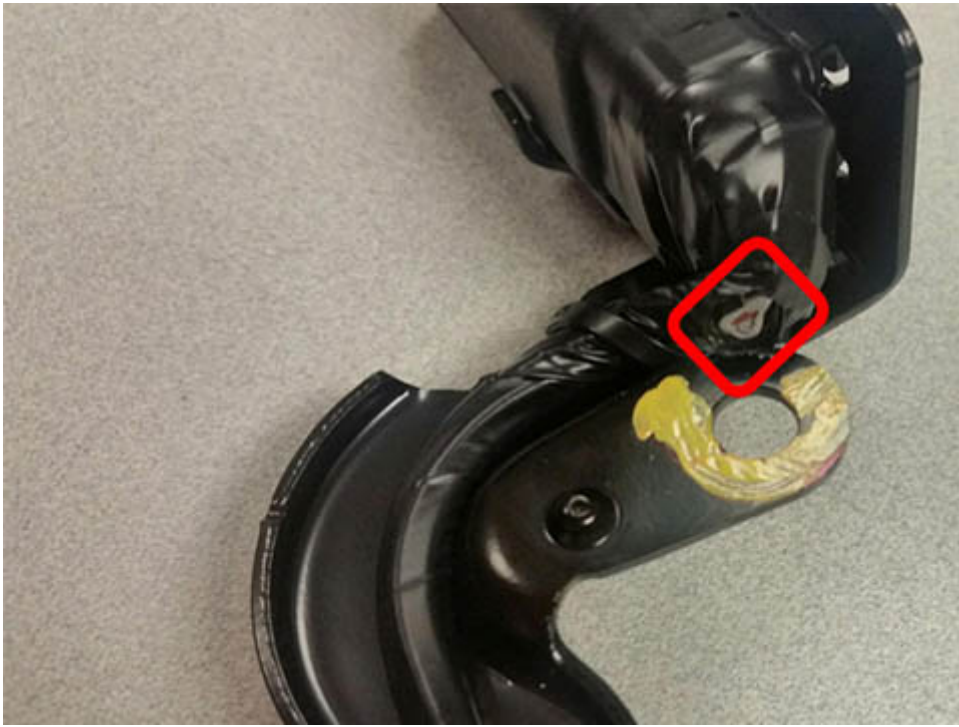
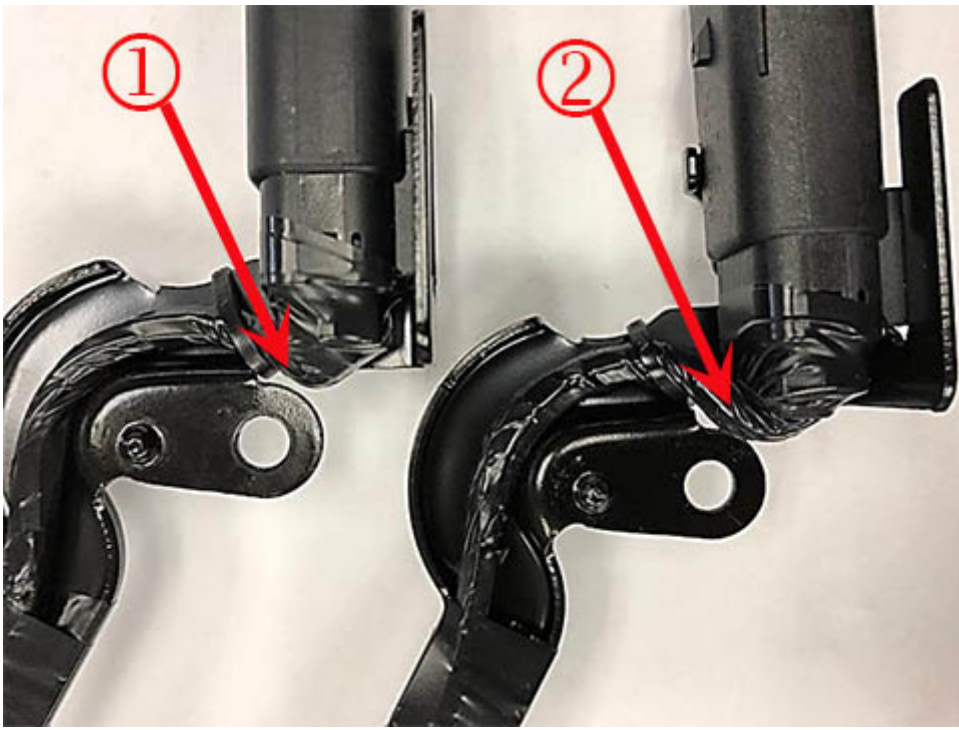
Below is what has been found

Before installing a new jumper harness be sure to inspect the wiring harness.
As seen above 1. shows a good harness 2. shows a suspect harness.
if the harness looks like number 2 please adjust the harness as needed.
