Mack Models

Volvo Models

Title Aftertreatment Hydrocarbon Injector (AHI, 7th Injector) Changes Between US10 And US17 (GHG17, Common Rail Fuel System) - Chassis Experiencing High soot Accumulation, Abnormal (Too High, Overtemp, Too Low) Regeneration Temperatures Following An Aftertreatment Hydrocarbon Injector Nozzle Replacement Procedure

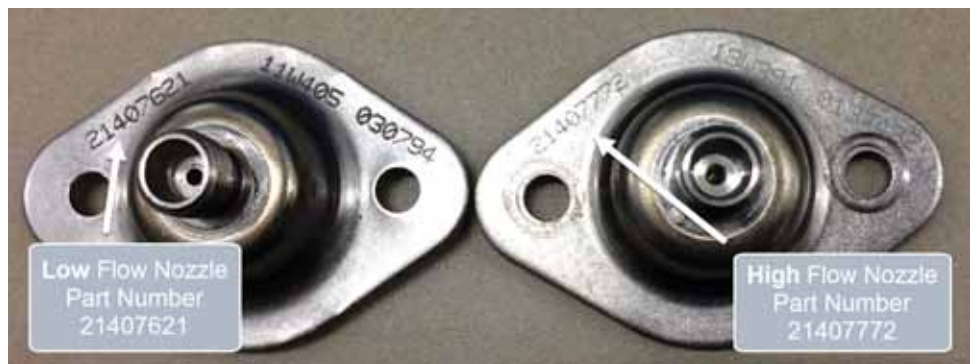
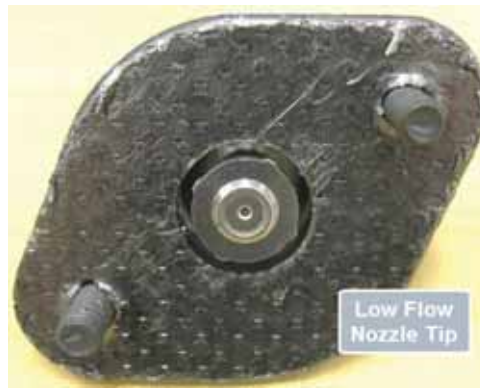
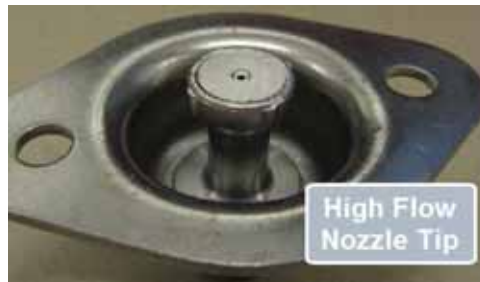
Cause Incorrect part number (P/N) AHI nozzle (7th Injector) may have been installed.

- The low flow nozzle has been used for North American heavy duty engines since 2011. All US17 11L and 13L engines will now use the high flow nozzle (16L engines will continue to use the low flow nozzle).
- The AHI nozzle tip of the low flow and the high flow nozzle are different in appearance. Other than this difference, the two nozzles are visually the same.

Solution Model Year (MY) US17 changes to the AHI system have been made. MY US17 has been updated to a High flow nozzle.
