**\*\* SOLUTION \*\***

**Title** Grounding Bus Bar On Frame Rail Stud; Inspection To Be Performed For Power And Ground, Data Link DTCs - **US13 And Newer Emissions, Common Model Year 2018 And Newer**

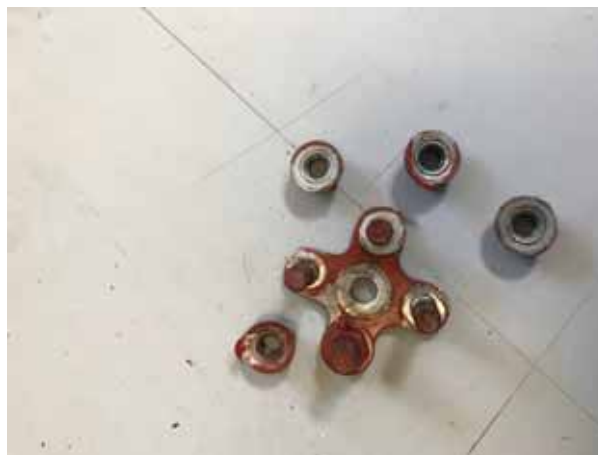
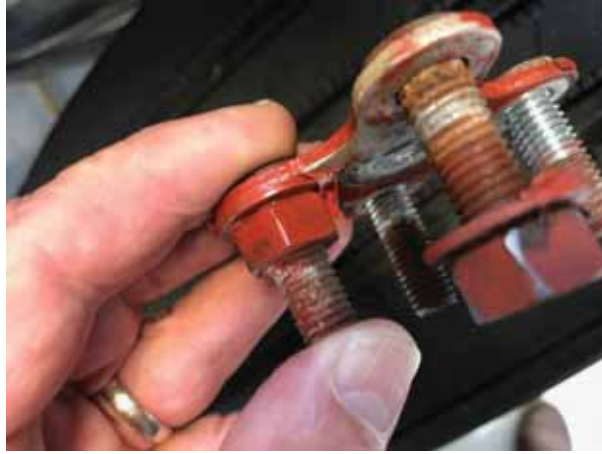
**Cause** The **ground star** is painted before the cables are installed causing insufficient grounding.

**Solution** The ground star is located on the driver's side frame rail near the battery box and fuel tank. Multiple grounds have been moved to this location. If the ground becomes loose or if it gets the protective coating in between the terminals the ground star needs to be removed, cleaned, and the protective coating needs to be reapplied.
