Technical Service Bulletin

01 MIL on, DTC P20E900 or P20FE00 stored in ECM

01 18 80 2034359/4 July 30, 2018. Supersedes Technical Service Bulletin Group 01 number 18-66 dated April 19, 2018 for reasons listed below.

Model(s)	Year	VIN Range	Vehicle-Specific Equipment
Q7	2012 - 2015	All	TDI

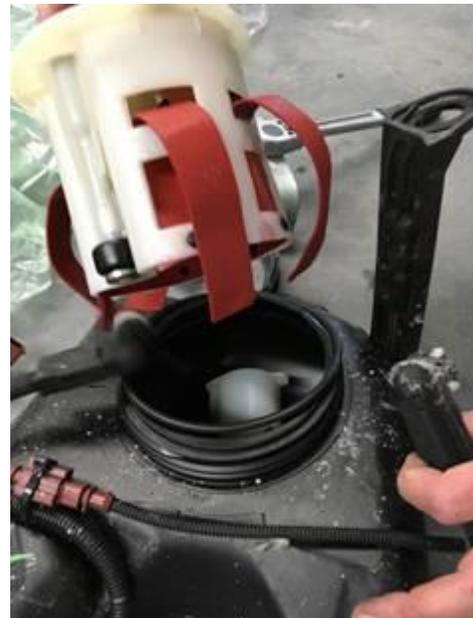
In vehicles produced during a certain period, the AdBlue filter seal within the level sensor module may have been damaged during the assembly process or the AdBlue filter housing may come loose over time. This can allow unfiltered AdBlue to be drawn into the delivery system, subsequently damaging the pressure sensor and reducing agent pump V437.

Figure 1. Filter element housing loose inside tank.

1. In cases with the above fault codes, remove the active tank according to instructions in the Elsa Repair Manual.
2. Remove the G684 Reducing Agent Tank level sensor.
3. Inspect the reducing agent filter housing which should be clipped to the G684 level sensor module. If the filter housing is loose (see Figure 1 and Figure 2), **then the G684 level sensor AND the V437 reducing agent pump must be replaced.**

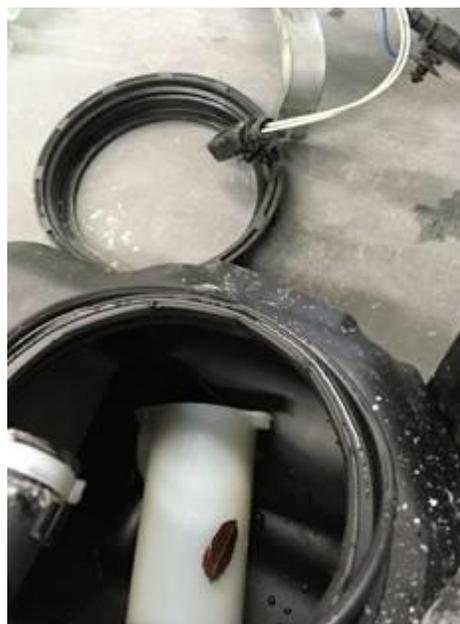
Figure 2. Filter element housing loose inside tank.
